# COATS MARSH REGIONAL PARK

2011-2021 Management Plan

# **Coats Marsh Regional Park Building Condition Report 2010**

**Building Name:** Coats Marsh Regional Park Caretakers Dwelling

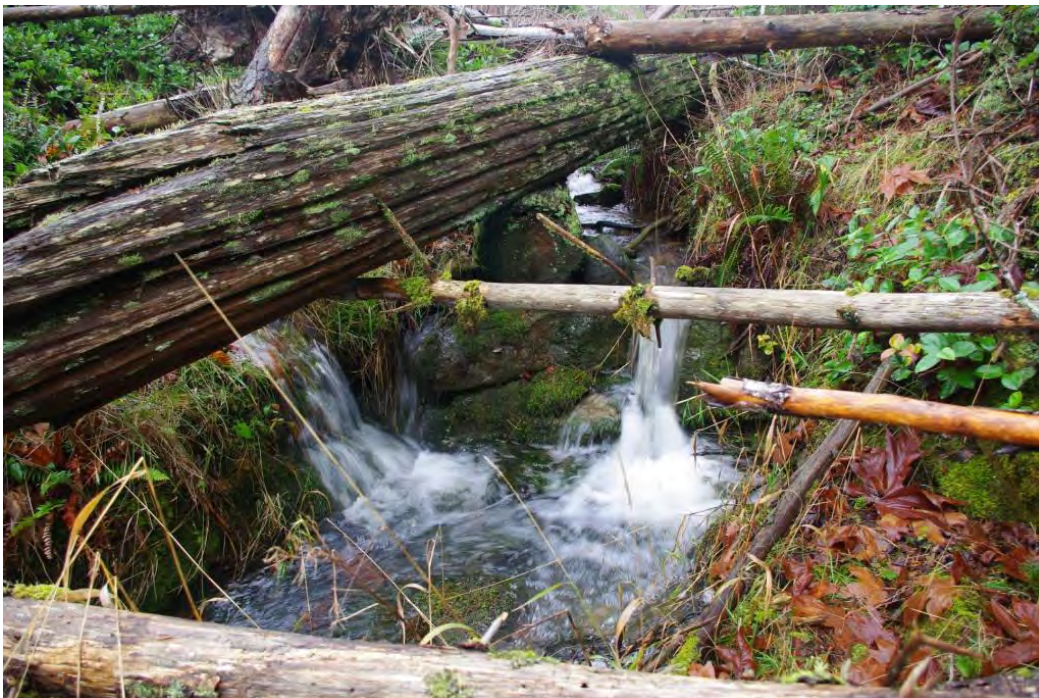
Photograph 6: View of a small rock fall along the Watercourse 1. It is at this point that the watercourse appears to switch between ephemeral and permanent.

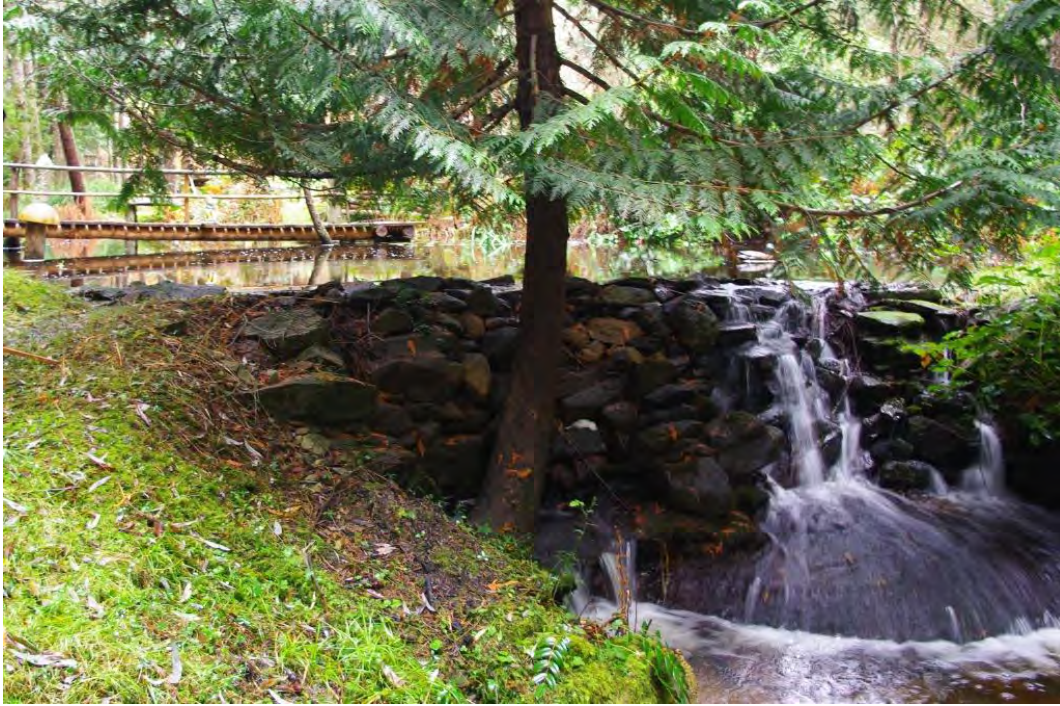
deep and 1.5m wide. Further downstream the trench is more shallow and widens out. On Lot 5 there are two dams made of loose stone, the first approximately 50m downstream from the weir, the second 90m downstream (Photograph 11). Each dam holds the water in ponds to the depth of the dug trench (Photograph 12).

Photograph 11: Watercourse 3, dam and pond on Lot 5.

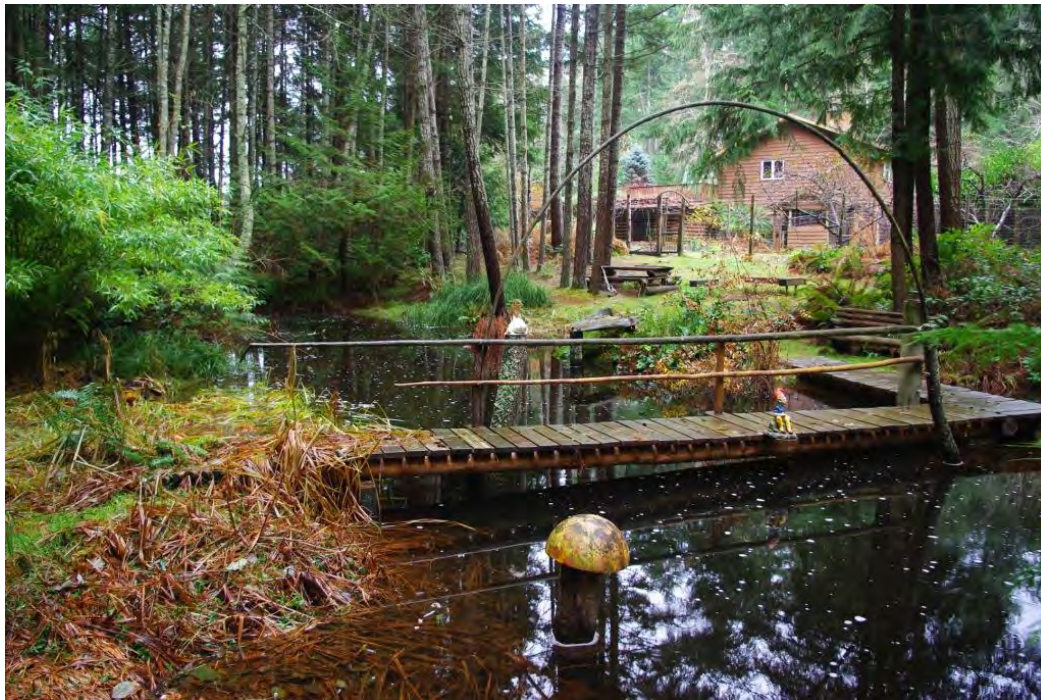
Photograph 12: Watercourse 3 and constructed pond on Lot 5

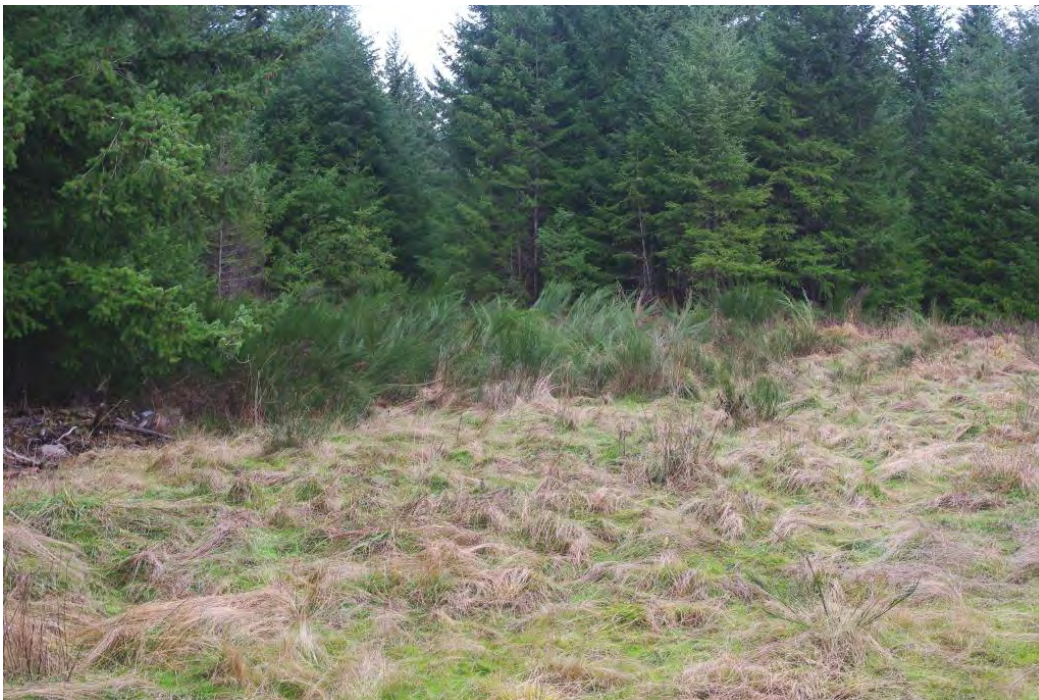
- Scotch Broom was observed as a few isolated plants along the roadways and in larger density within the two burn pile clearings (Photograph 16). In comparison to other sites, the infestation of scotch Broom would be considered very manageable. Scotch Broom becomes established when soil is disturbed. Tilling the soil and attempting to remove the roots may increase the problem. The accepted method for removal at this scale of site would be to cut plants off at ground level just as the plants have flowered but before seed pod production. If this is repeated each year for three to five years the scotch broom would likely be eliminated.

Photograph 16: Scotch broom along the edge of one of the Burn pile clearings.

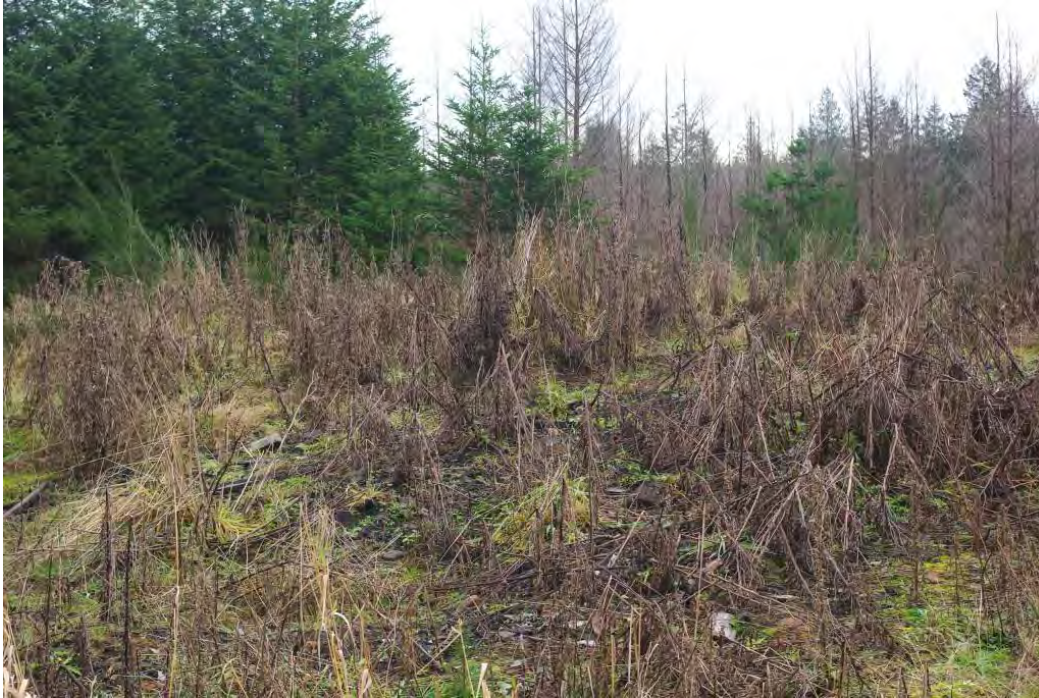
- Canadian Thistle was also observed in burn pile clearing (Photograph 17). Canada thistle spreads rapidly through horizontal roots, As with Scotch Broom, it is best to not disturb the soil, as small roots can grow into new plants compounding the problem. Mowing or cutting plants at the bud stage may be the most effective measure for this site.

Photograph 17: Canadian thistle within a burn pile clearing.

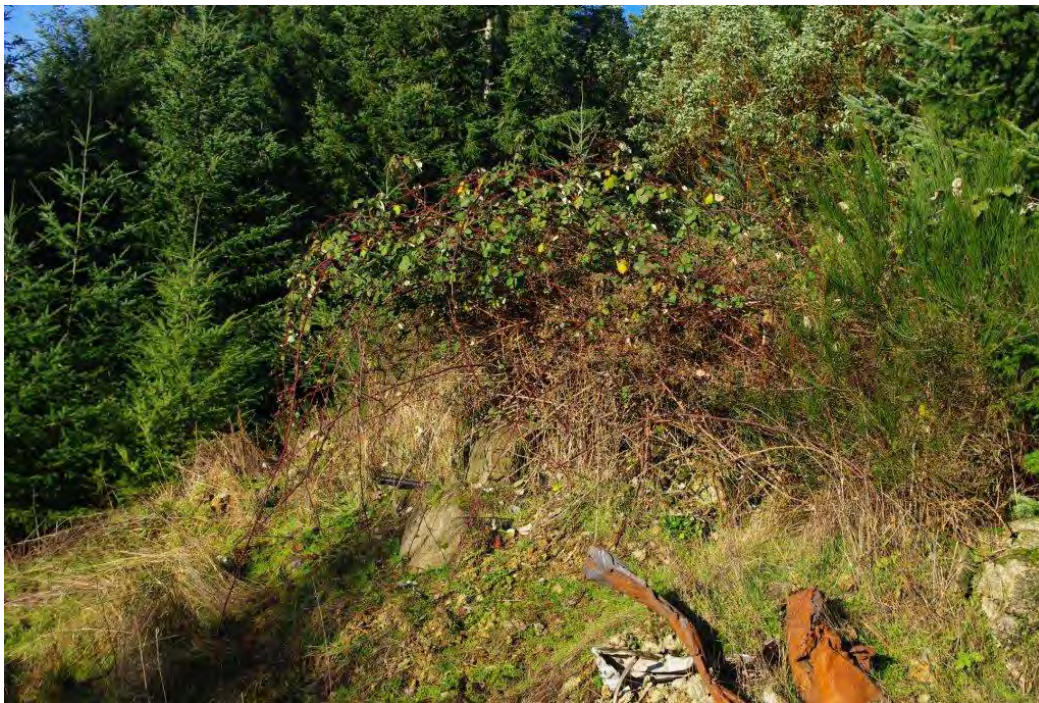
- Himalayan blackberry was observed in an isolated patch around the perimeter of the westernmost burn pile area (Photograph 18). At this time, the infestation of Himalayan blackberries appears minimal as compared to other sites in the local area. Mowing or manual cutting is likely the best method for removal on this site. This would require more frequent cutting than broom or thistle (i.e. mowing or cutting multiple times in a year).

Photograph 18: Himalayan Blackberry within the western burn pile clearing.

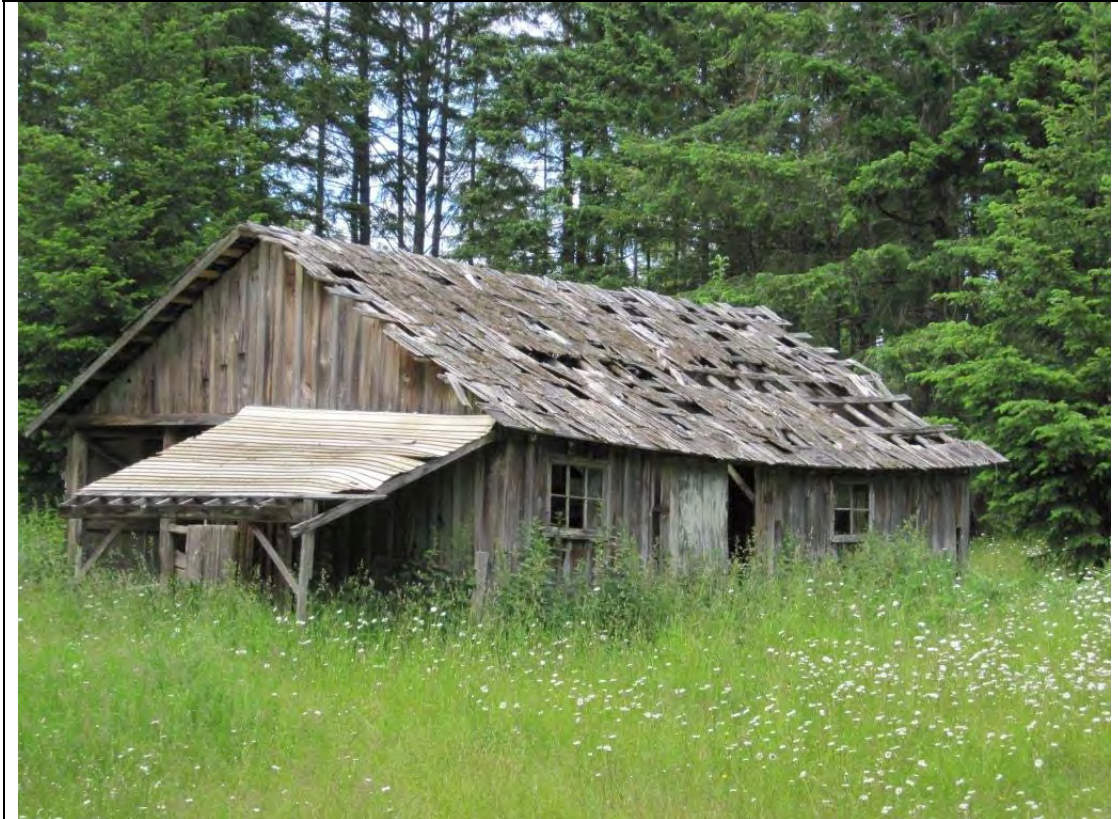
**Building Name:** Coats Marsh Regional Park Barn

The loss of structural integrity due to decay and deterioration will eventually reduce the buildings ability to resist environmental forces resulting in collapse.

This building is beyond a reasonable level of repair, and has no asset value.

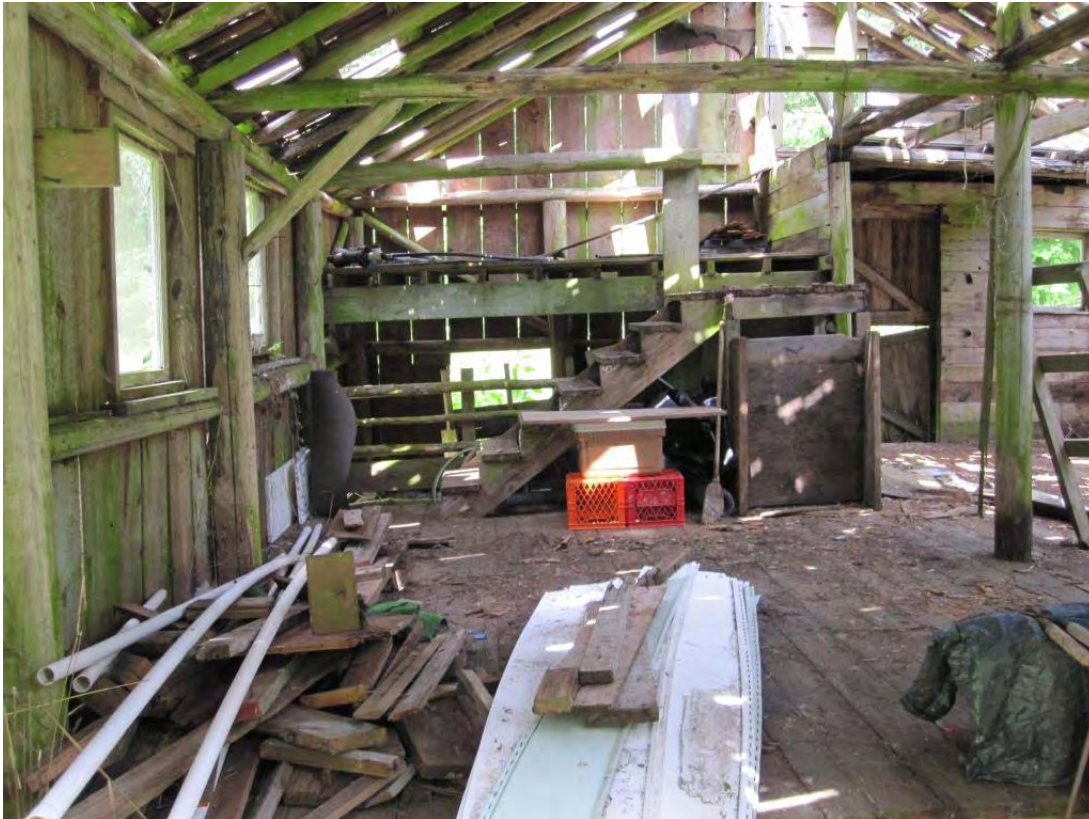
Interior view of barn.

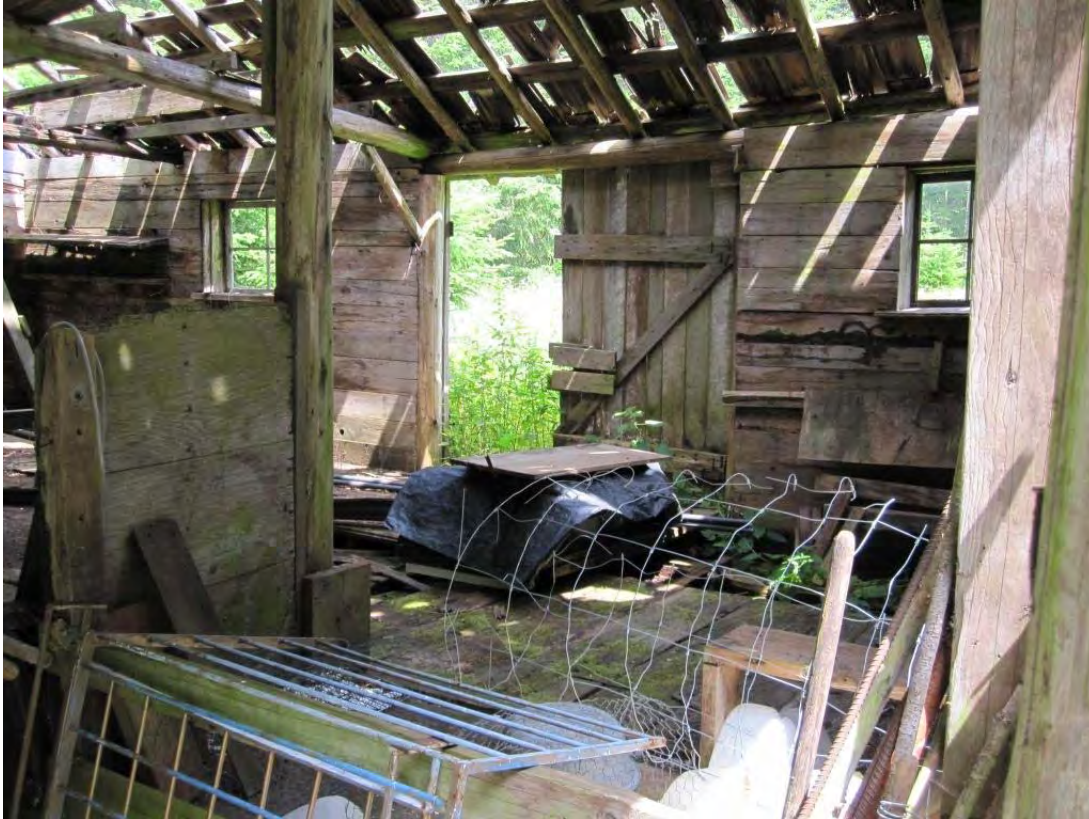
Interior view of Barn.

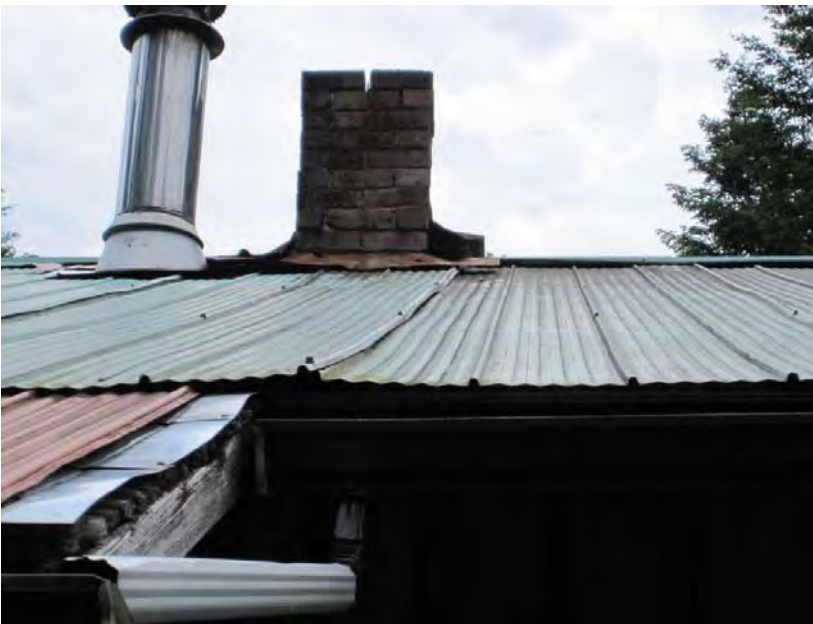
Roof and brick Chimney are in poor condition.
