northwest hydraulic consultants

Project No. 300063

January 3, 2013

**Subject: Miller Road Community Park
Construction Completion Report**

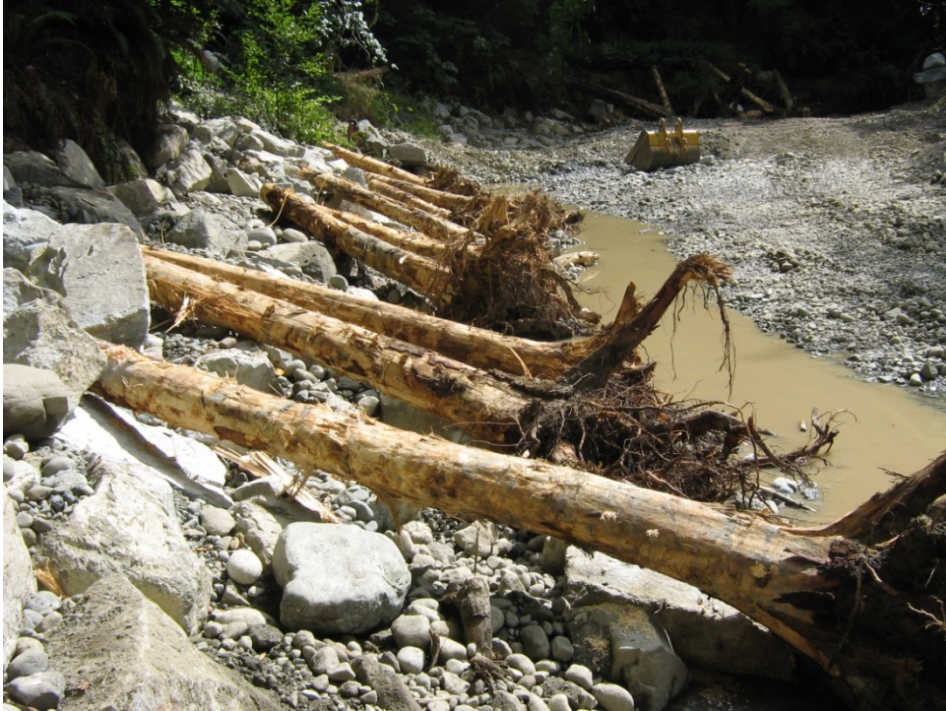
The linear riprap section downstream of the tri-log structures incorporated single stem logs with roots. The LWD is intended to add hydraulic variability, reduce near-bank water velocities, and create small scour pools and provide cover habitat (Photo 8). All LWD was anchored using boulder ballast secured with 12.5 mm diameter wire rope, clamps, and epoxy as per the design (Photo 9).

Photo 8. LWD was added to the linear riprap section to improve fish habitat values.

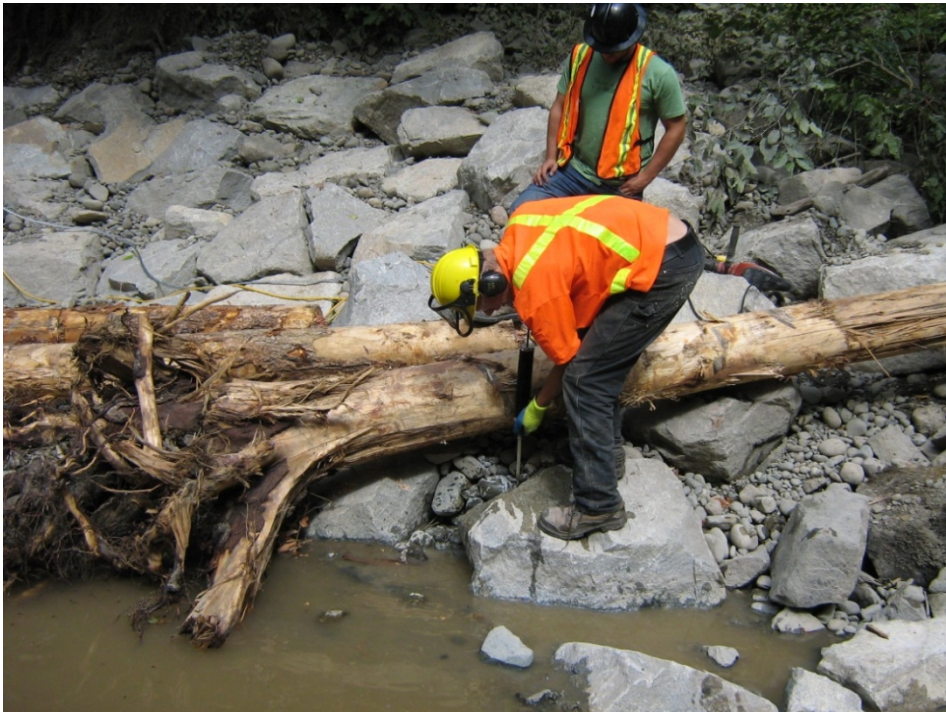
Photo 9. The BCCF crew anchored the LWD to boulders using wire rope, clamps, and epoxy.
