# Grandon Creek Stream Survey – 2015

The Regional District of Nanaimo

August 2015

Written By D.R. Clough Consulting

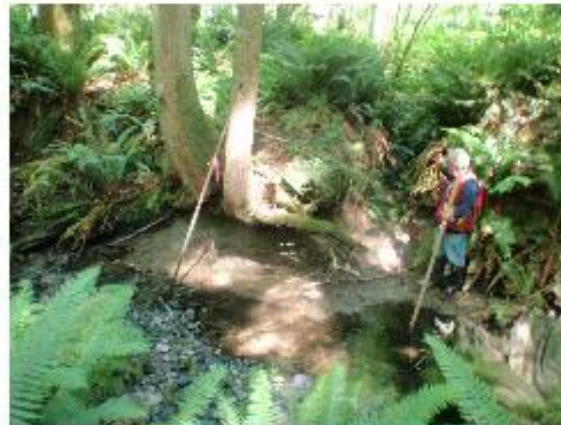
4). Undercut trees in reach 3
