Millstone River Habitat Survey – 2016

The Regional District of Nanaimo

Drinking Water & Watershed Protection

Written By D.R. Clough Consulting

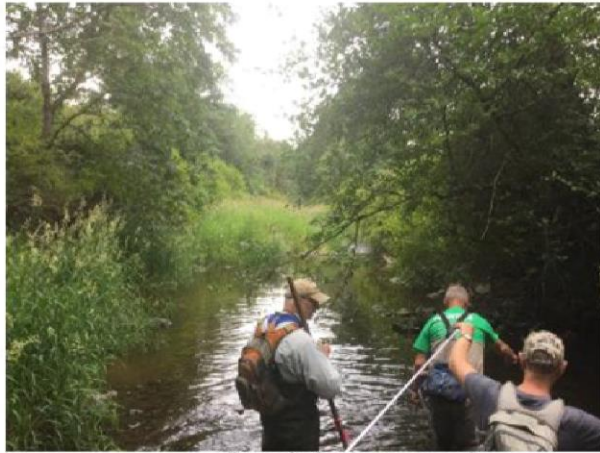
Reach 3 - large pools

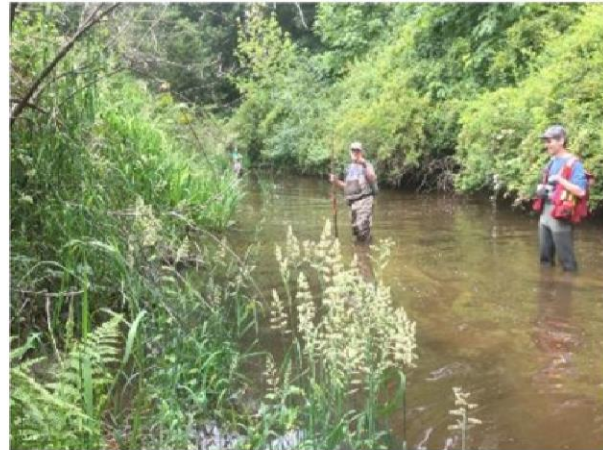
reach 3 - steep treed left bank

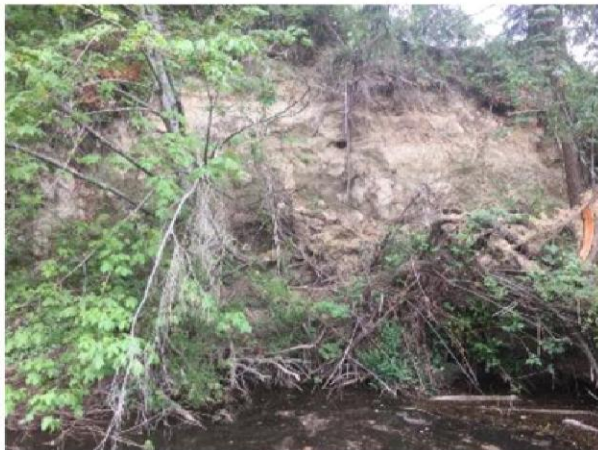
- Lack of wood cover (LWD). This material was washed out or removed over time.
- Erosion was observed on the steep left bank; a treed slide spanning the creek was reported to the City of Nanaimo to inspect for its immediate concern.
- Fine substrates were high indicating sediment inputs. They may be from a storm drain off Bowen that enters into the top of this reach. It also had the most significant bank failure and single sediment source observed in the survey.
- The thin riparian average width of 10m resulted in a canopy closure of only 61%.
- Lack of conifer riparian trees, most were young trees and/or deciduous trees with poorer canopy and root structure.

Reach 3 - Slide site

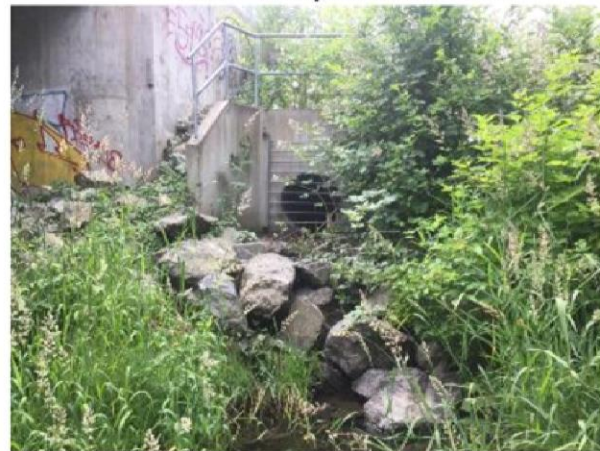
Reach 3 - Outfall into creek

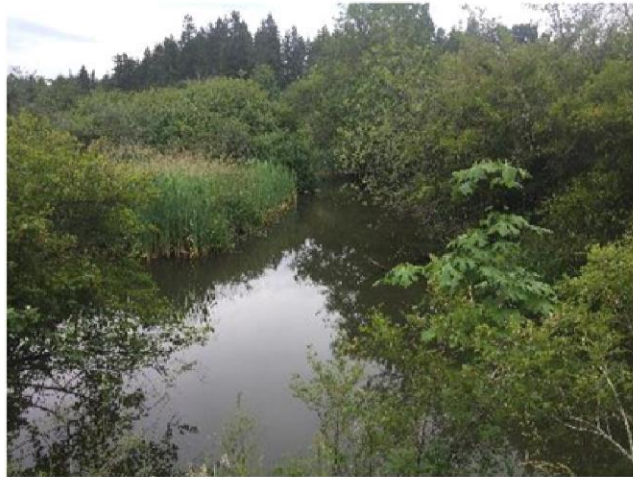
Reach 4 - with shrub riparian

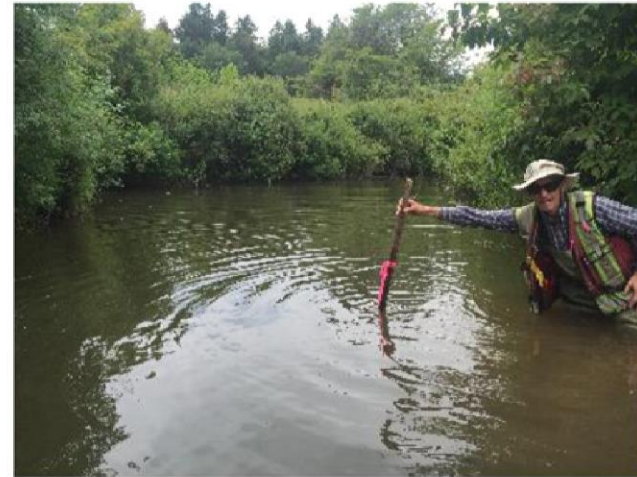
Reach 4 - with deep pools

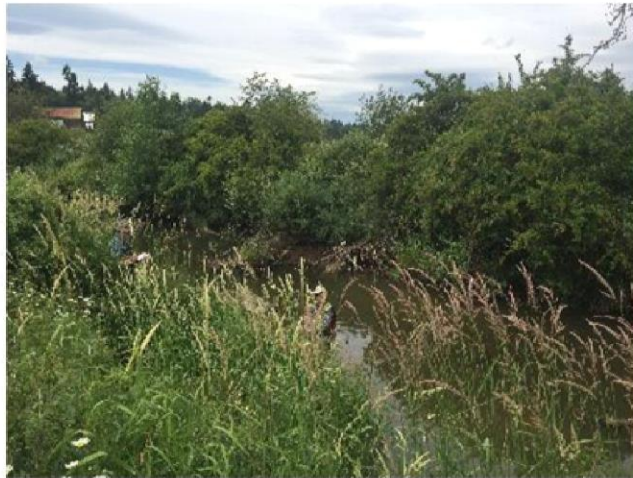
- Lack of wood cover (LWD). This material was all removed when the first farmers cleared and drained the land.
- Erosion was evident along most of this reach, primarily due to the steep gravel/sand banks with no embedded tree roots. The reach had soil blocks calving off the sides of the bank.
- Fine substrates were high confirming the sediment inputs from erosion.
- The thin riparian average width of 5m resulted in a canopy closure of only 45%.
- Lack of riparian trees and shrubs is the most significant impairment, much of the erosion and sediment could be minimized with a healthy riparian community.

Reach 4 - eroding soil blocks

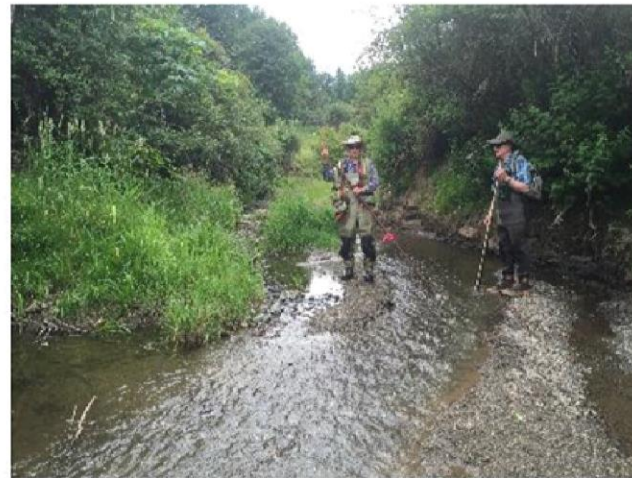
Reach 4 - the only gravel riffle

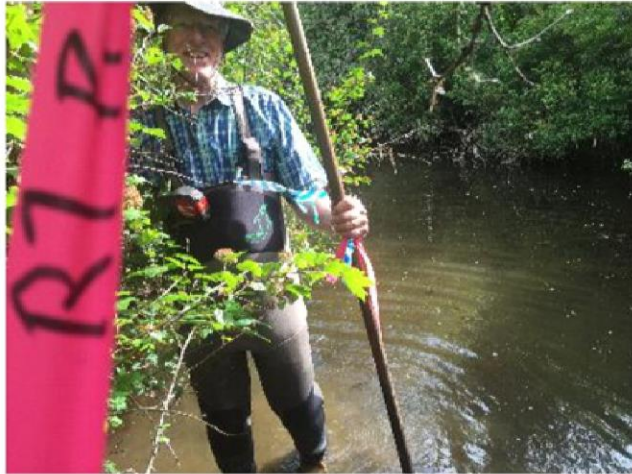
Reach 7 - Pool start

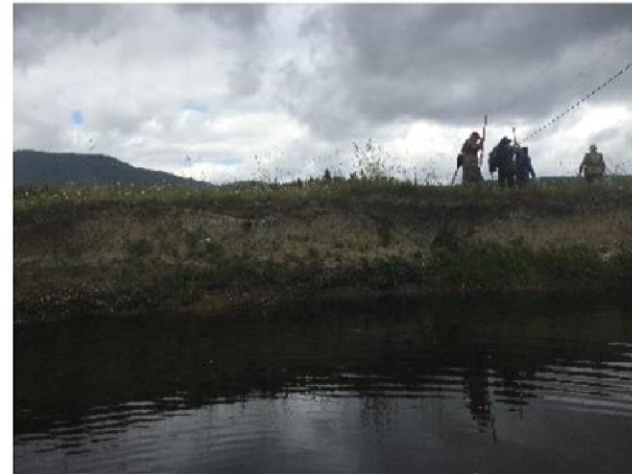
Reach 7 - erosion at bridge outlet

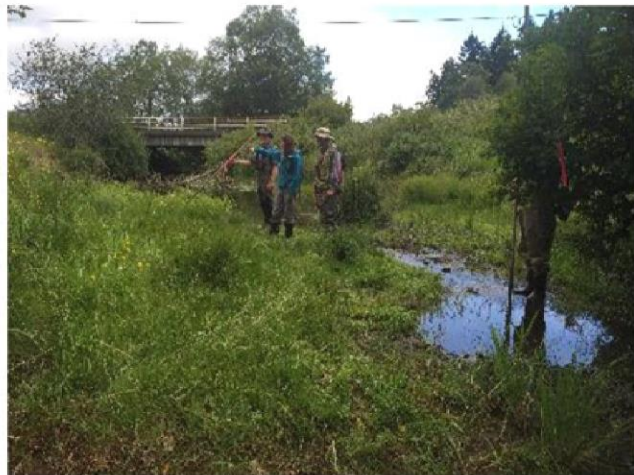
R7 - Sediment across stream channel

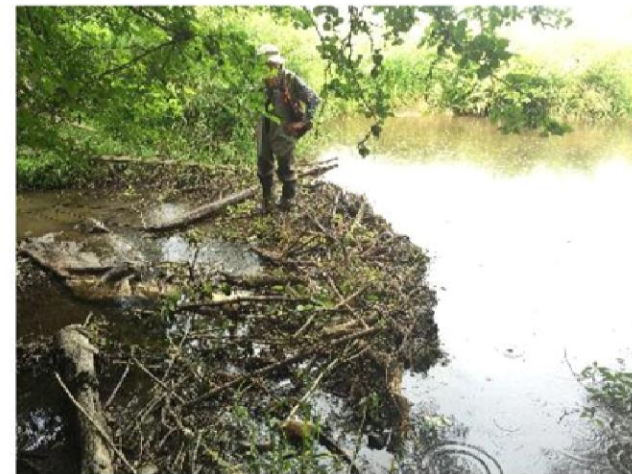
R7-beaver dam above Biggs Rd bridge

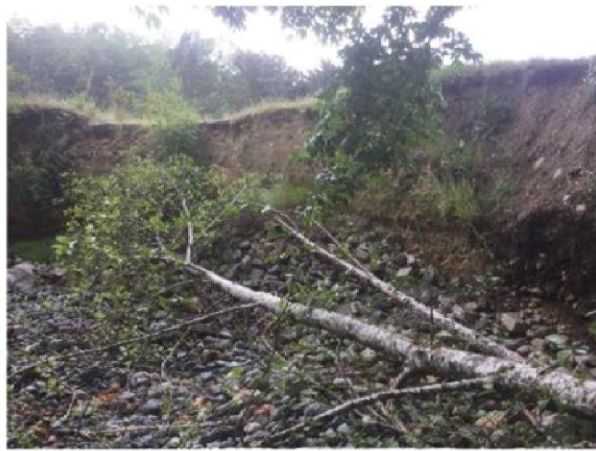
- Lack of instream wood cover (LWD). This material was all removed when the first farmers cleared and drained the land.
- Erosion was evident but less than Reach 4 as the banks were lower and slightly better riparian strength.
- Fine substrates were high confirming the sediment inputs from erosion.
- The thin riparian average width of 5m resulted in a canopy closure of only 53%.
- Lack of riparian trees and shrubs is the most significant impairment, much of the erosion and sediment could be minimized with a healthy riparian community.

Reach 5 - Erosion site

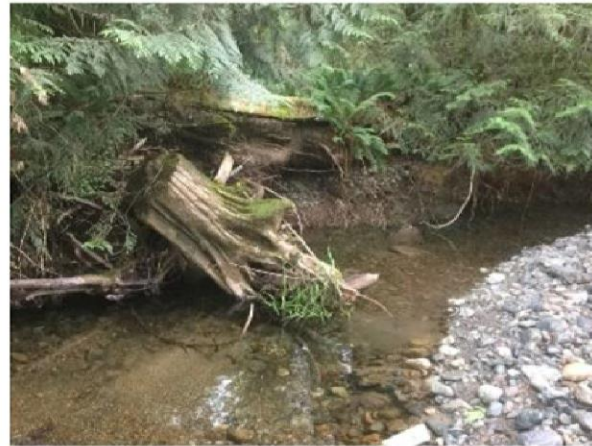
reach 8 - small loose wood debris

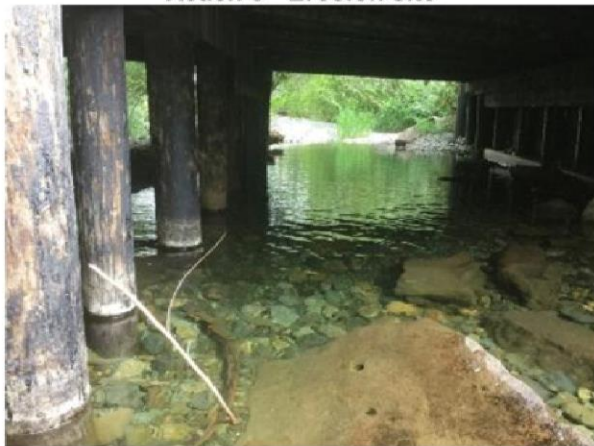
Reach 8 at Biggs Bridge

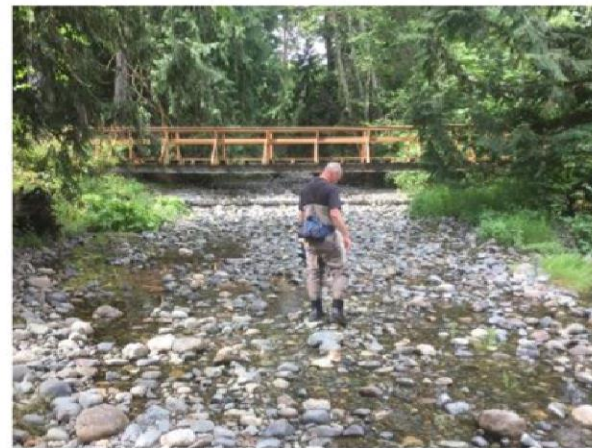
Reach 8 - shallow site

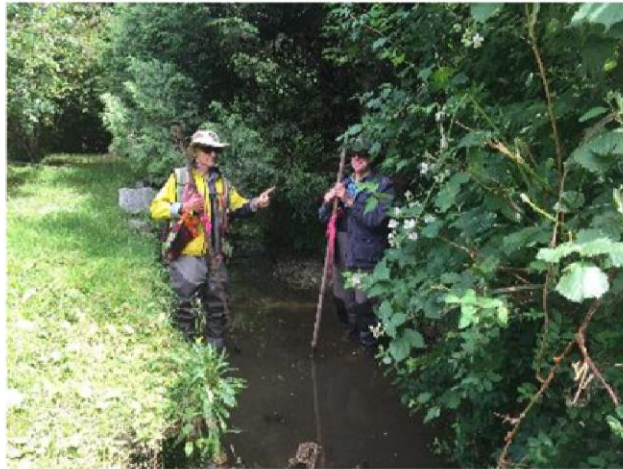
Metral M1- cleared right bank

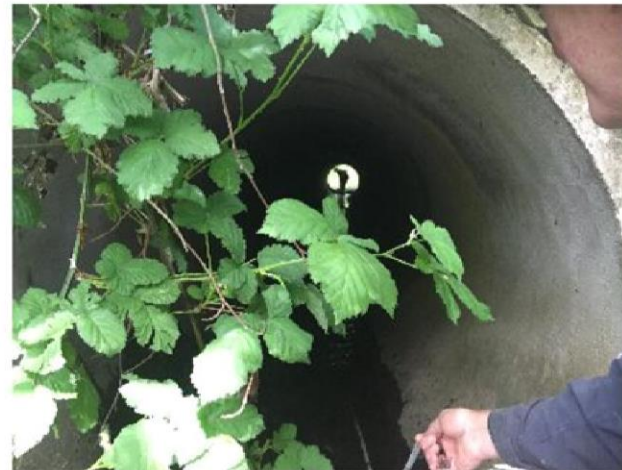
Metral M1 - Garside Rd Culvert

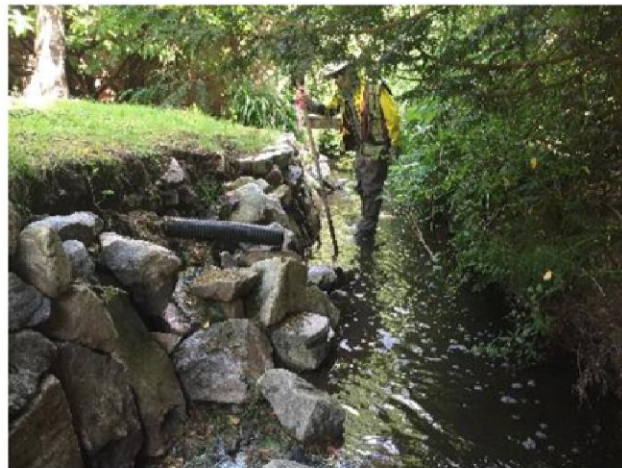
Metral M1 - altered bank and drains

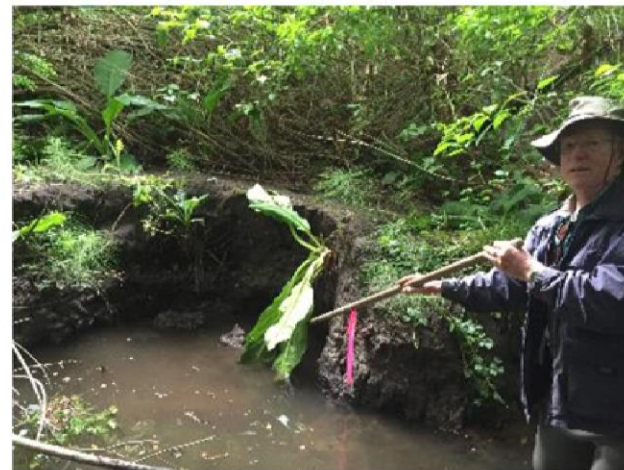
Metral M1- erosion from storm water

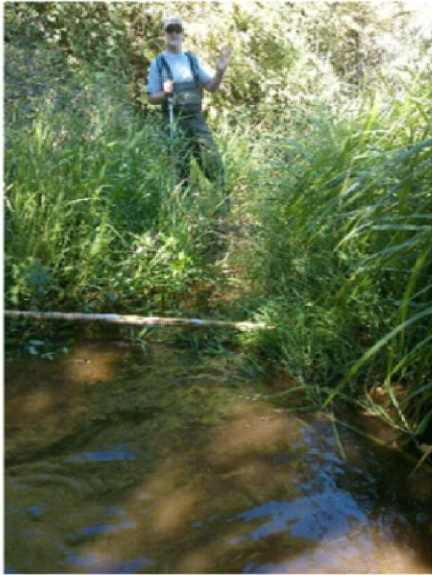
1.) Deep pool in brushy area.

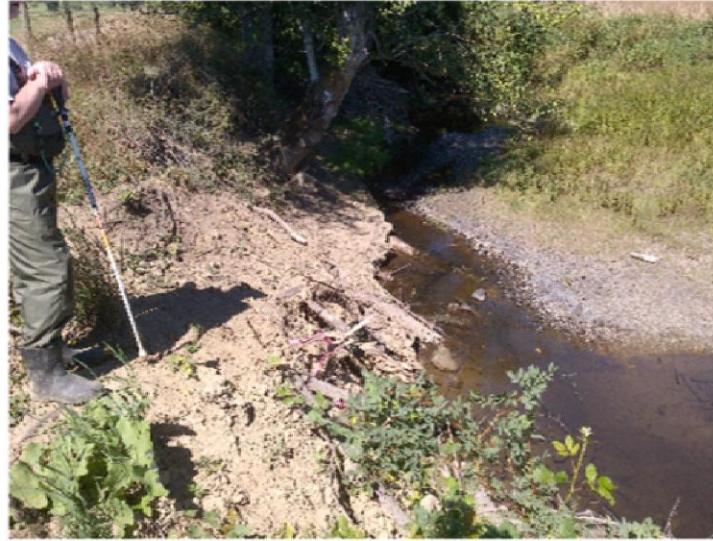
We only waded in a few sections of the river on Island Valley Farms section but did meet the manager, Mark Fortin. He was looking for solutions to fixing three areas with eroded banks. He does have access to an excavator. I suggested that eventually a consultant such as Dave Clough could provide a design and work plan and the farm could do the work. We could only find one eroded bank which was getting close to the farm’s road. It was about 3 metres high and had a log and some signs of remediation work done on it. We found another fairly long riffle near an unused cattle crossing section of the river. The other beaver dam that I had observed over 6 years ago was also not located but likely still there. The section of the river on the land leased by the Correction Center was not accessed either.

3.) washout on Island Valley Farm

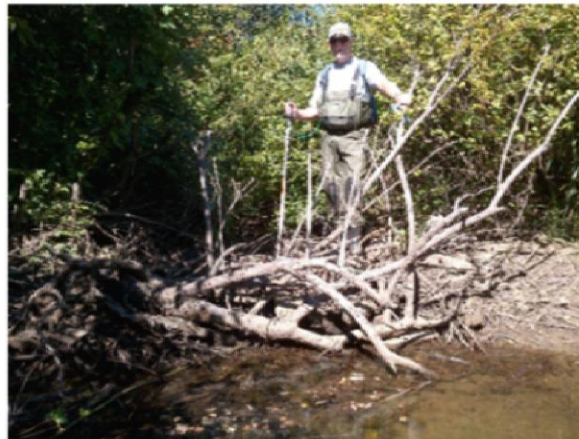
2.) Inactive beaver dam
