REGIONAL DISTRICT OF NANAIMO

ACCESS TO WATER SITES

INVENTORY AND SITE DESCRIPTIONS

ELECTORAL AREA H

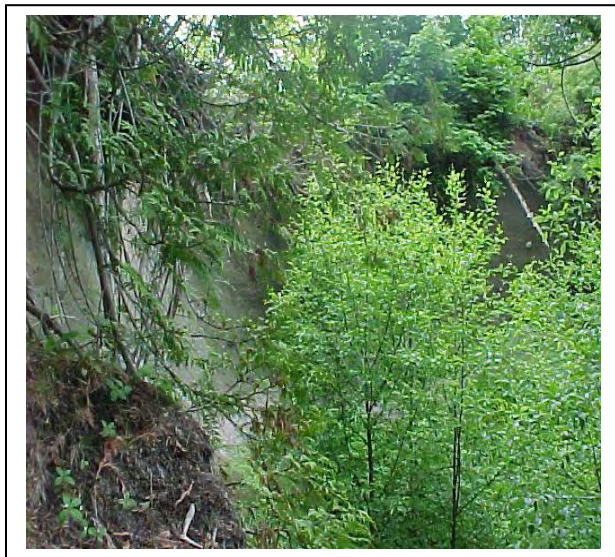
Hazards: Major bank slump at edge of bluff (6-8 m's in height), steep slopes

Bank slump

Development options: Leave as is for now.

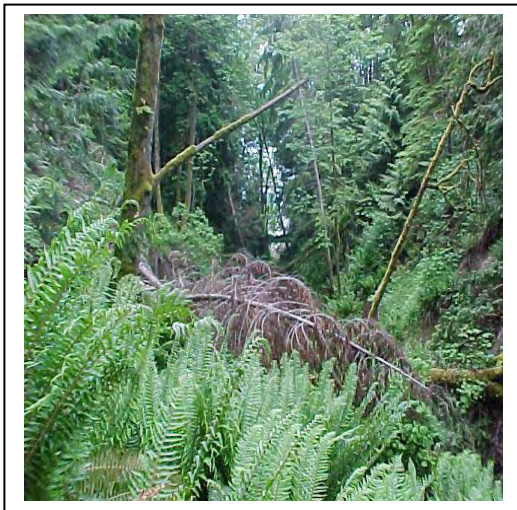
Description: Appears that the R/W is totally within the lower ravine topography. Major slump at bluff edge and the lower creek ravine is moderately steep sided (70%+) and unstable. Last 1/4 of ravine has shallow sloped bottom out to beach. MoTH has erected Danger /Hazard signs at the bluff edge.

Ravine from 1/2 way down slope

Development options: Leave as is for now.

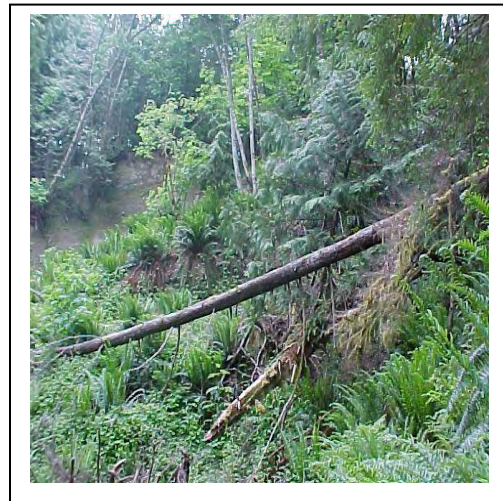
Slump and ravine slope

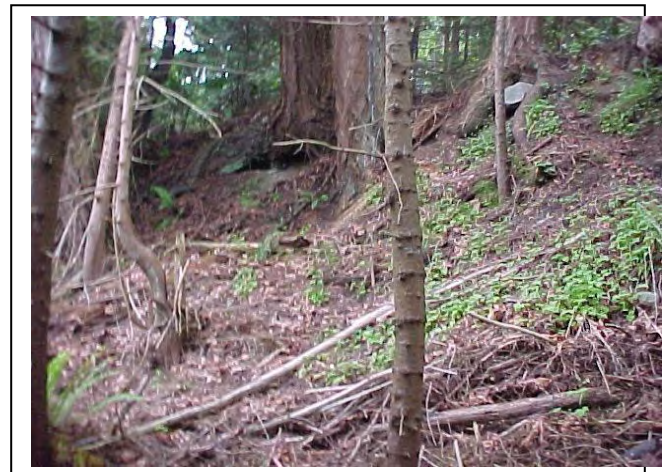
Hazards: Steep bluff slope

Bluff slope just back of beach

Development options: No treatment at this time as good access is available immediately north at Alert Rd.

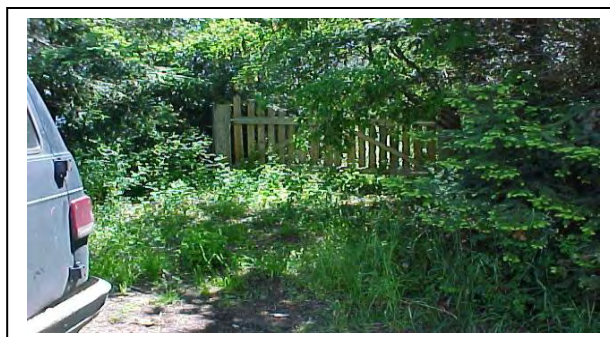
Hazards: Backing out into highway traffic, highway parking

Gate and brush

Development options: Post beach access sign. It may be possible to brush out moderate to heavy brush for 2 additional parking spots or to improve turnaround capability. No development at this time.

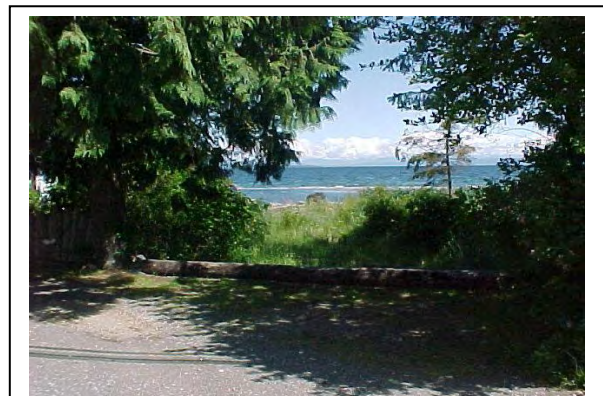
Description: Easy foot access to beach area. Site has a community mailbox and bus shelter located on the R/W. Extensive depressed lowland back of the beach, this is no problem for access but may become a moist area in the wet seasons. The backbeach of the 1st Nations property has been extensively reinforced with large concrete blocks. Beach area is composed of mixed fine sediments and a sandy backshore

Blocked access, private fence in shade-left, depression beyond log barrier

Development options: Post beach access sign. Fill road depression for improved vehicle access for boat launching.

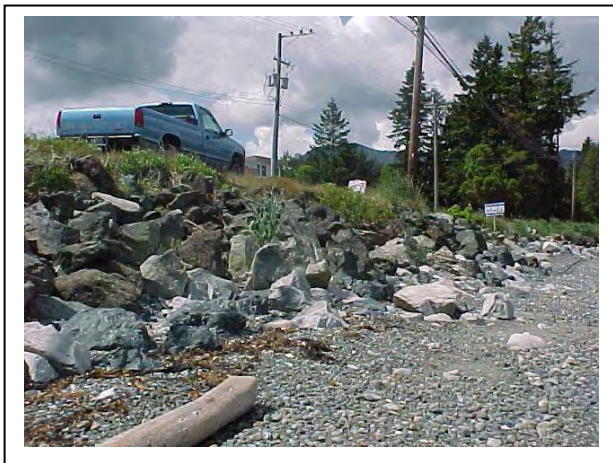
Hazards: Proximity to highway, steep rip rapped bank down to beach, dangerous highway parking

Riprap reinforced bank

Development options: None at this time

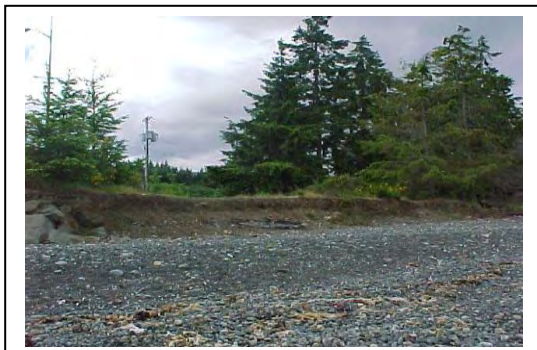
Hazards: Portion of bank eroding (20 m. x 1 m. ht.), 1 small snag (minimal safety concern)

Backbeach erosion

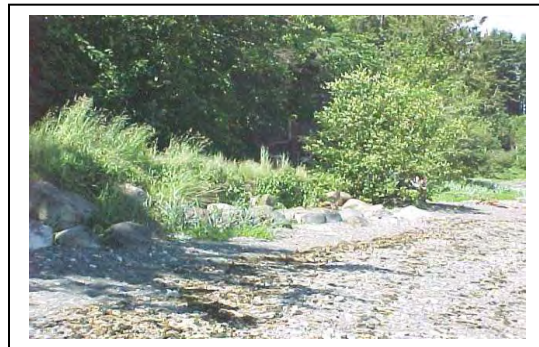
Hazards: Eroding road bank 1 m. in height at back beach

Eroding bank with open access in background

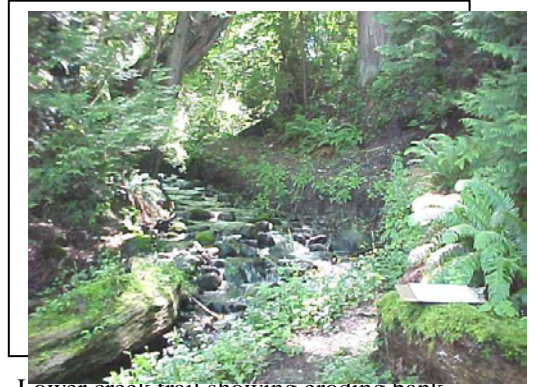
Hazards: Steep side slopes on main trail, creek trail too close to creek, vertical bluff at back of upper park area

Lower creek trail showing eroding bank

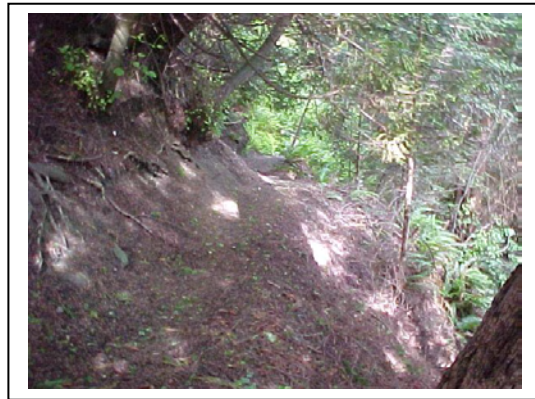
Footpath: A trail of variable width and slope leads to the backbeach area. The upper portion of the trail runs along the top of the creek ravine. It has exposed, steep side slopes (80-100%), exposed roots and an extreme tread outslope. These are all potential safety hazards. The lower sections; are lightly brushed in, have muddy or rutted sections, and have improvised wooden steps. At the ravine section there is a steep "goat" trail that switchbacks down to the creek edge below. This is a very unsafe access route for the unaware. The creek is also accessible by way of a wide, level trail from the bottom of the main beach access trail. At the creek, there is a narrow path that leads along the creek bank for an unknown distance. A section of this is along an eroded creek bank. The trail is becoming brushed in and has some windfalls crossing it.

Mid main trail showing tread out slope and open side slope
