DECOURCEY

Water Service Area Annual Report 2011

Water & Utility Services Department

June 2012

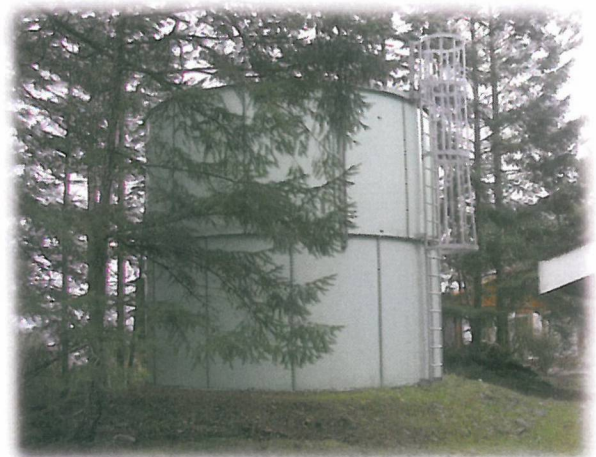
**Decourcey Water
Storage Reservoir**

One steel above-ground reservoir is present at 3280 Bissel Road, and has a capacity of 136 m³ (30,000 imperial gallons).

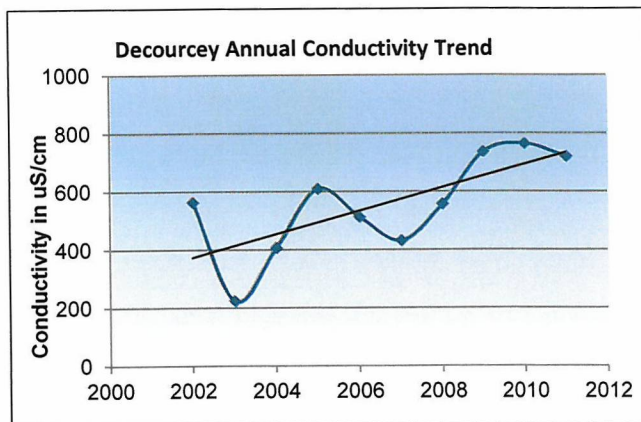
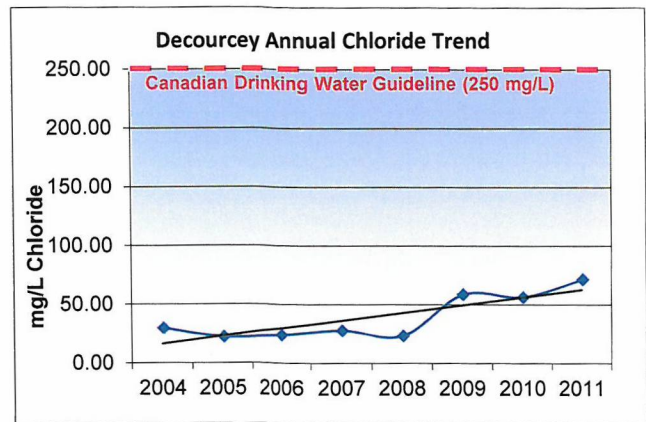
The Conductivity and Chloride levels in the Decourcey water system are generally increasing year to year. In 2010 and 2011, letters were sent to all water system users encouraging year-round water conservation in order to reduce or reverse the potential for saltwater intrusion.

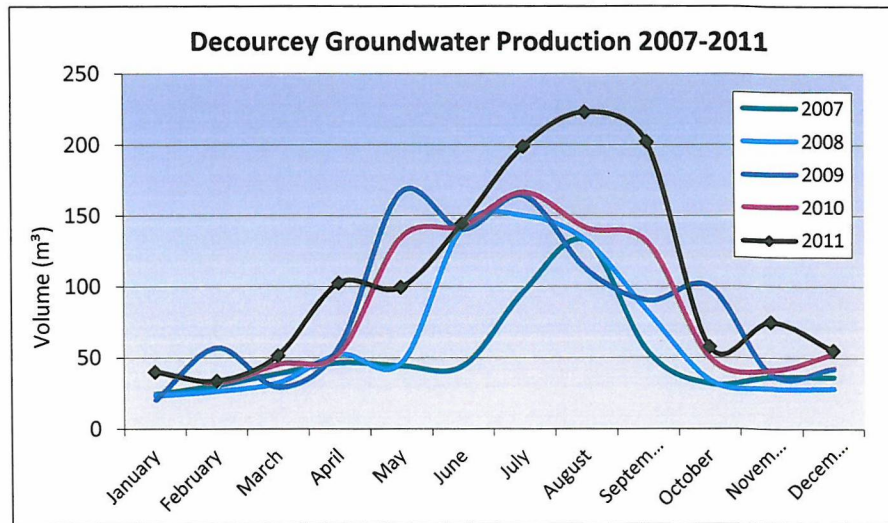
The monthly groundwater production in the Decourcey system for the past 5 years is shown in the chart below. Groundwater production in 2011 was higher than previous years. The higher water usage can be attributed to one new home being added to the water system, and extensive renovations taking place at another home in the water system.

In the Fall/Winter of 2011, the average usage per home in Decourcey was 0.33 cubic metres per day (72 imperial gallons). In the summer, the average water usage was 1.04 cubic metres per day (229 imperial gallons). Based on these figures, the annual consumption per capita is estimated to be 237 L/day (based on 2.4 people/household). This consumption is 12% less than the RDN system average of 269 L/day/capita for 2011.

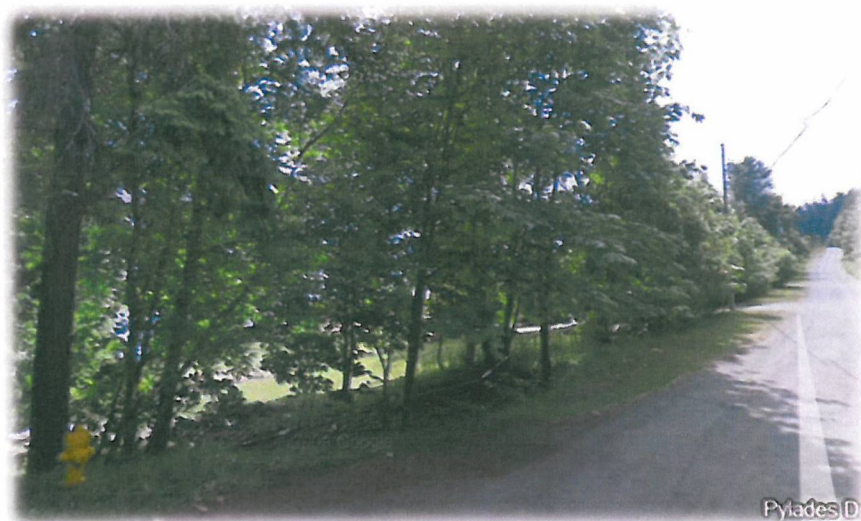
APPENDIX A

**MAP OF DECOURCEY
WATER SERVICE AREA**

The Decourcey Water Service Area was established in 1998 in a rural area south of Nanaimo, and comprises two properties on Bissel Road and three properties on Pylades Drive. The water source for the Decourcey Water Service Area comes from one groundwater well located nearby. The water supply is stored in one reservoir and is chlorinated manually. A portable generator is available in the event of a power outage. A map of the Decourcey Water Service Area is provided in Appendix A for reference.
