# COATS MARSH REGIONAL PARK

2011-2021 Management Plan

# **Coats Marsh Regional Park Building Condition Report 2010**

**Building Name:** Coats Marsh Regional Park Caretakers Dwelling

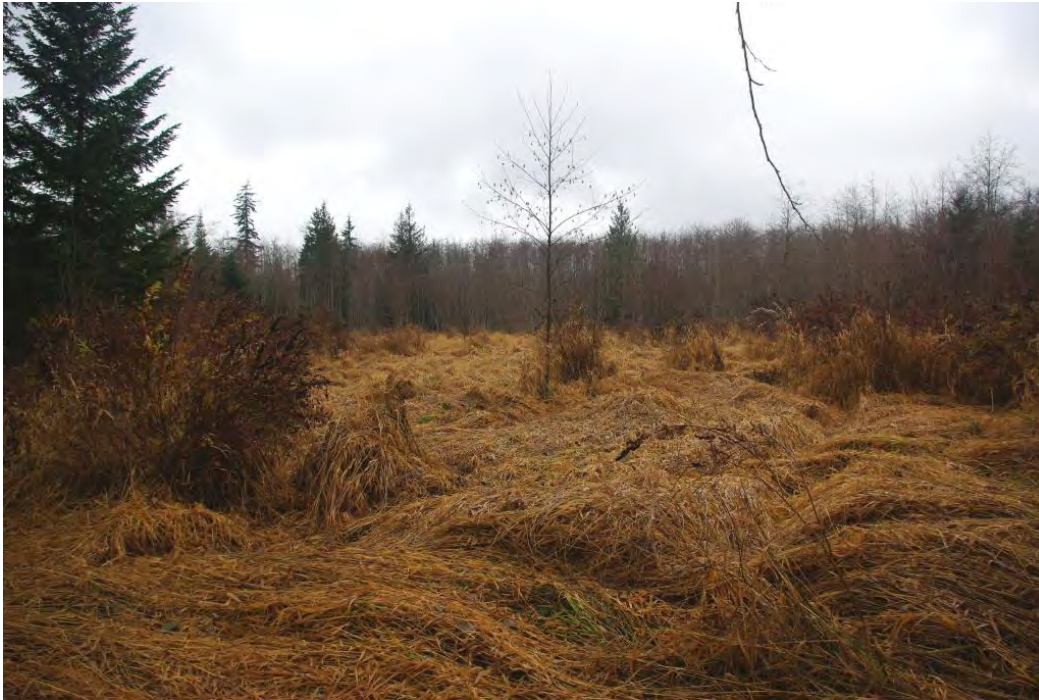
Watercourse 1 flows from the wetland beyond the NE corner of the park (Photographs 1, 2 and 3) approximately parallel to the north park boundary. The first portion, to halfway across the park, at Photographs 4 and 5, had a flow of approximately 1m wide and 0.2m deep at its deepest point. Watercourse 1 most likely picks up subsurface flow from lands within the Hoggan Lake watershed to the north. The abundance of arbutus trees, as shown in Photograph 5, suggest well drained soils on the rise to the north. The upper section of the Watercourse 1 appears to be an ephemeral flow as the creek bottom was fully vegetated. Beyond a small fall, as shown in Photograph 6, the watercourse appears to have year-round flow as there is a sand and gravel streambed. Near the west park boundary is a shallow basin water catchment area (Photograph 7). Watercourse 1 exits the park at the west boundary and flows through private land to Hoggan Lake.

Photograph 1: Wetland area north-east of Coats Marsh Regional Park

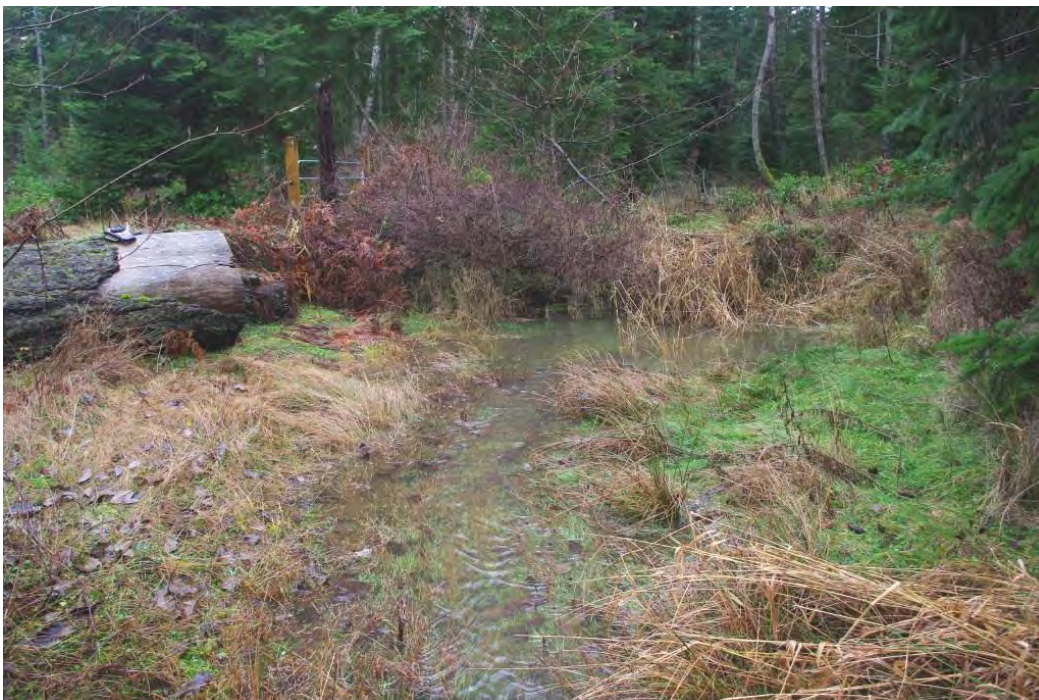
Photograph 2: Watercourse 1 leaving a wetland area and flowing into Coats Marsh Regional Park at the north-east park boundary.

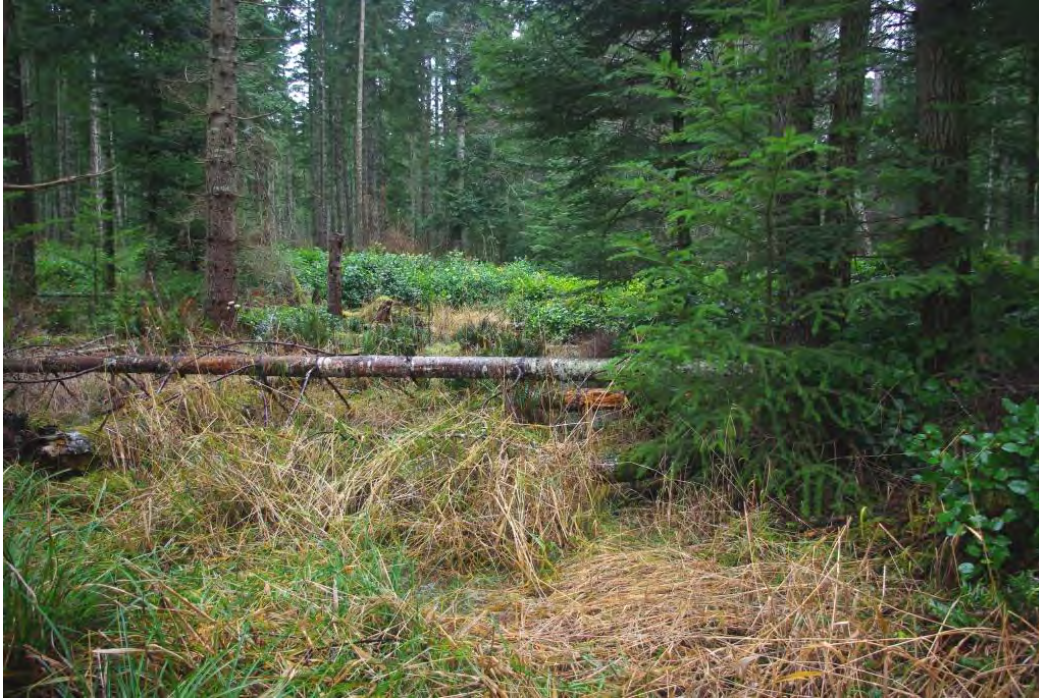
Photograph 3: Watercourse 1 looking downstream near the north-east park boundary

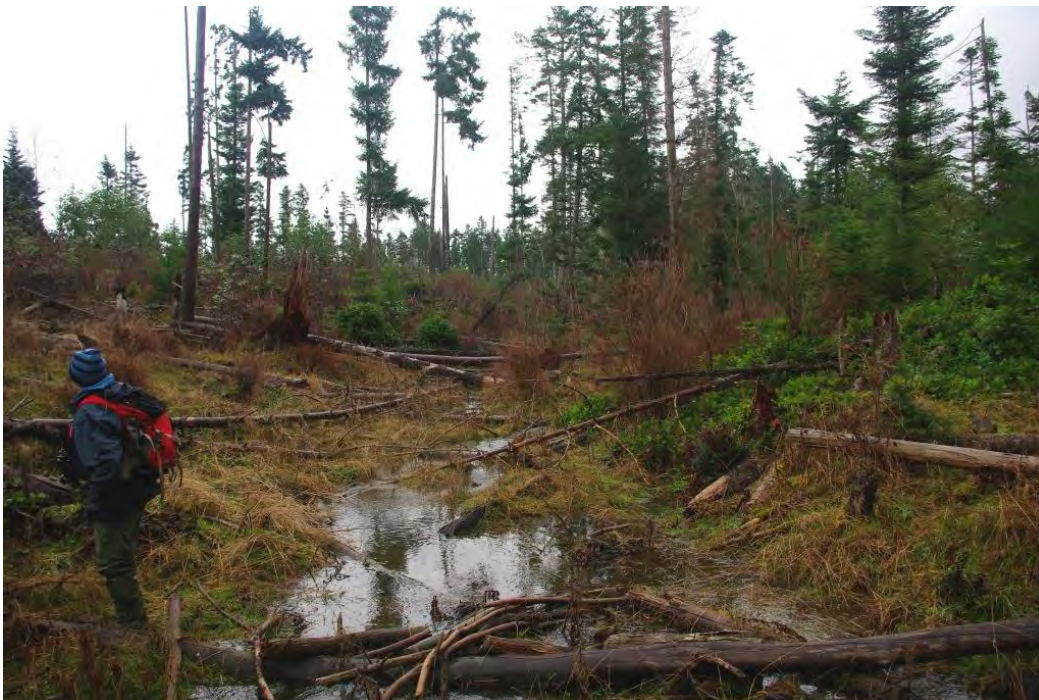
Photograph 4: Looking upstream along Watercourse 1 near the centre of the north park boundary.

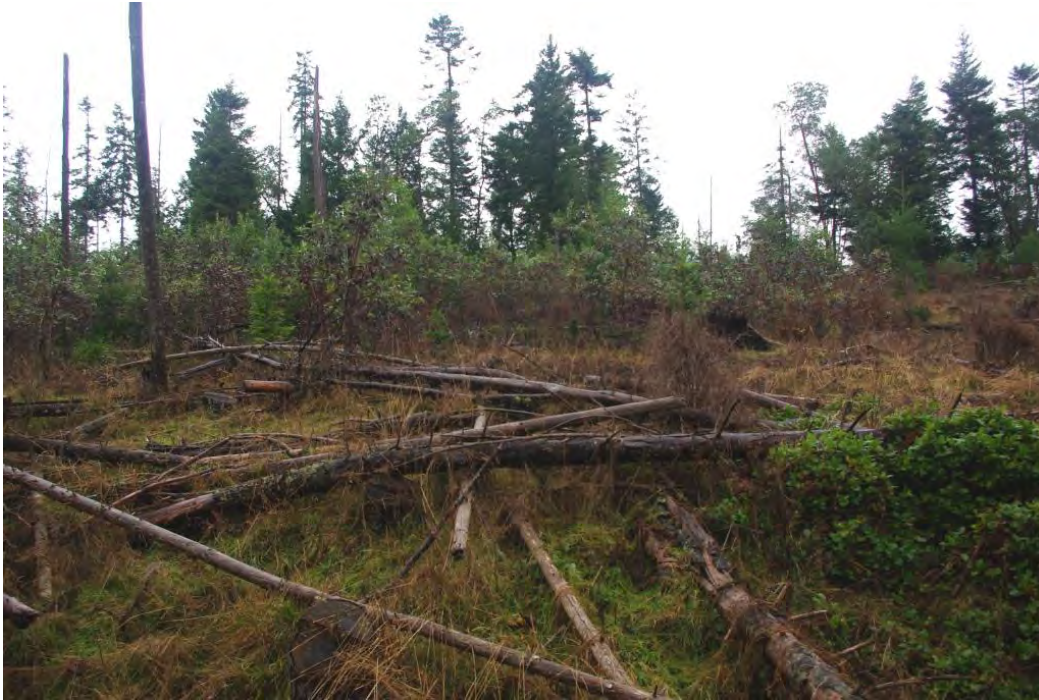
Photograph 5: Looking north towards the park boundary from Watercourse 1. The shrub-like growth in the near distance is a thicket of young arbutus trees

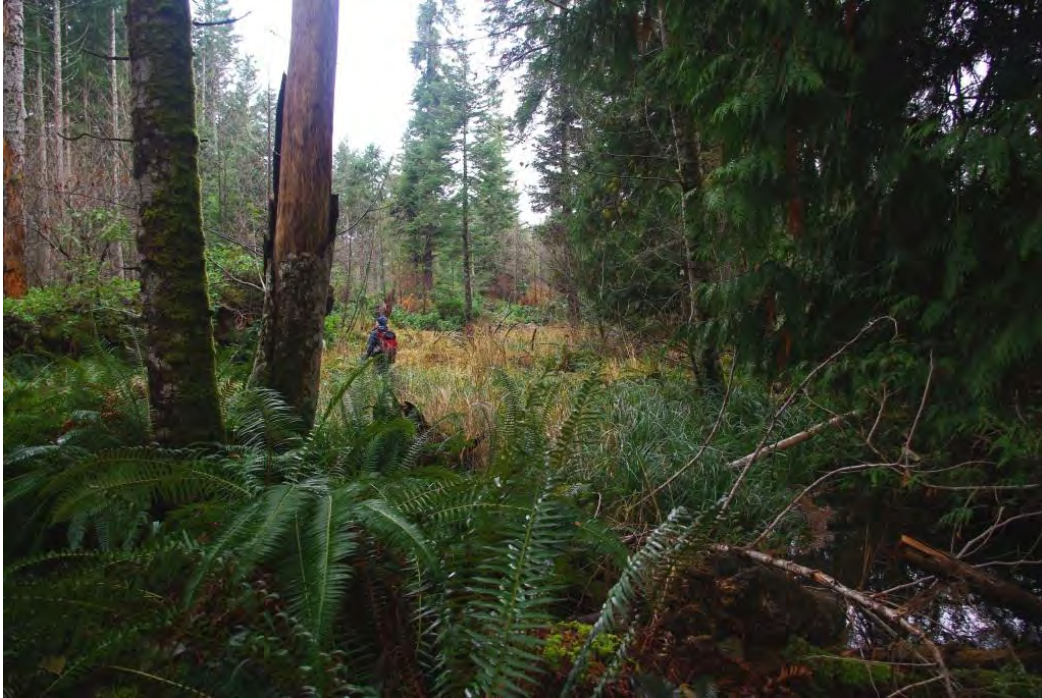
Downstream of the park road (Photograph 13), Watercourse 3 flows rapidly down a naturally steeper grade before joining Watercourse 1 in a shallow water catchment basin at the site of Photograph 7.

Photograph 7: Water catchment area near the west park boundary. High wildlife value

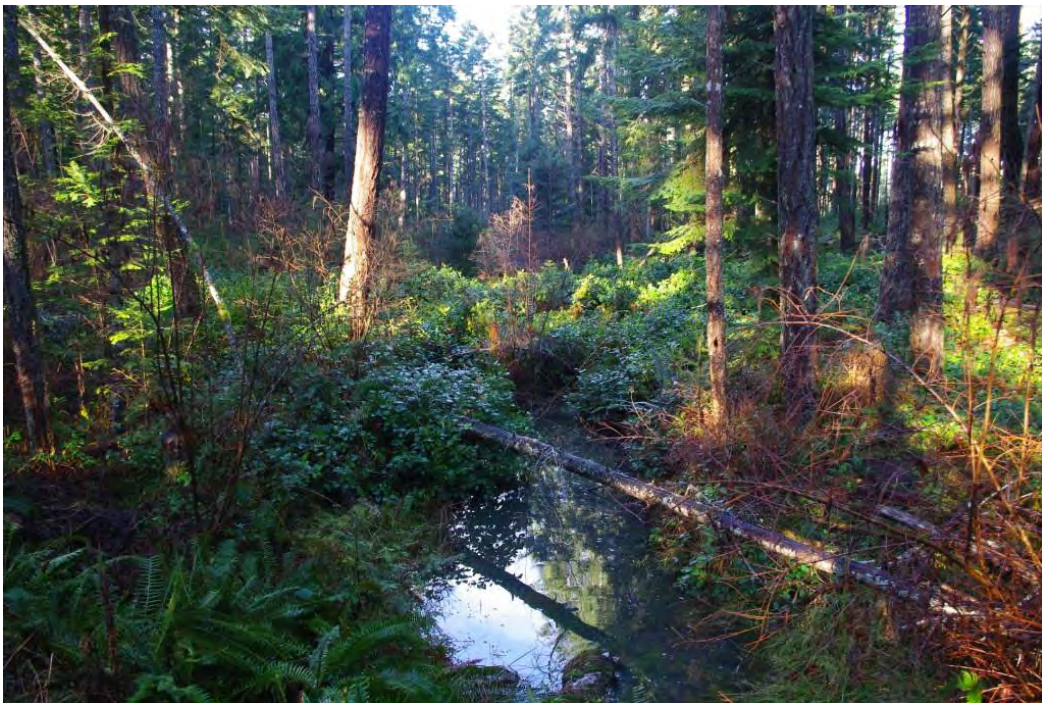
Watercourse 2 flows from the east through most of the centre of the park. Its origin is separated from Watercourse 1 by what might be classified as a low terrace or is possibly an old dune. The landscape is a shallow swale. Water flow appears to be ephemeral and represents a high water table as much as a true watercourse. On the 17<sup>th</sup> of December, following a few days of rain, there were many shallow ponds ranging from 0.2m to 0.4m in depth (Photograph 8). In a few locations there was no sign of surface water.

Photograph 8: Watercourse 2 looking downstream from the park road

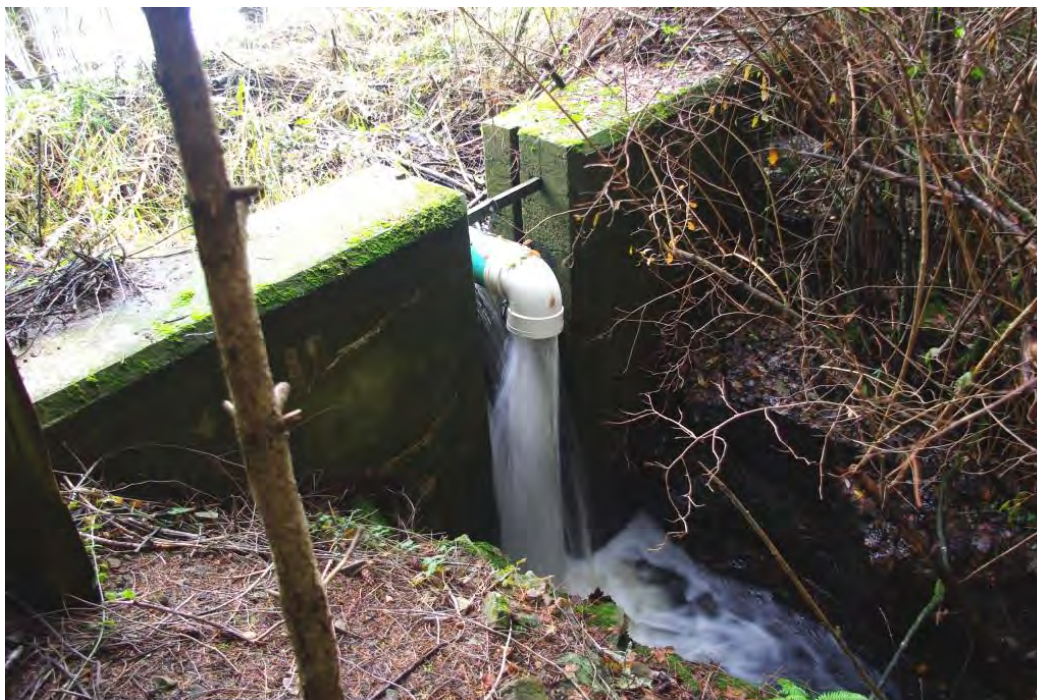
Watercourse 3 commences at the outflow of Coats Marsh. It flows from a weir (Photographs 9 and 10) at the edge of Coats Marsh through two private properties (Map 2), back into Coats Marsh Regional Park, and then north to join Watercourse 1. Conversations with the land-owners of both lots 5 and 6 suggest that this watercourse flows year-round though flows in the summer months can be minimal.

- The baseline water level of Coats Marsh was established by a measurement from the top surface of the concrete weir.
- On December 2<sup>nd</sup> 2010, from the top of the concrete weir to the top of the wooden baffle was 64.4 cm. The beaver dam was holding the water level at 15cm below the top of the concrete of the weir. The entrance to the 8" diameter (20cm) PVC pipe was fully submerged and the pipe was running at full volume (Photograph 9). The level of Coats Marsh at the weir site was 44.4cm above the wooden baffle.

- Downstream of Coats Marsh are three significant barriers to fish passage. The first is the concrete weir structure with a 2m fall between the top of the baffle and the water surface below the weir (Photograph 9). A second barrier, approximately 50m downstream from the weir, is a 1.5m constructed rock dam filling the trench of watercourse 3. The third, approximately 90m downstream from the weir is another 1.5m constructed rock dam (Photograph 11) resulting in a pond (Photograph 12).
- Fish presence has been demonstrated in Hoggan Lake; it was stocked with Cutthroat Trout in 1924 and 1927 (FISS 2010). Both Cutthroat Trout and Rainbow Trout were observed in Hoggan Lake in 1972 (FISS 2010).

Photograph 9: Water discharge from Coats Marsh at the weir.

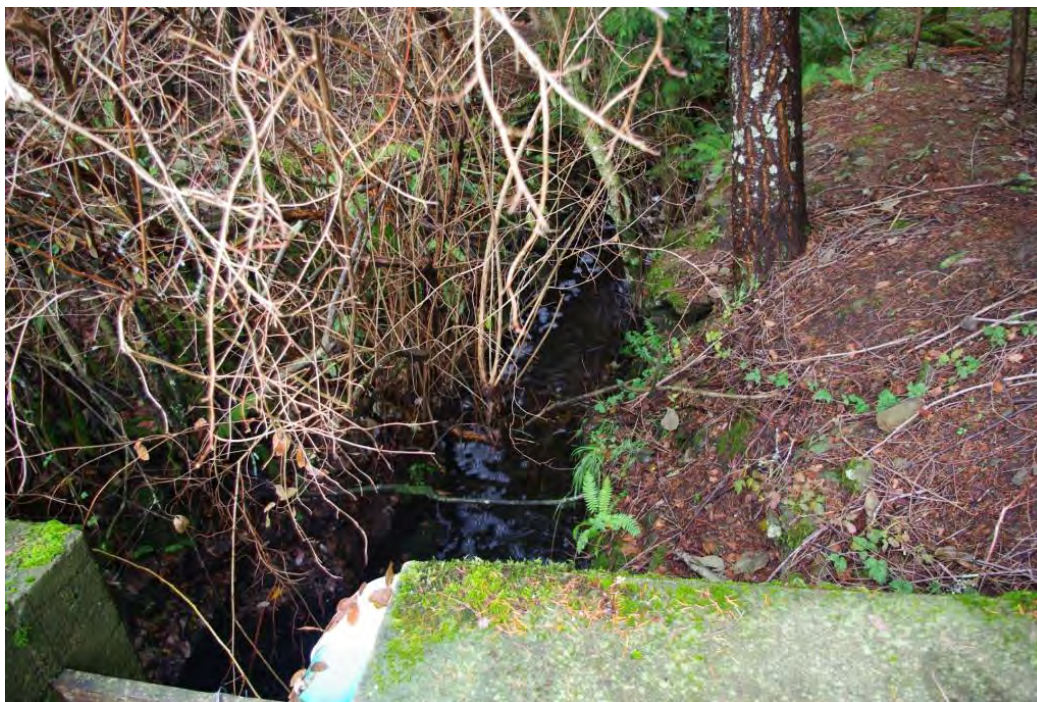
Photograph 10: Water discharge from Coats Marsh looking downstream of the weir.

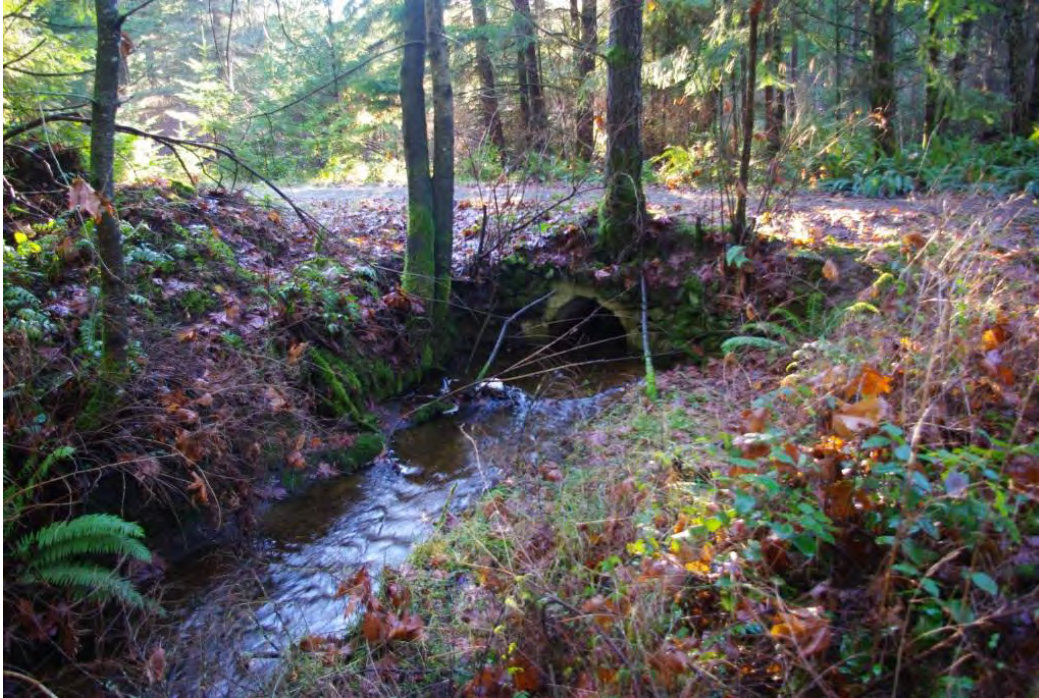
Photograph 13: Watercourse 3 where it flows under the park road in culvert.

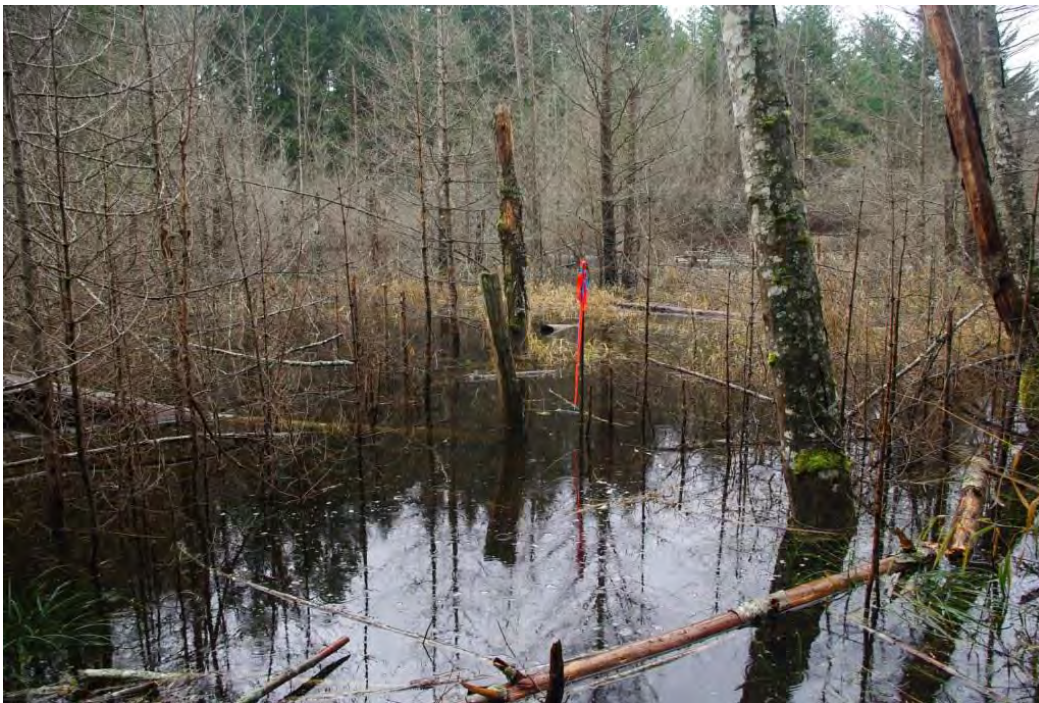
Photograph 14: Flagging showing the submerged property line between the park and Lot 5

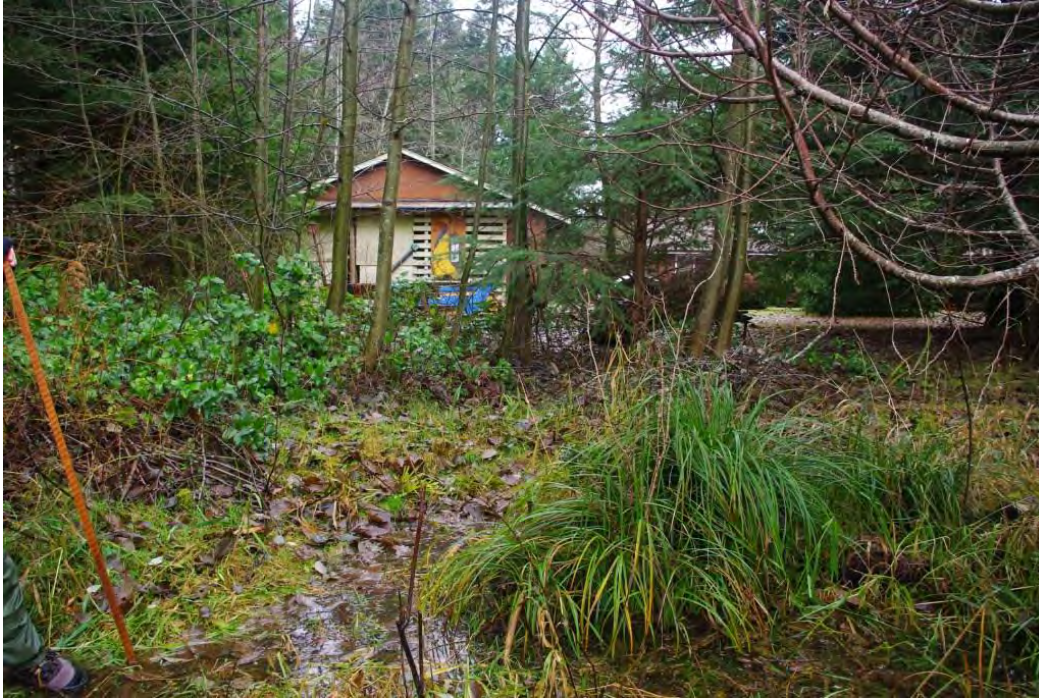
- While on-site at Lot 5 the closest distance between a building (which appeared to be a garage or an out-building) and the wetted edge of the marsh was measured at 18m (Photograph 15).

Photograph 15: View of buildings on Lot 5 from the marsh shoreline.

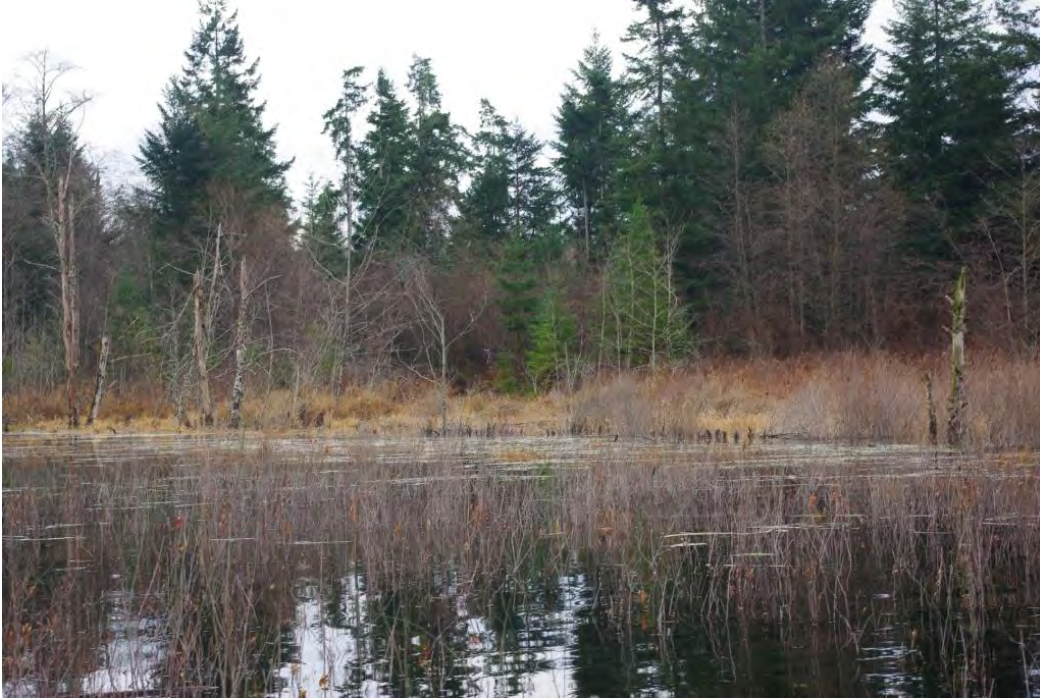
Photograph 19: The south-east portion of Coats Marsh in the vicinity of Aiden Road. Flagging at the park boundary is visible near the centre of the photograph.

- A section of boardwalk and a viewing platform off of Aiden Road (in the vicinity of Photograph 19) would offer excellent long views of the marsh area with good light aspects for photography (Map 6). If in the future a trail is planned around the east shore of the marsh it should be back from the open marsh and give the occasional pocket views. Ideally these viewpoints could be concealed such that they are not visible from each other.

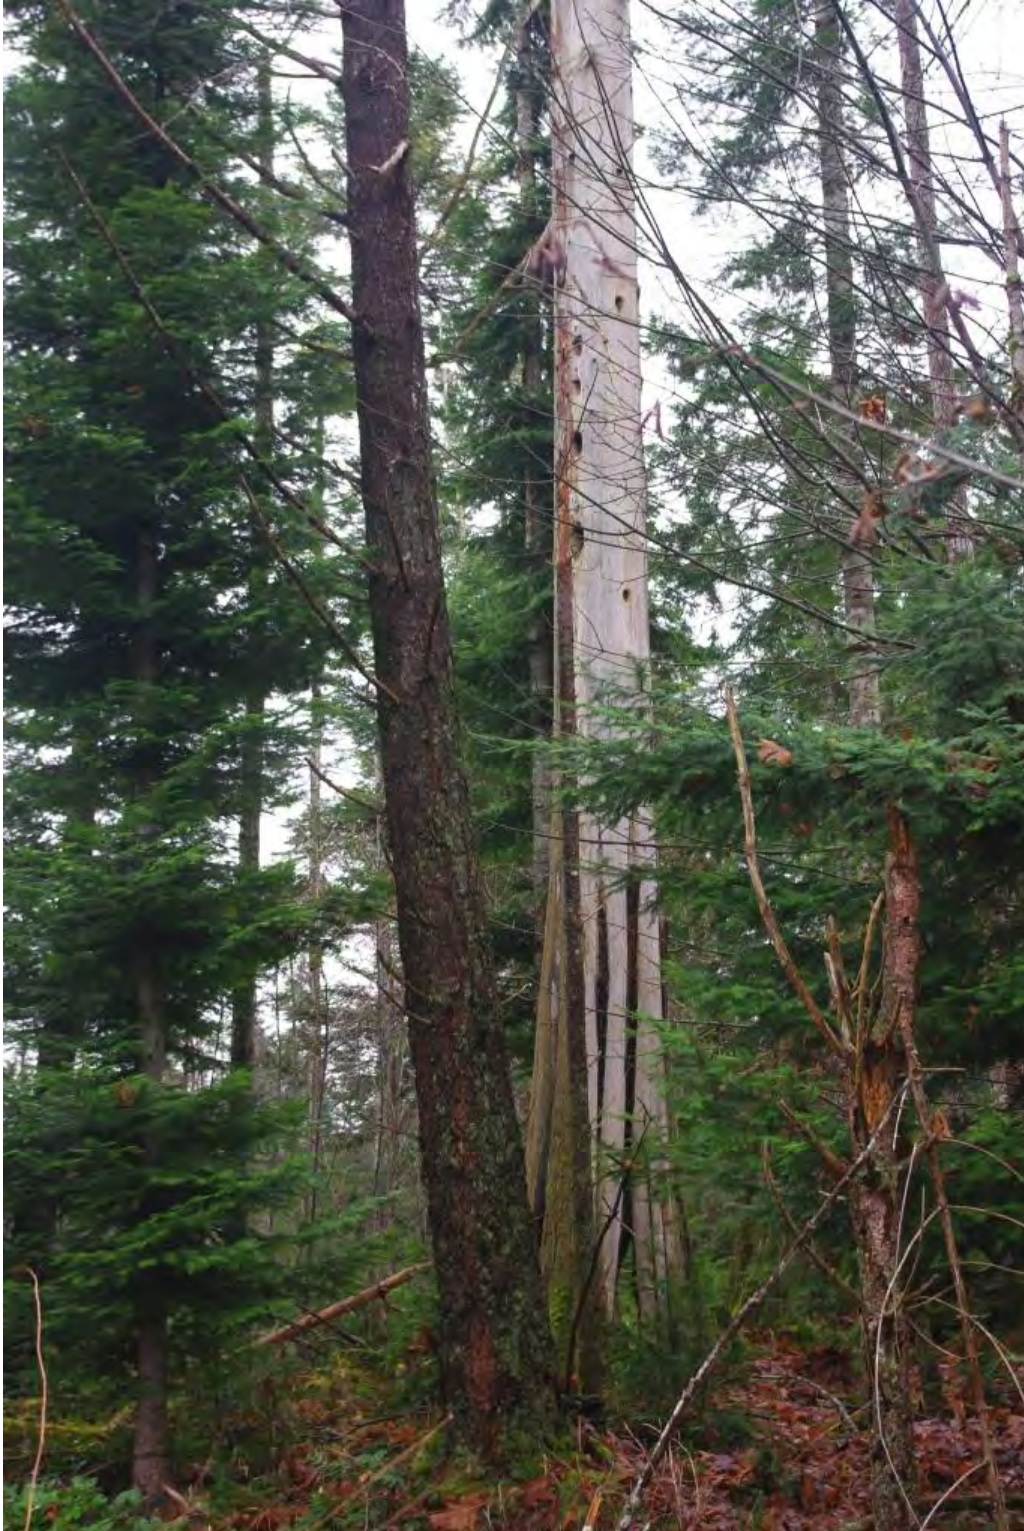
- Aside from the marsh, an area of high value avian wildlife habitat is shown on Map 4. This area has many dead or decaying trees that are very important to wildlife, especially cavity nesting birds and bats. Two trees are identified on Map 4, a cedar snag (Photograph 20) and a veteran Douglas fir (Photograph 21).

Photograph 20: Western red cedar snag/ wildlife tree

- The wildlife habitat area as shown on Map 4 has a large proportion of mature, dying, and dead alder and maple, plus a cedar snag and a veteran fir. All of these trees have high wildlife value. These trees are potentially more hazardous to park users than trees in most other area of the park. We suggest that this area not be identified on park maps

and that trails not be located in immediate proximity to this area. It would be best to not bring attention to this area and to leave it to the birds, bats and other wildlife.

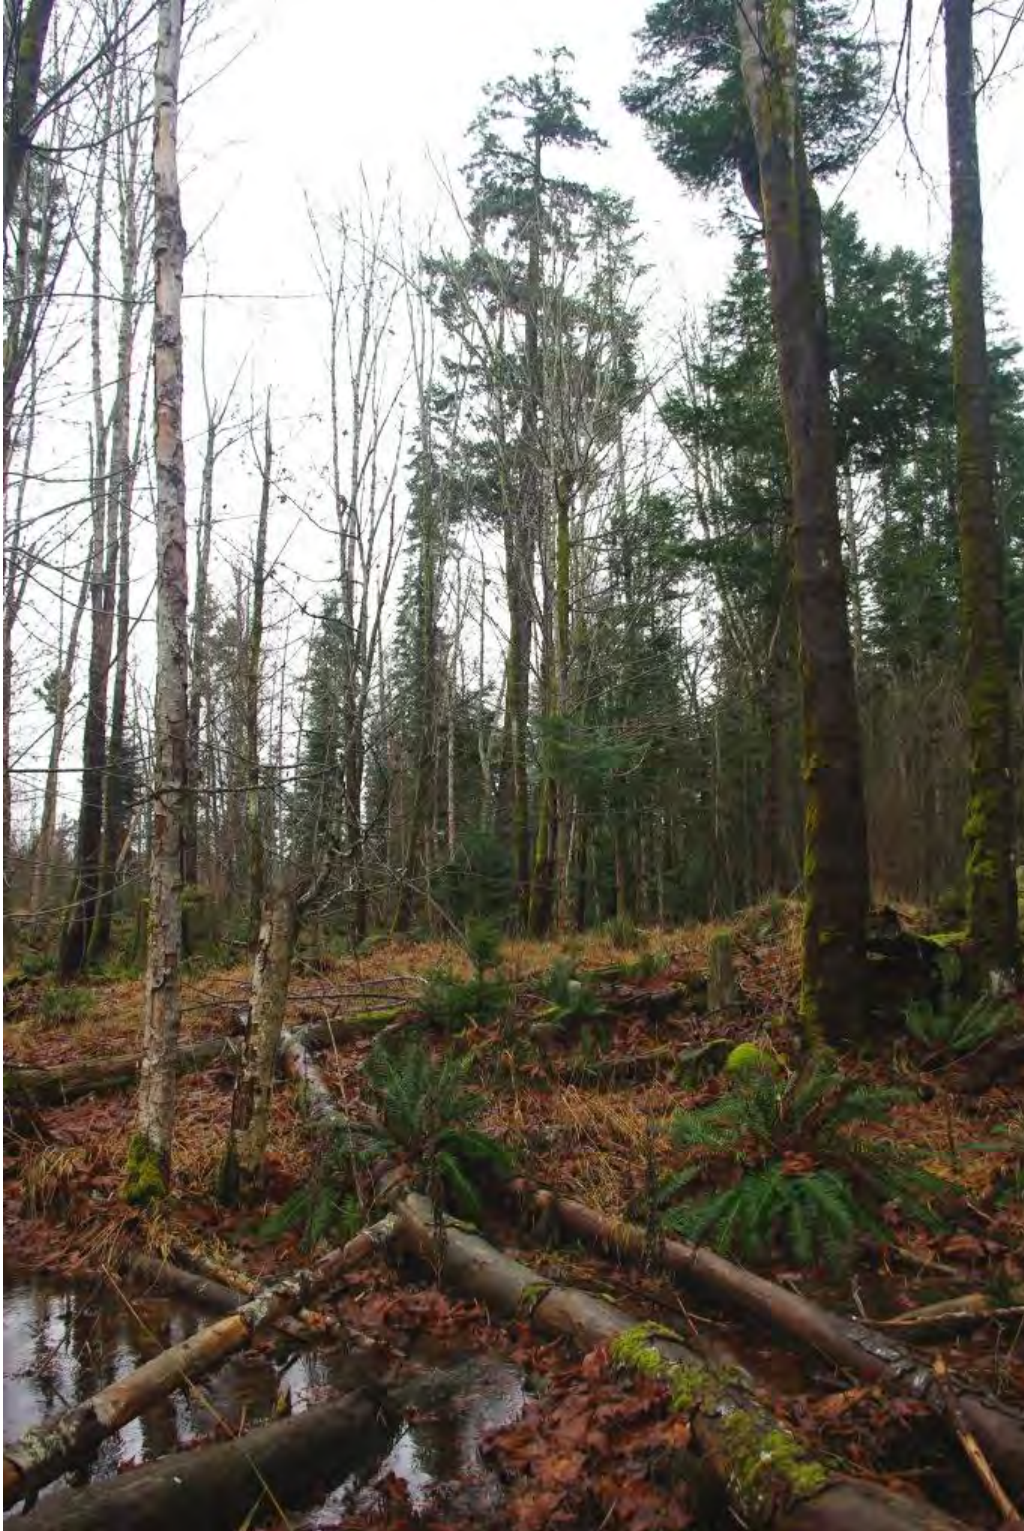
- While in the vicinity of the veteran Douglas fir noted on Map 4 (Photograph 21), two Bald Eagles arrived, perched in the tree top and called repeatedly. While no nest was observed, the crooked aspect of the tree top has potential to support a nest. The tree might have better nest tree qualities if the top were to blow off.

Photograph 21: Veteran Douglas fir in a stand of mature red alder and bigleaf maple.  
This is high value wildlife habitat.

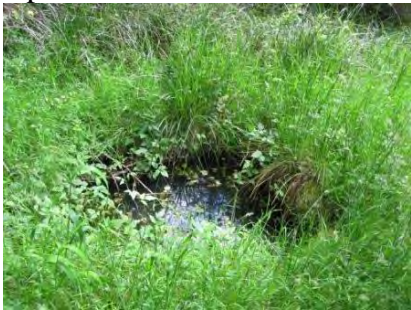
Open surface well at Coasts Caretakers House.

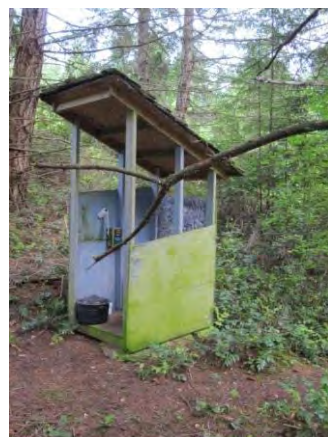
Open Pit Toilet at Coasts Caretakers House

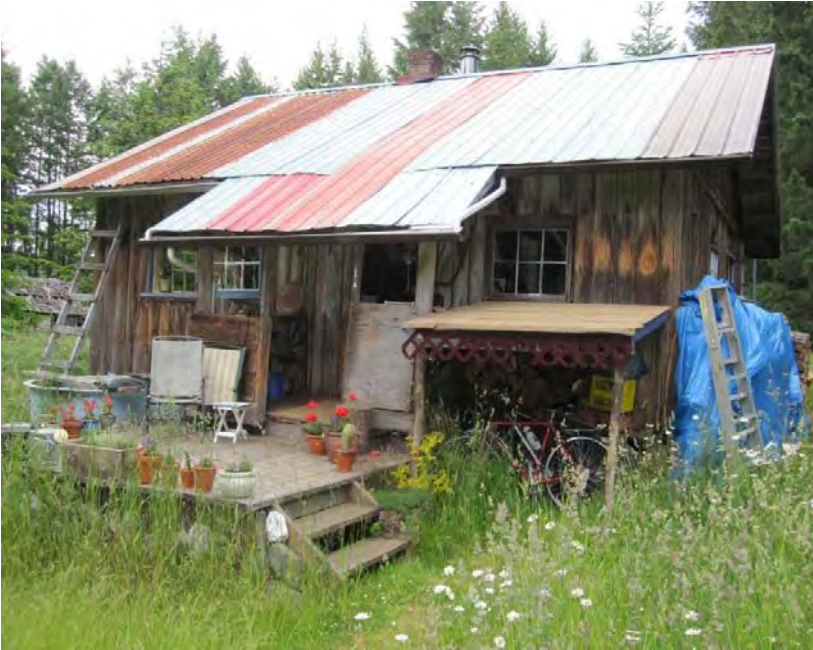
Rear view of house and back porch
