REGIONAL DISTRICT OF NANAIMO

Water Service Area Annual Report 2012

Nanoose Bay Peninsula Water System

June 2013

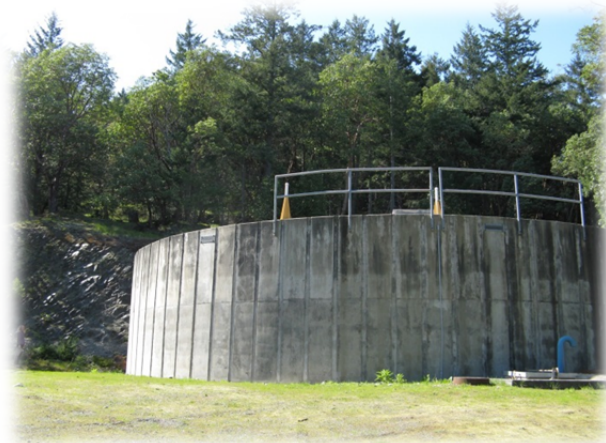
Photo of Fairwinds Reservoir No. 1

- Madrona (concrete) - 485 m³ (100,000 imperial gallons) capacity
- Beachcomber (steel) - 591 m³ (130,000 imperial gallons) capacity
- Eagle Heights (concrete) - 341 m³ (75,000 imperial gallons) capacity
- Dolphin (steel) - 455 m³ (100,000 imperial gallons) capacity
- Fairwinds Res #1 (concrete) - 701 m³ (154,000 imperial gallons) capacity
- Fairwinds Res #2 (concrete) - 701 m³ (154,000 imperial gallons) capacity
- Arbutus Park (concrete) - 568 m³ (125, 000 imperial gallons) capacity

- Drained and cleaned the Beachcomber, Eagle Heights, Dolphin, Fairwinds #1, Fairwinds #2, and Arbutus Park water storage reservoirs;
- Installed additional dedicated water sampling locations;

- Drain and clean the Fairwinds #1 (again) and Madrona water storage reservoirs;
- Install the new Dolphin Beach reservoir access ladder;
- Paint the Beachcomber reservoir;
- Update Standard Operating Procedures; and
- Continue to offer a low-flush toilet and rainwater harvesting (rain barrel) incentive.

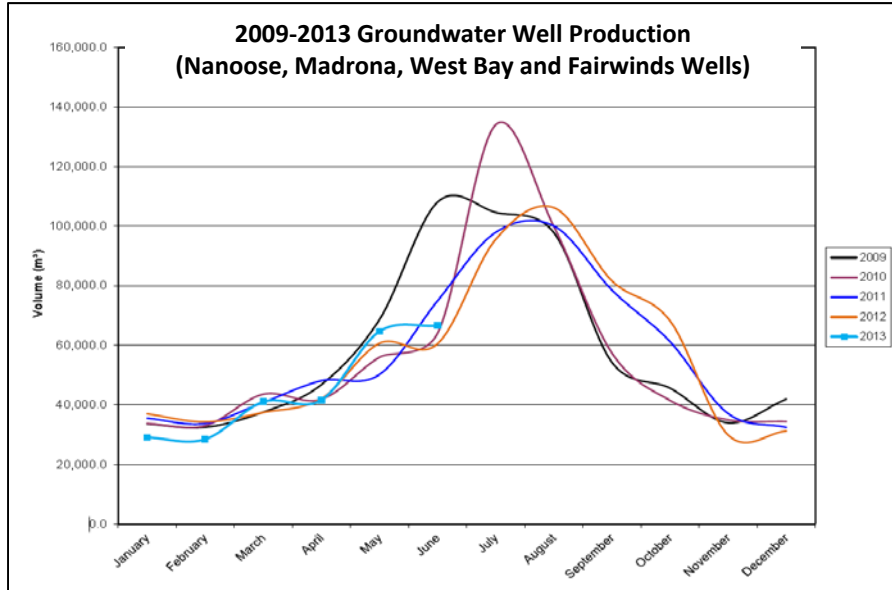
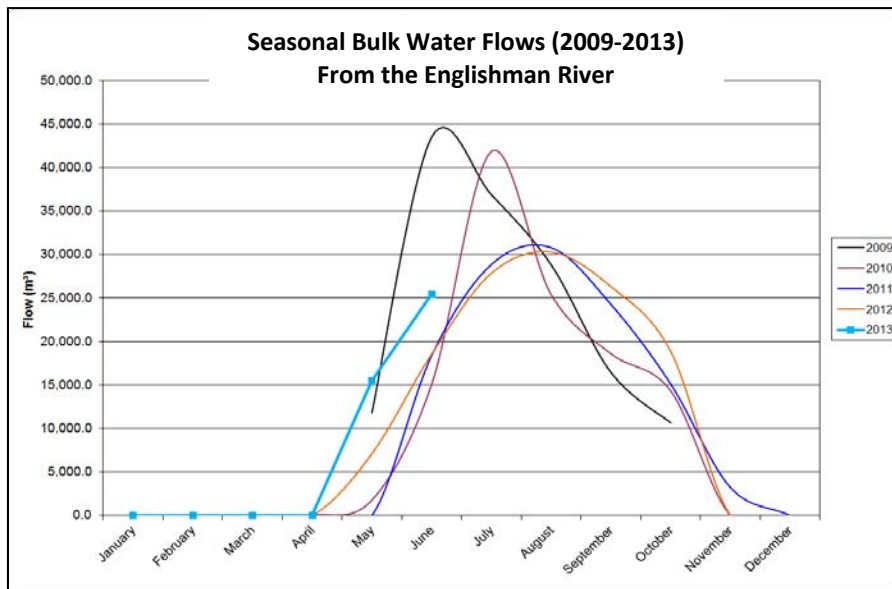
The monthly groundwater well production and bulk water flows for the past 5 years are shown in the charts below. Groundwater production and bulk water flows in 2012 were low to average in comparison to previous years.

In the Fall/Winter of 2012, the average usage per home in Nanoose Bay was 0.38 cubic metres per day (84 imperial gallons). In the summer, the average water usage was 1.15 cubic metres per day (253 imperial gallons). Based on these figures, the annual consumption per capita is estimated to be 267 L/day (based on 2.4 people/household). This consumption is similar to the RDN system average of 268 L/day/capita in 2012.

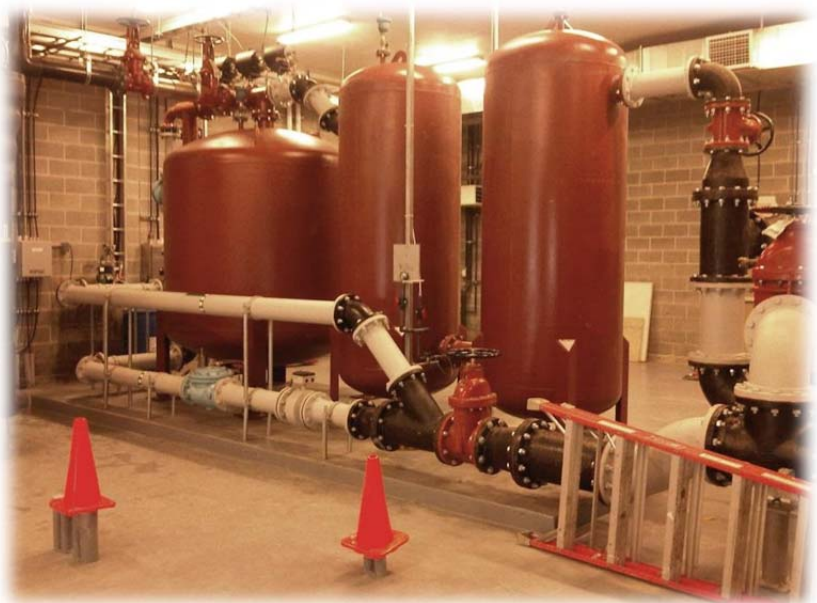
**Completed Water
Filtration Plant**

**Filtration chambers
shown**

In 2012, construction of a drinking water filtration plant was completed at 2480 Nanoose Road. This filtration plant has been in operation since November 2011, and it’s purpose is to filter out iron and manganese particulate from the groundwater pumped from Fairwinds Wells #1, 2, and 3, and the West Bay Well #3.

- Completed construction of the Nanoose Bay Water Treatment (filtration) Plant;
- Completed well automation and well upgrades associated with water filtration plant requirements;
