Parker Road Monitoring program

Water level graphs to February 1st, 2018

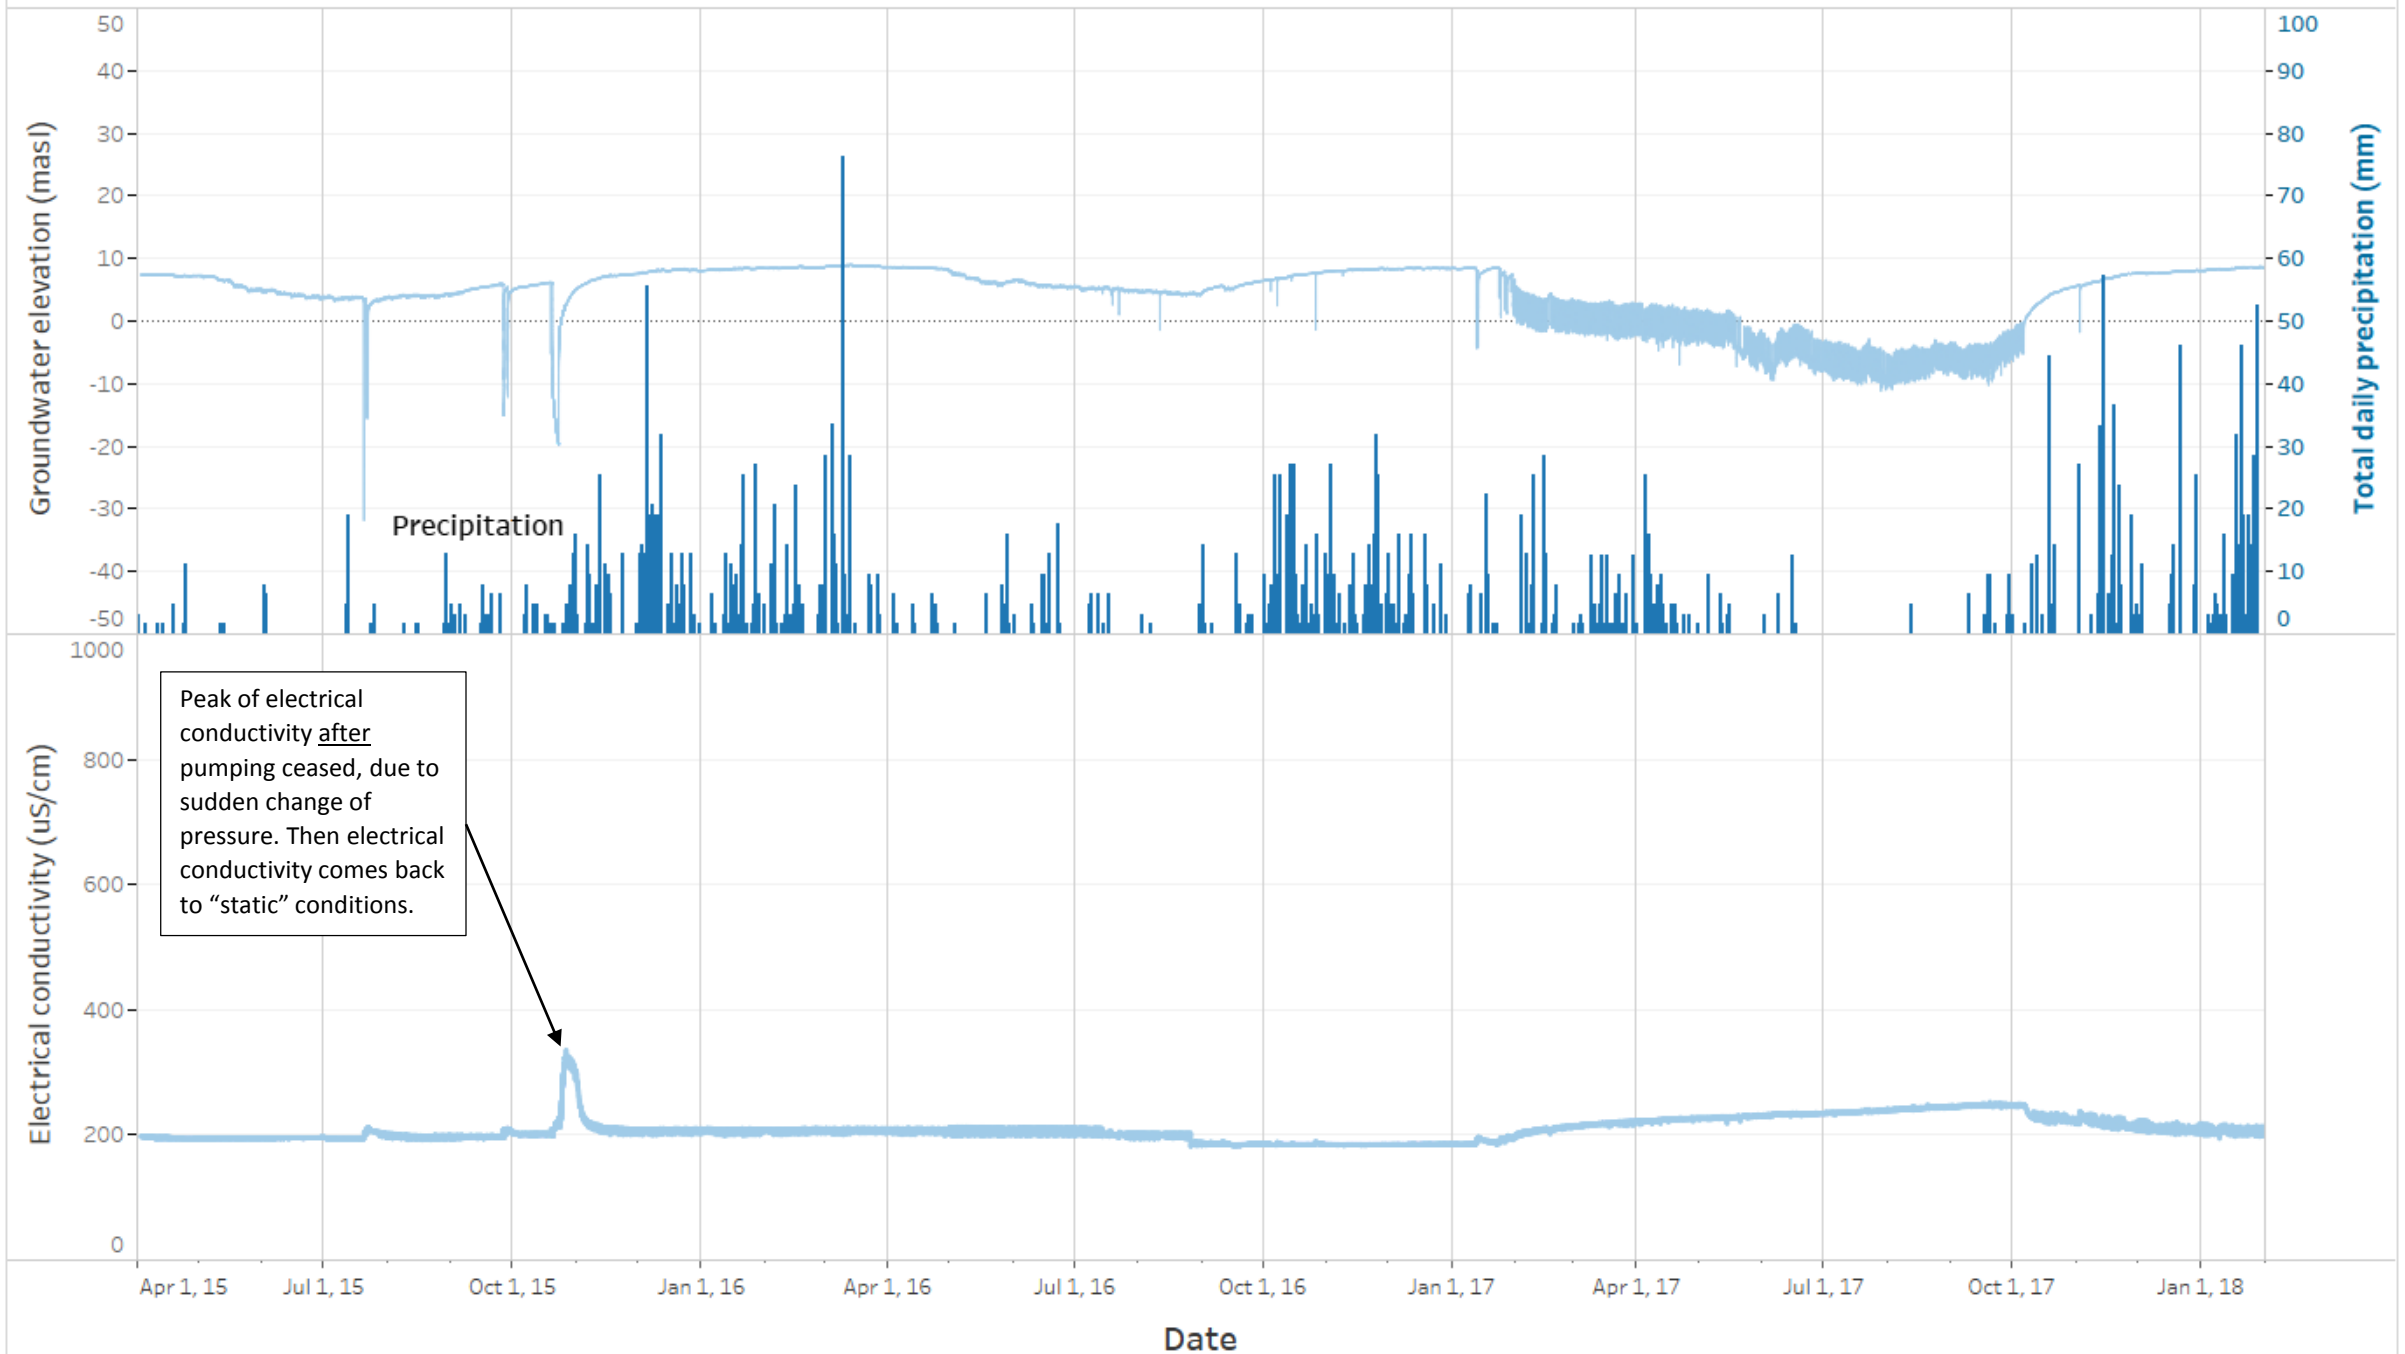
Groundwater elevation, precipitation and electrical conductivity in B1

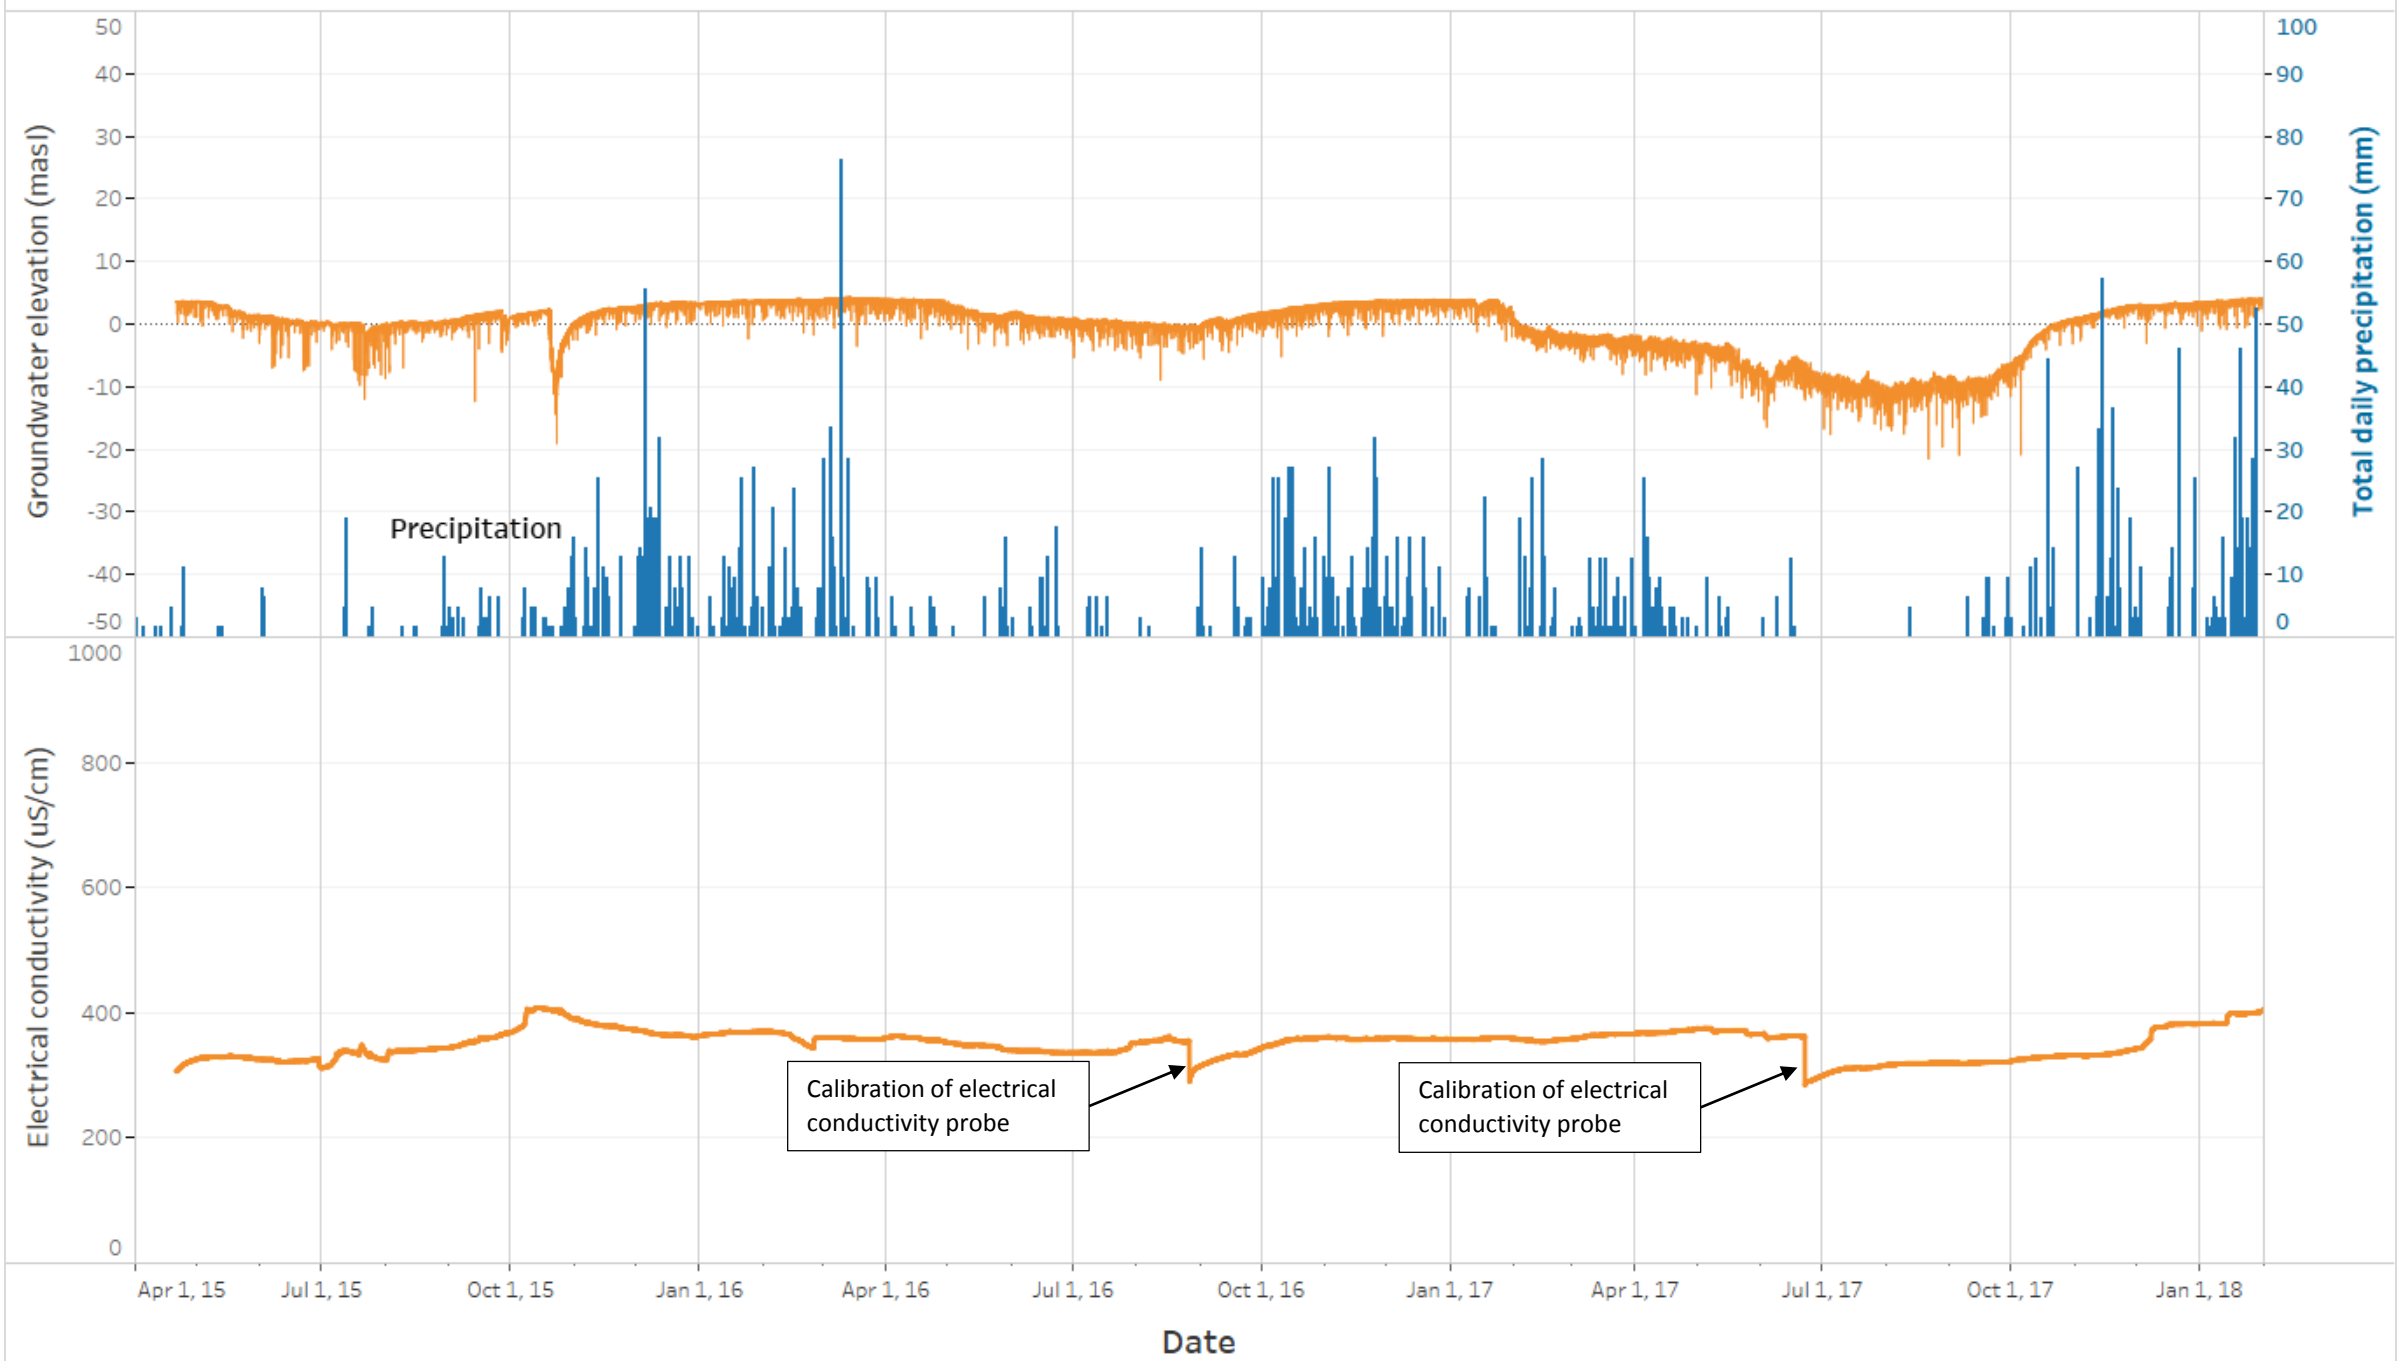
Groundwater elevation, precipitation and electrical conductivity in B2

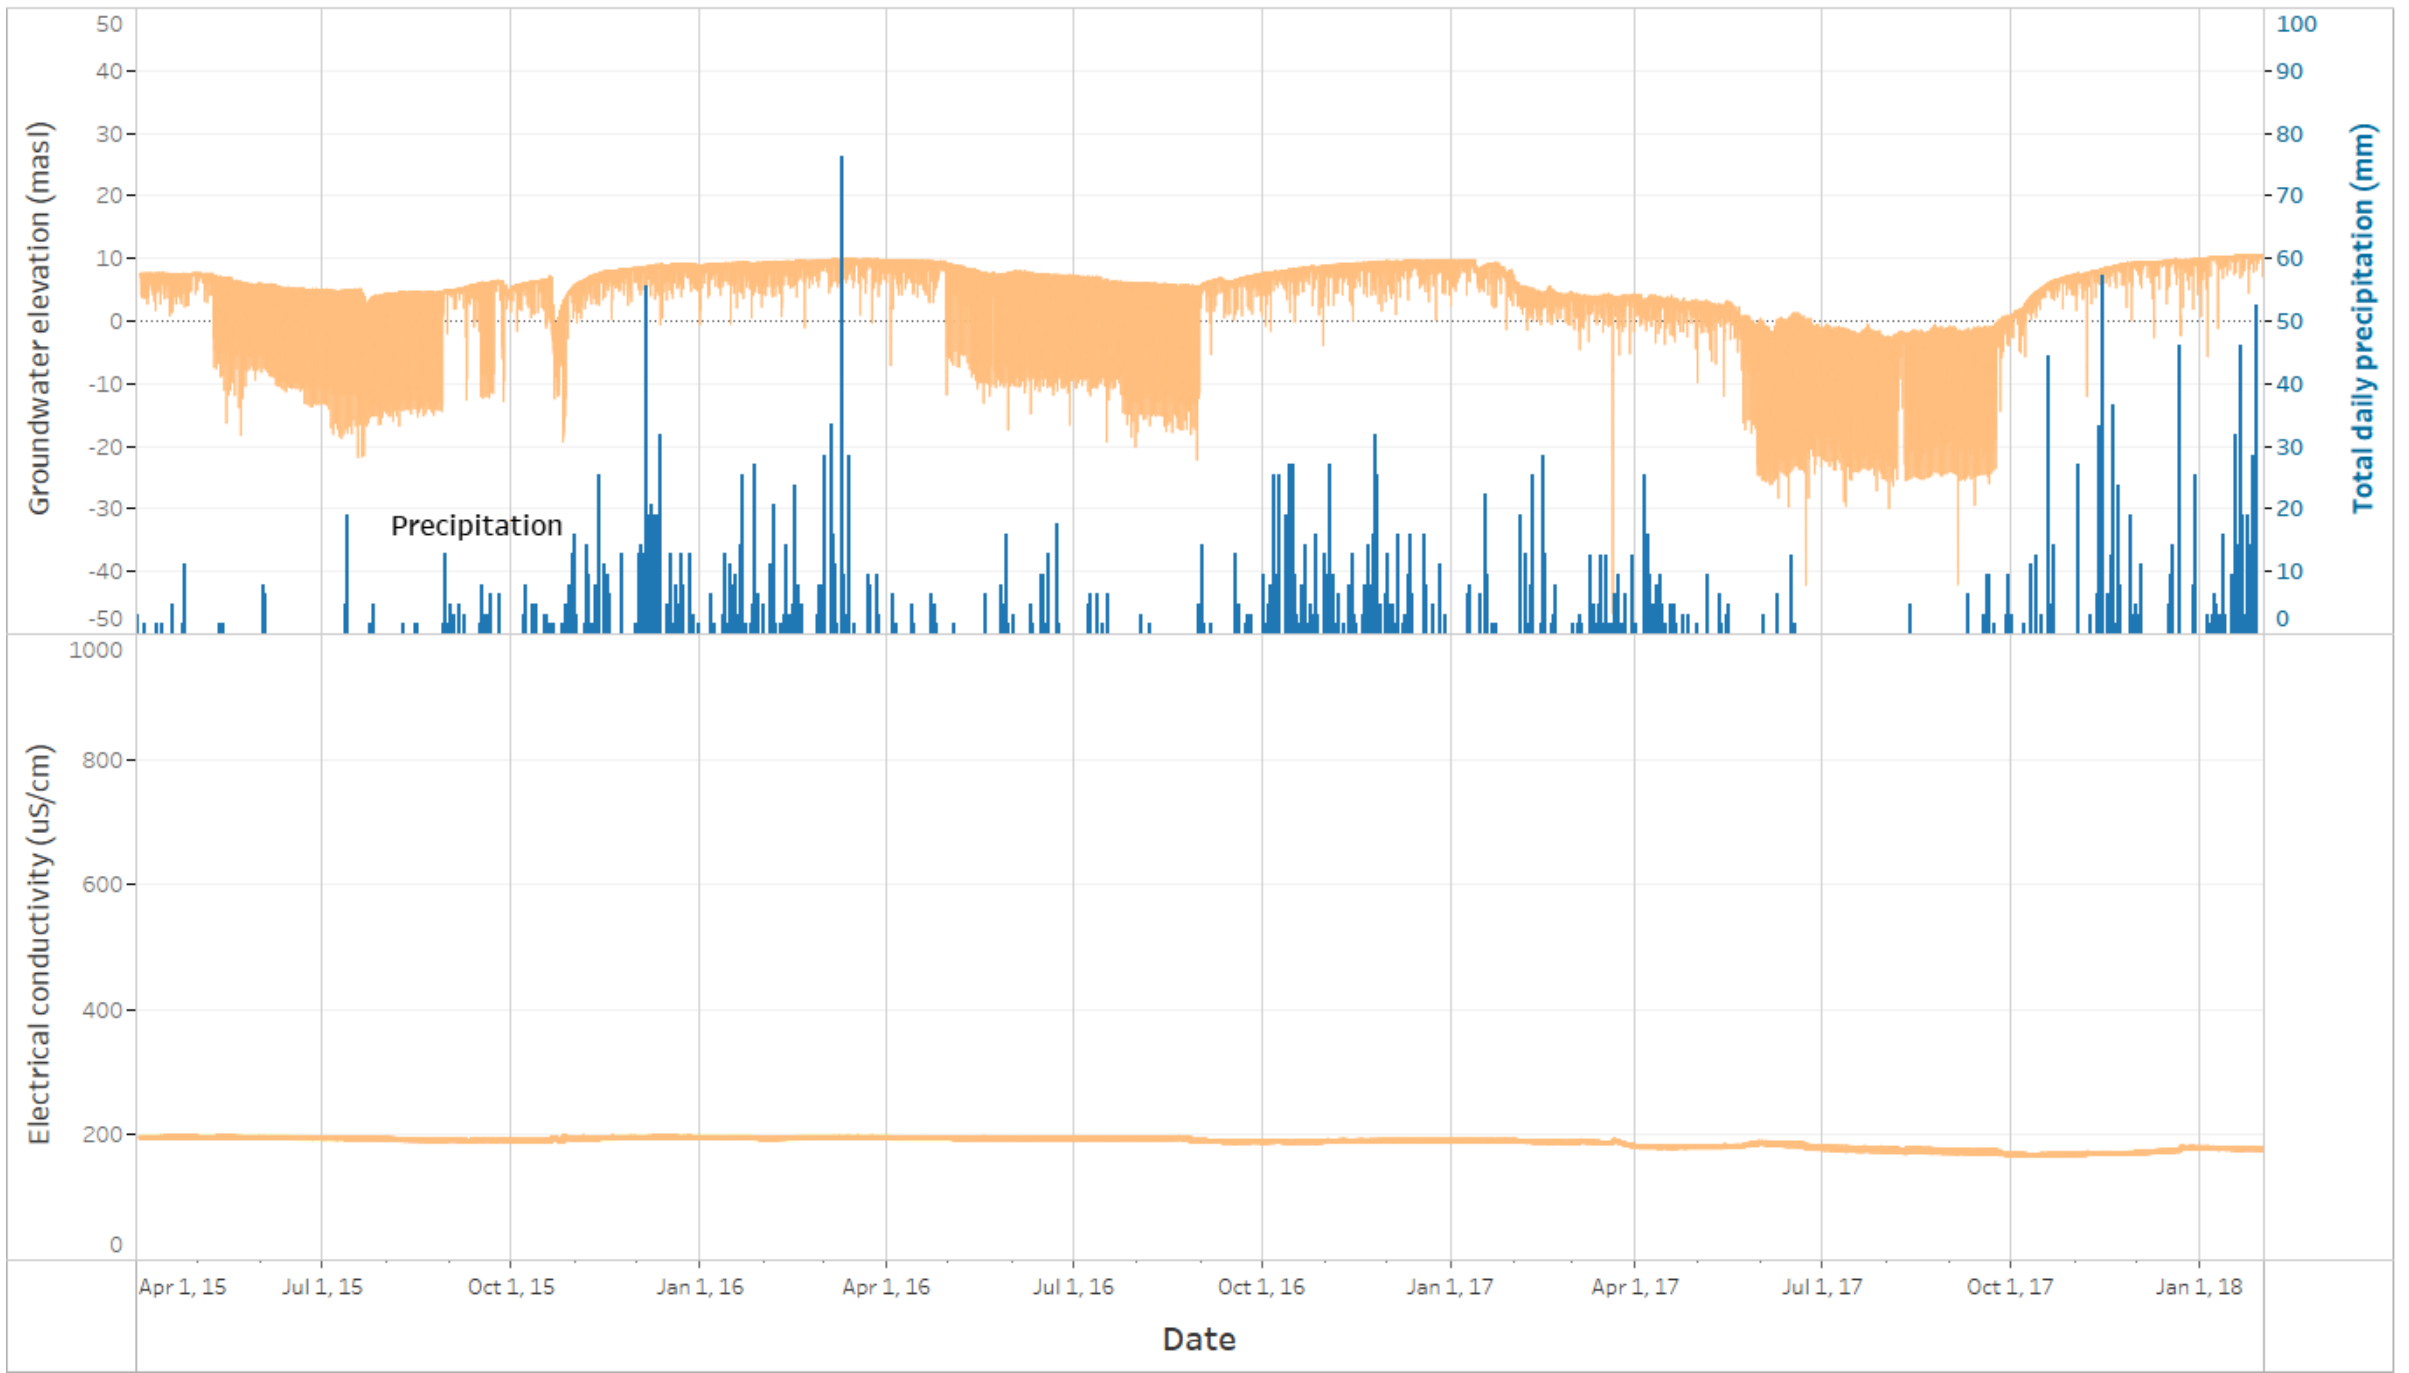
Groundwater elevation, precipitation and electrical conductivity in B3

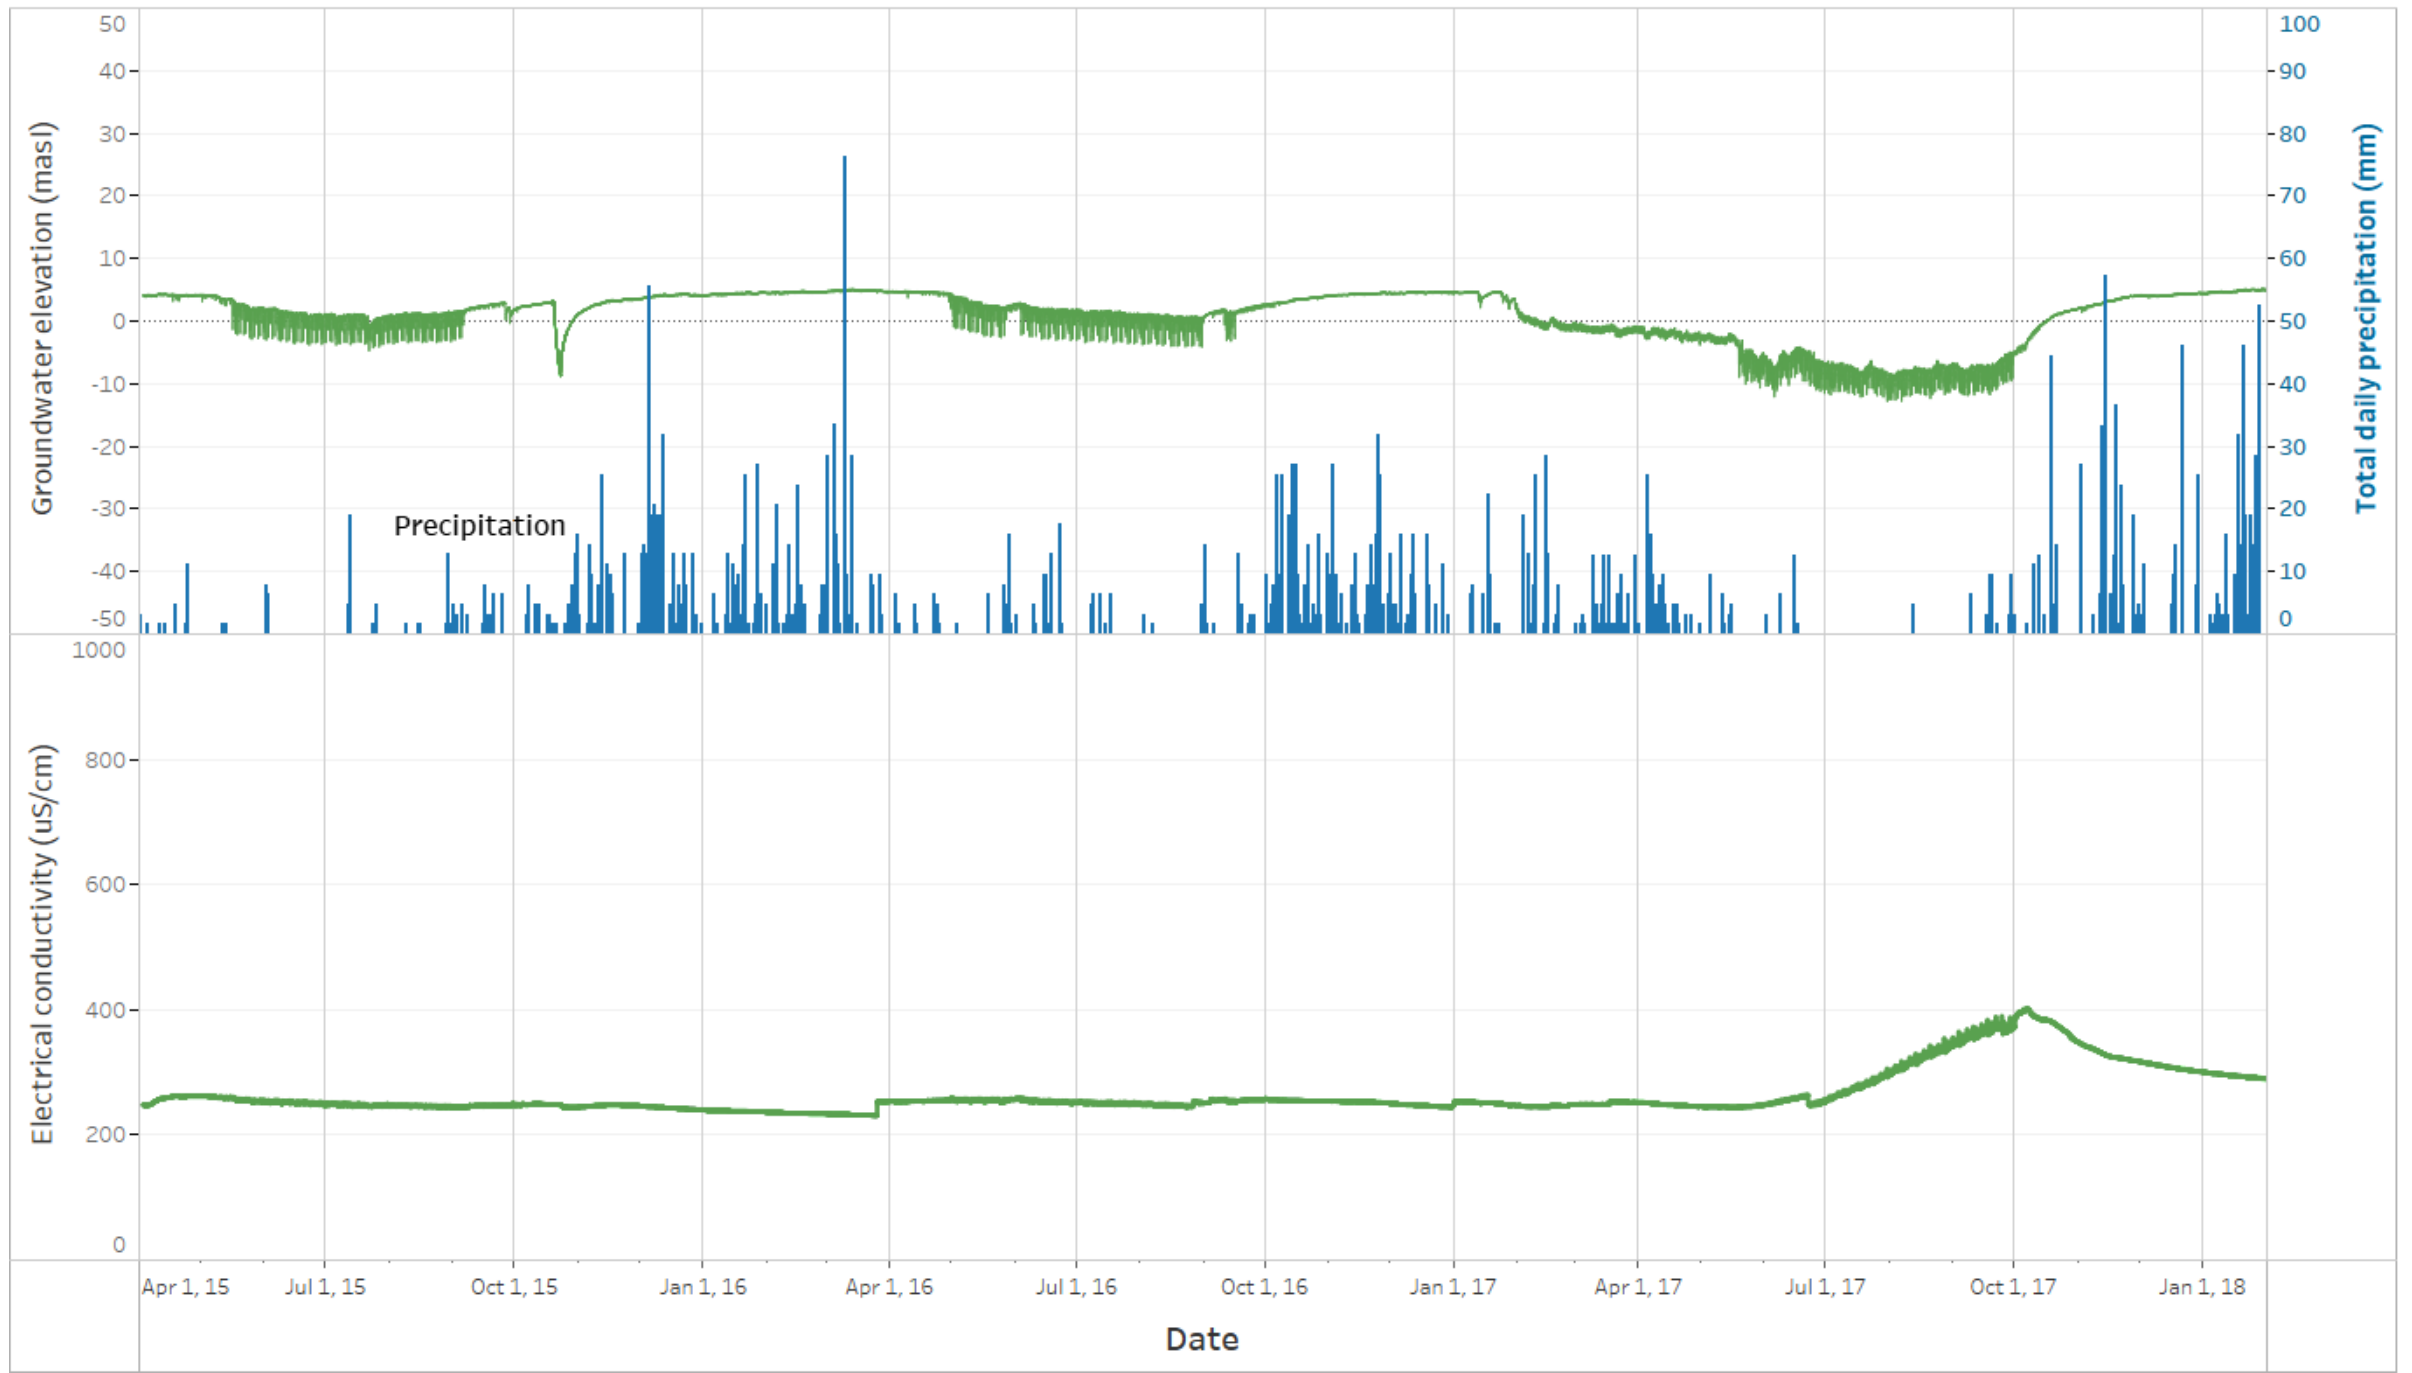
Groundwater elevation, precipitation and electrical conductivity in B4

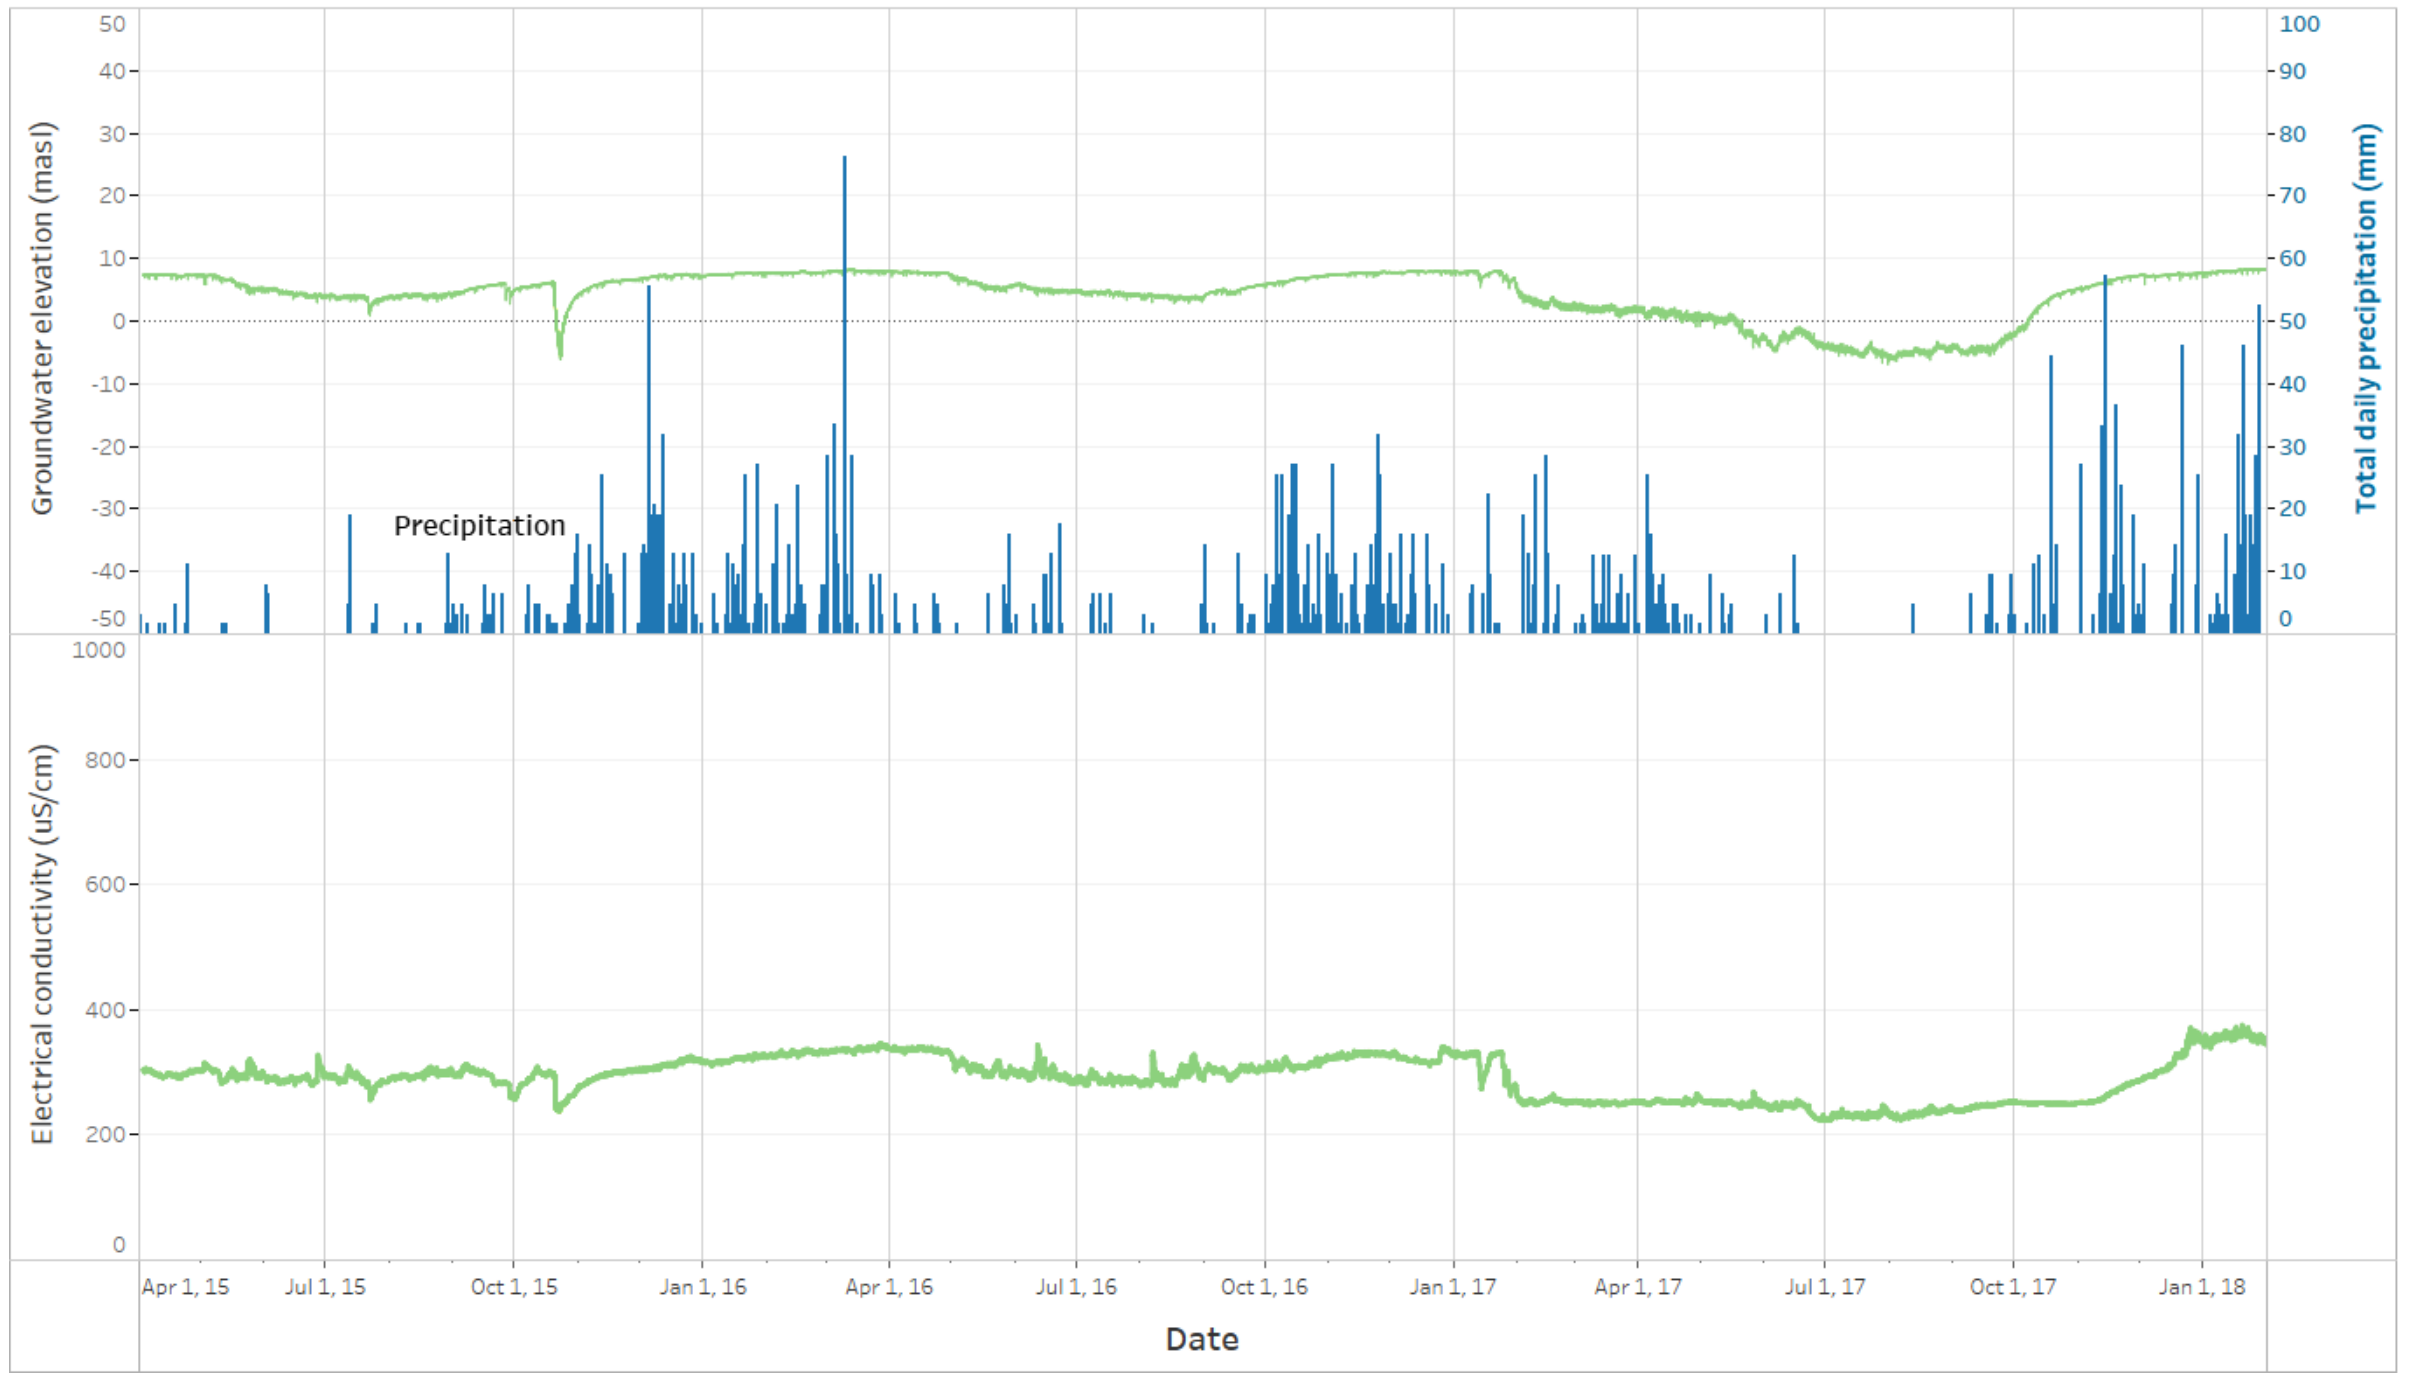
Groundwater elevation, precipitation and electrical conductivity in B5

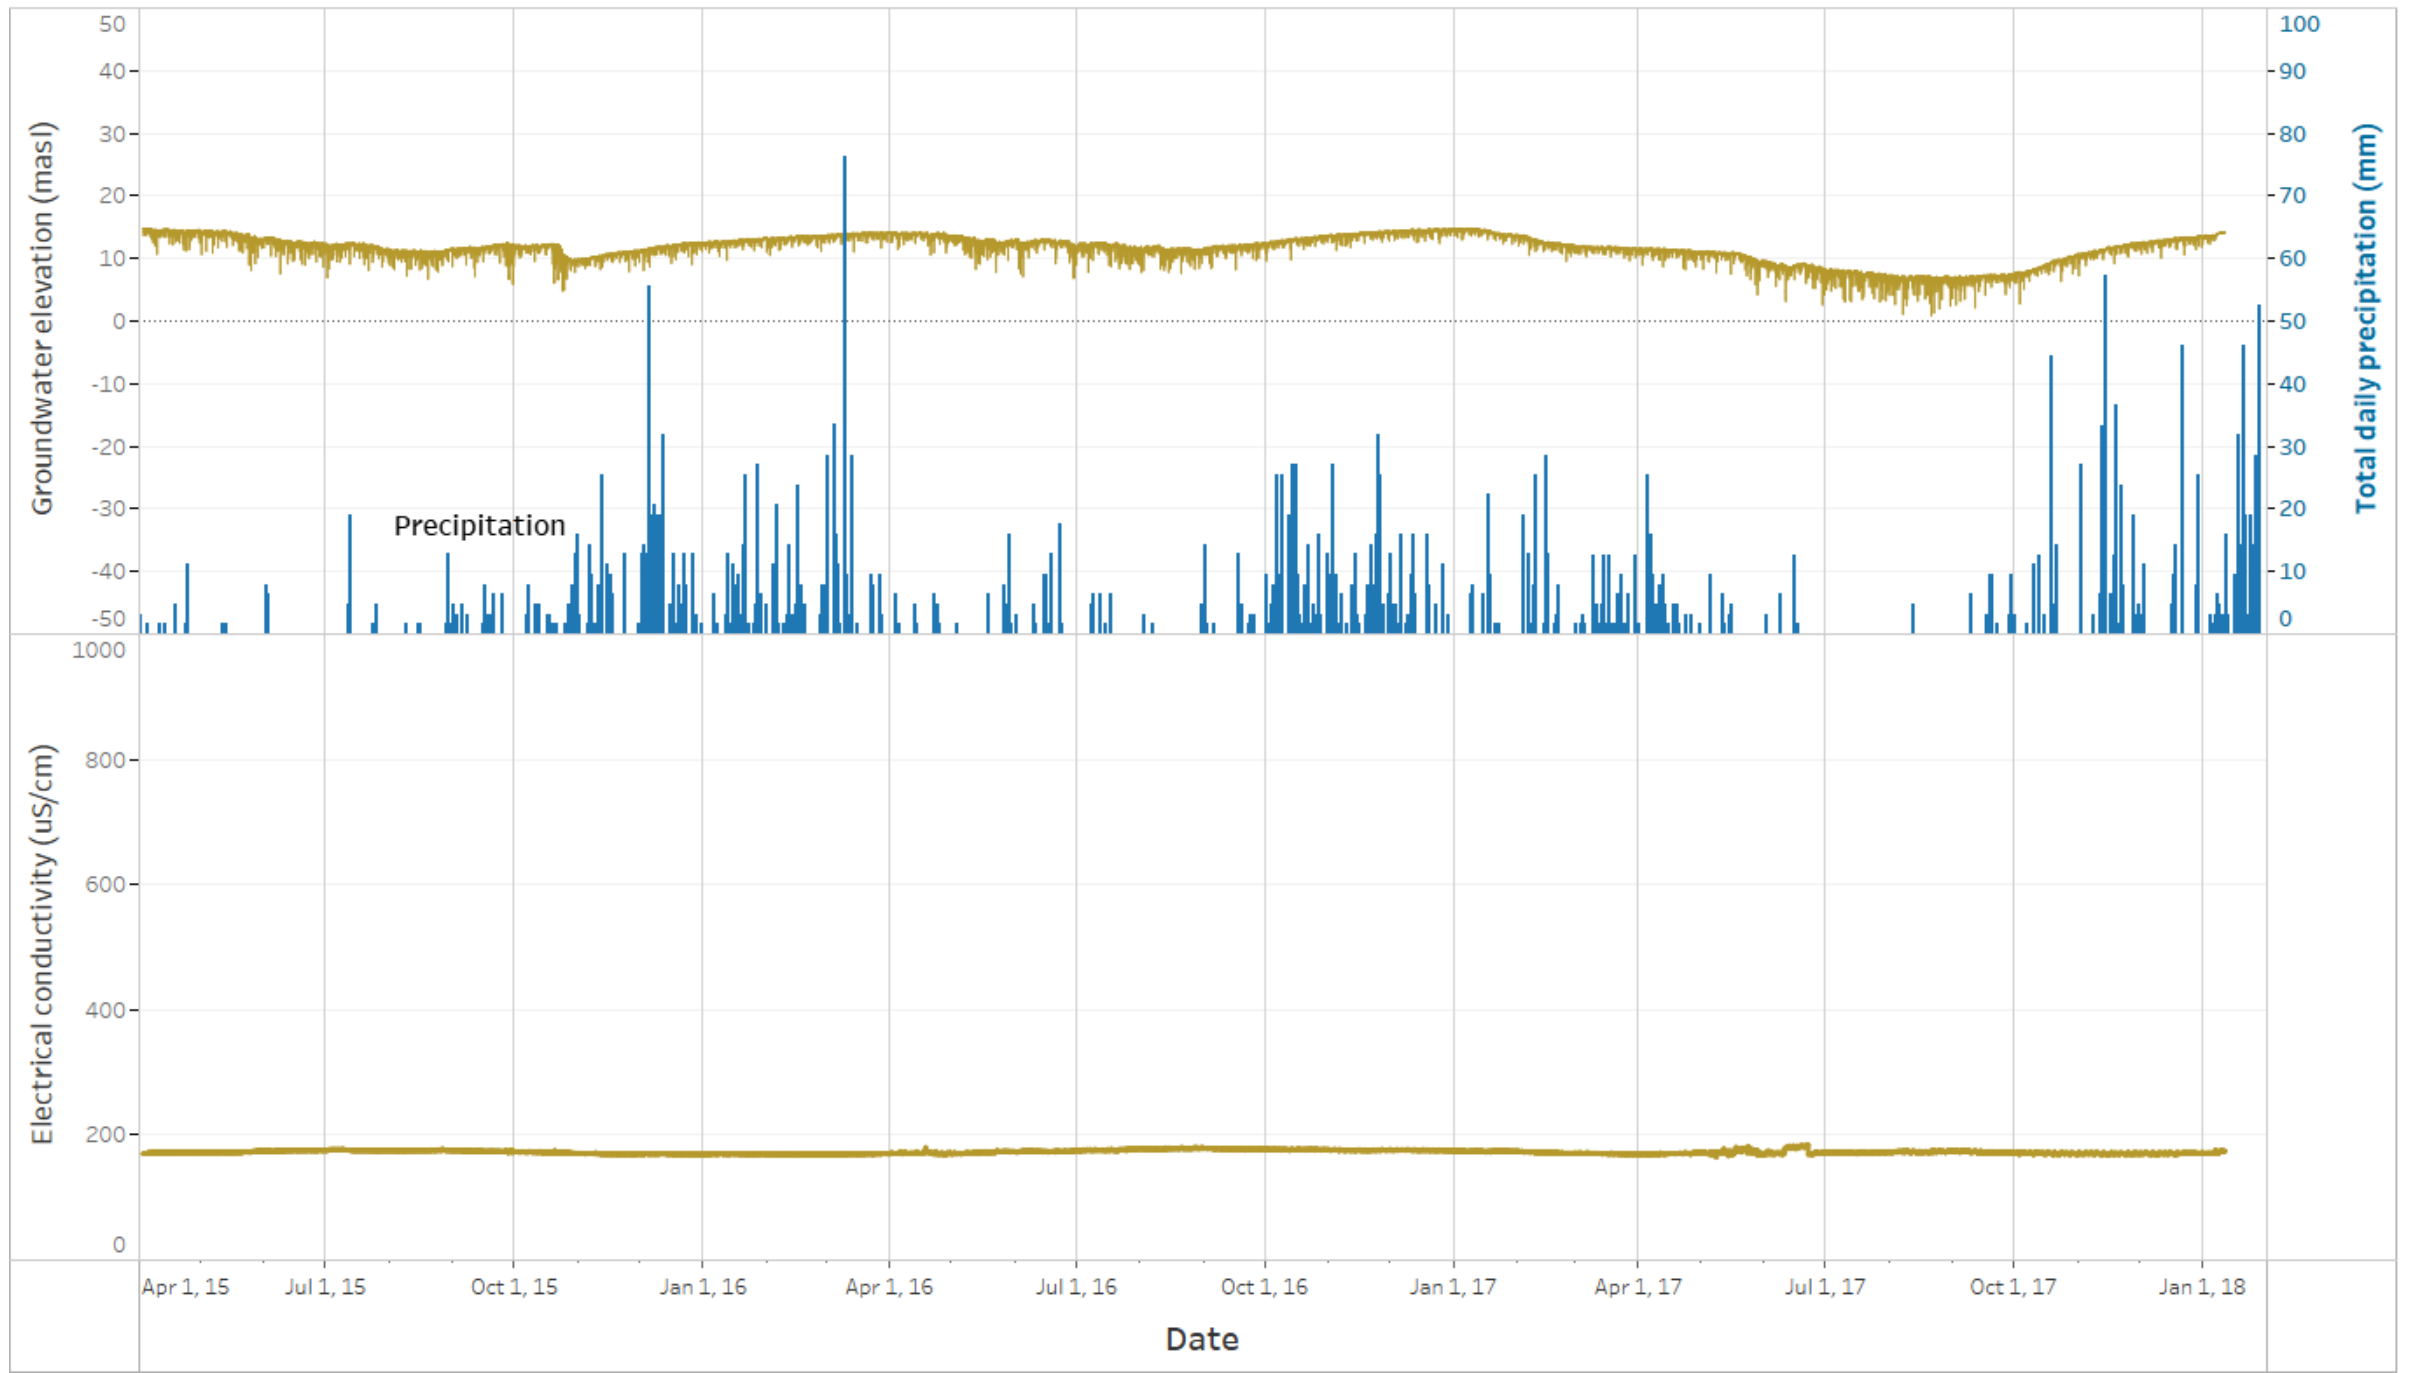
Groundwater elevation, precipitation and electrical conductivity in B6

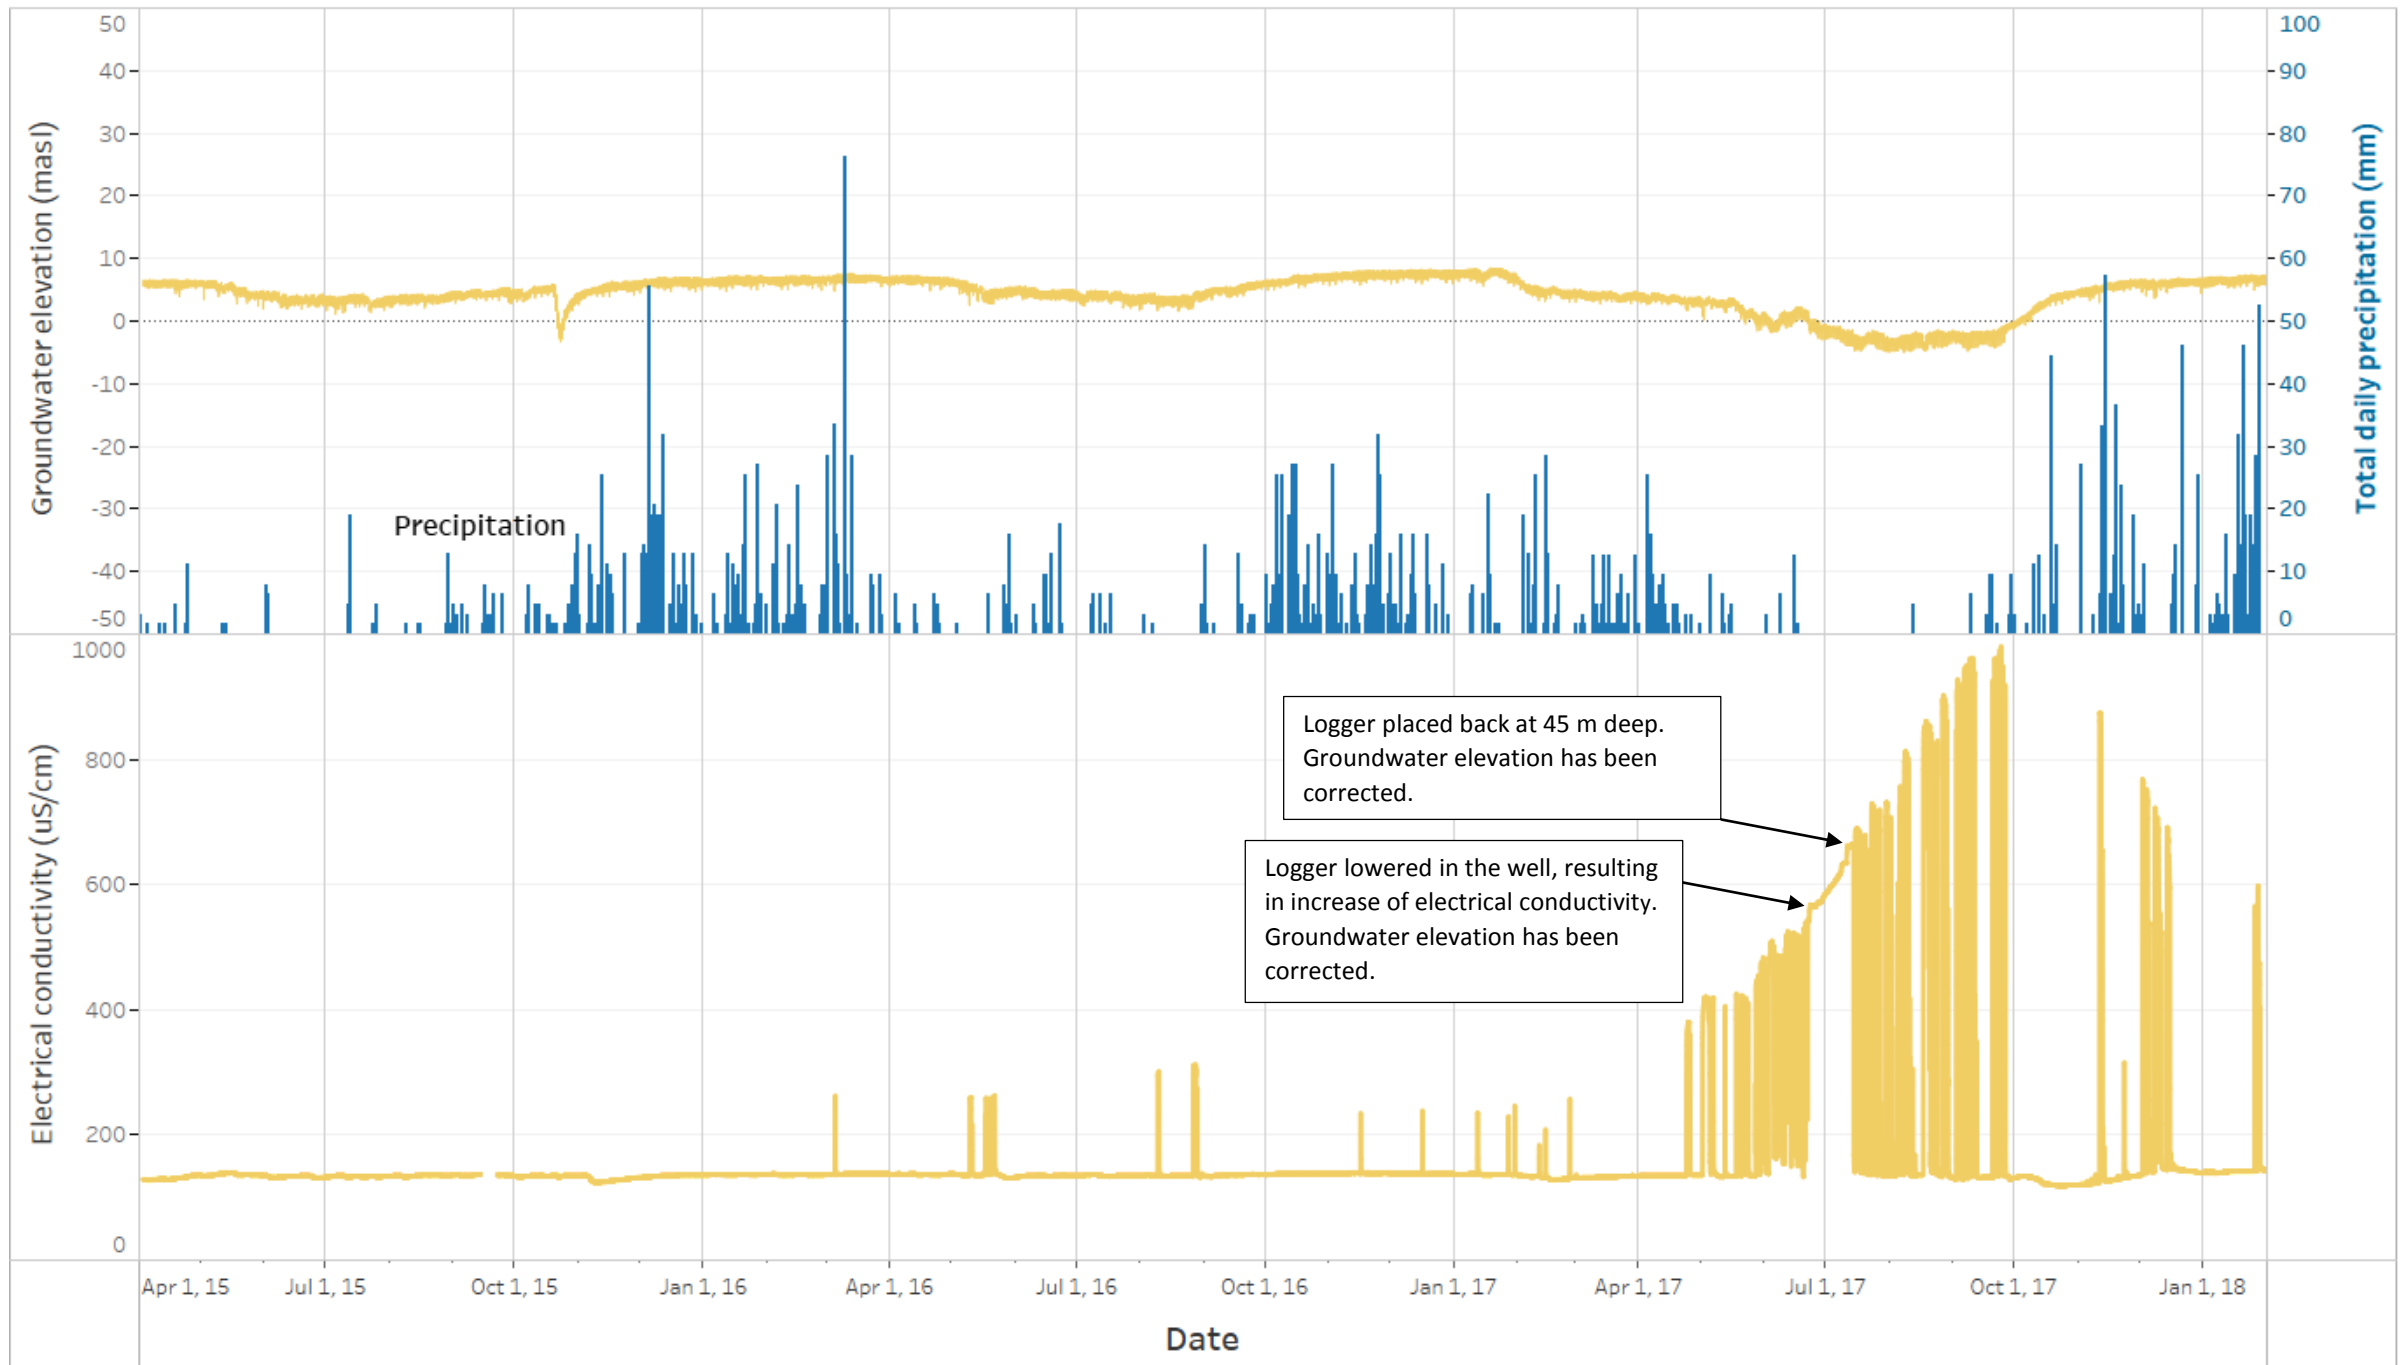
Groundwater elevation, precipitation and electrical conductivity in B7
