Parker Road Monitoring program

Water level graphs to February 1st, 2018

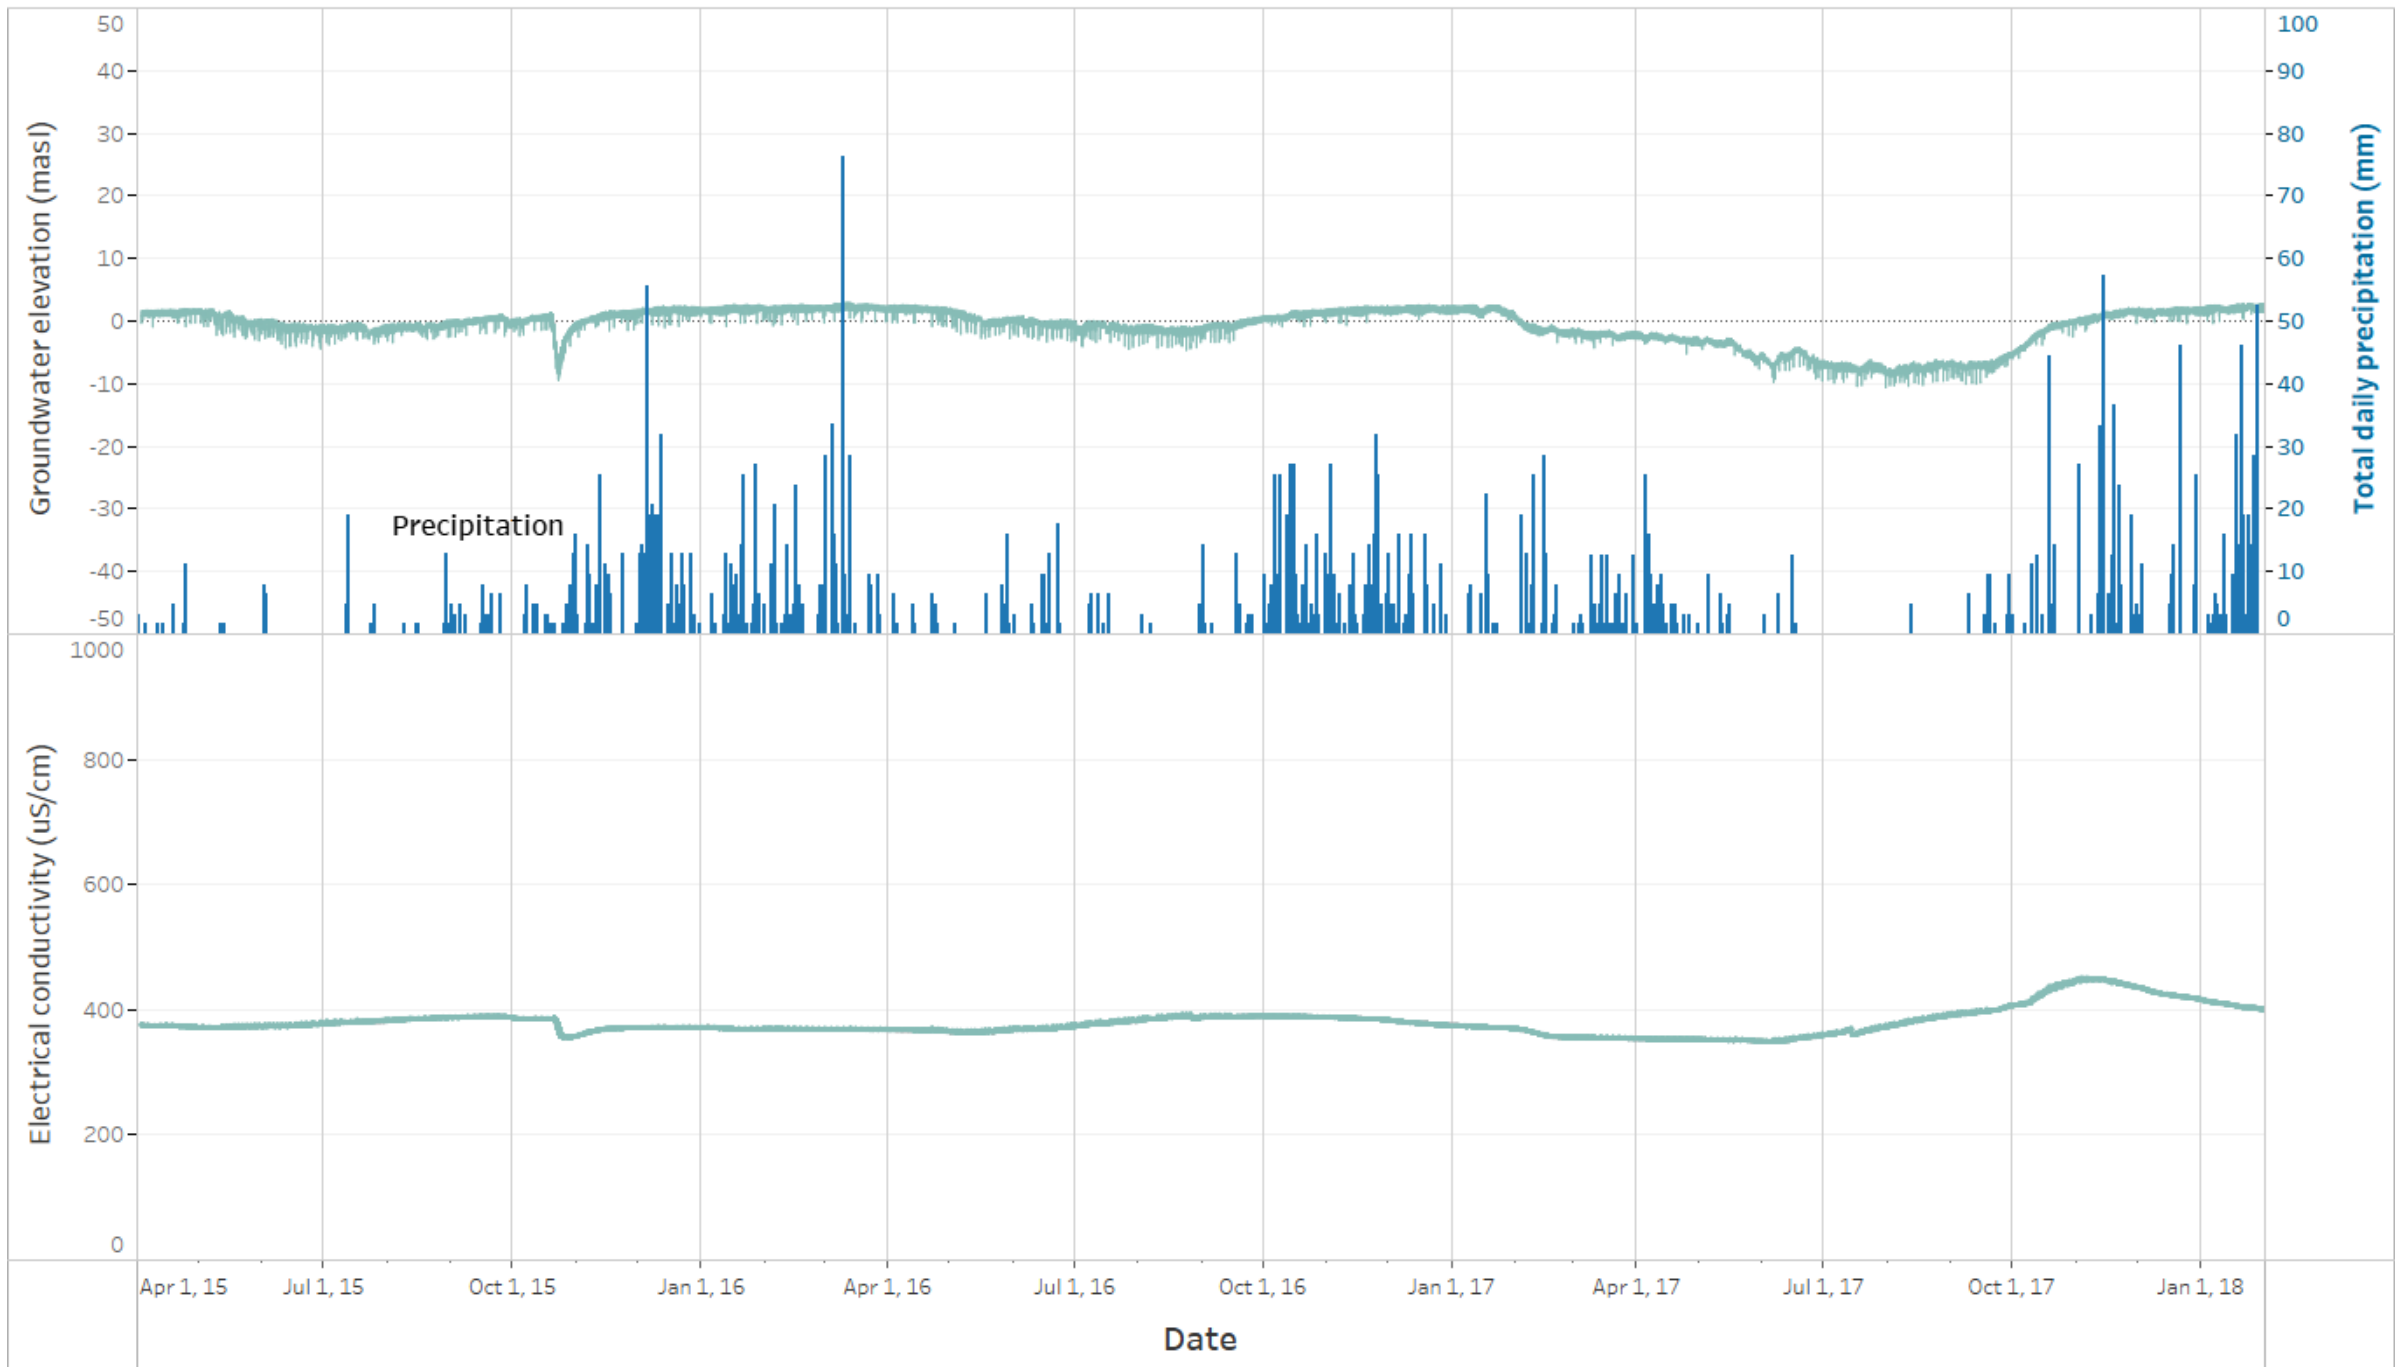
Groundwater elevation, precipitation and electrical conductivity in B9

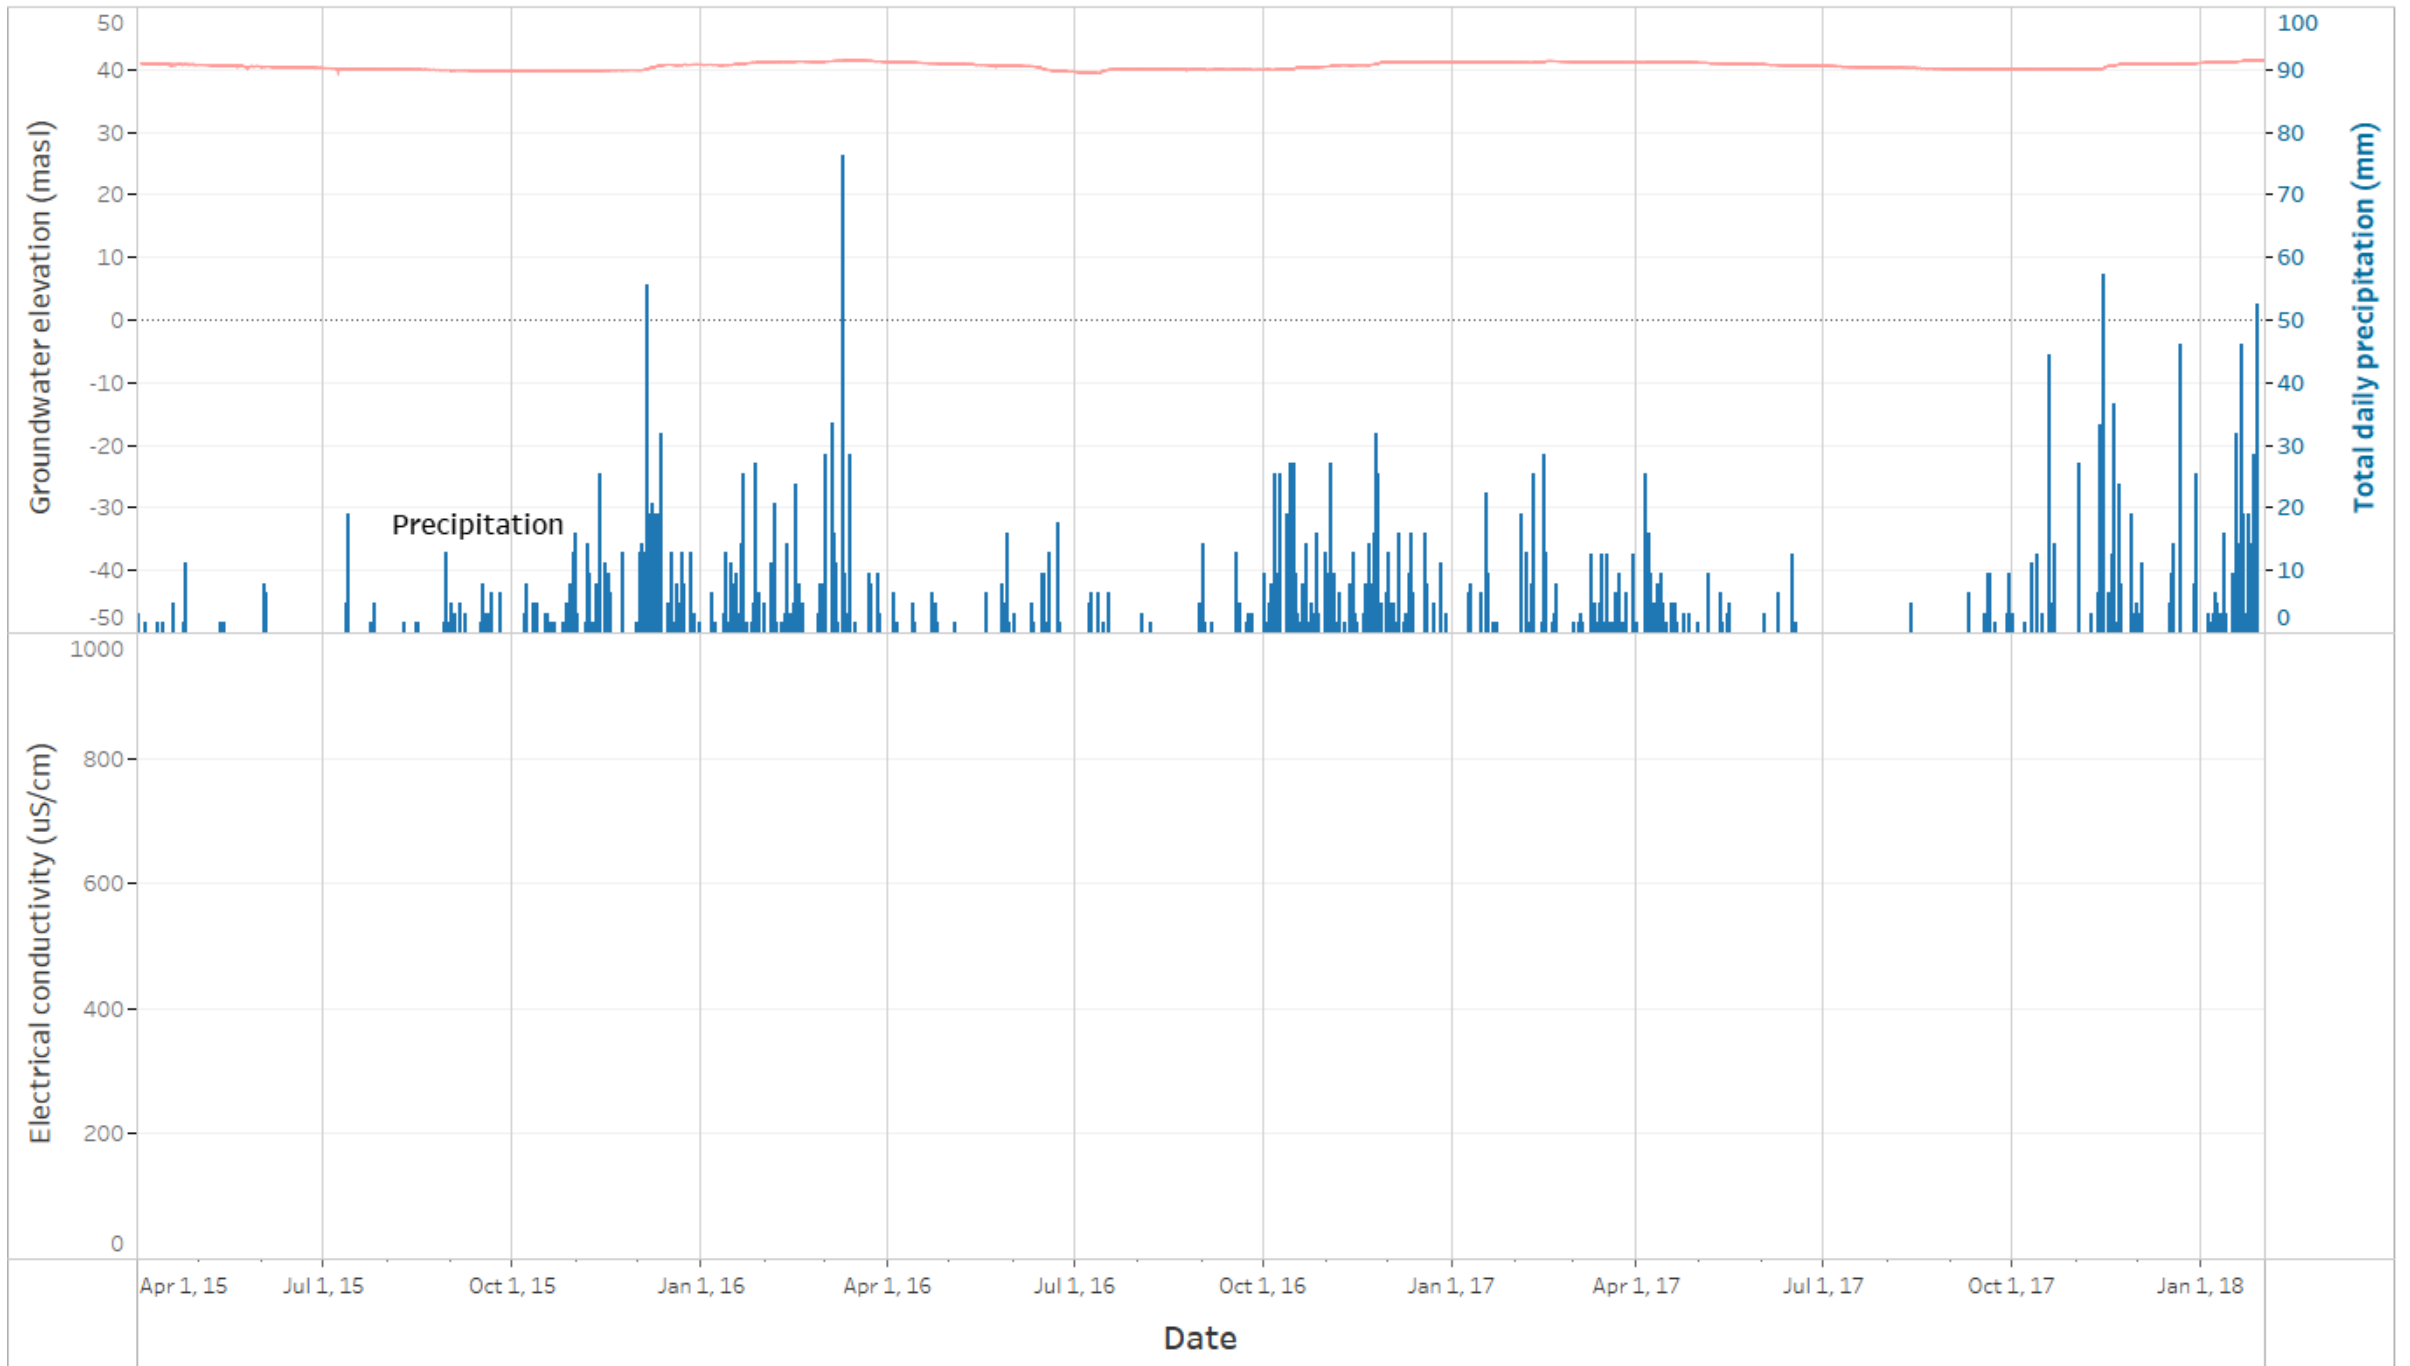
Groundwater elevation and precipitation in O1

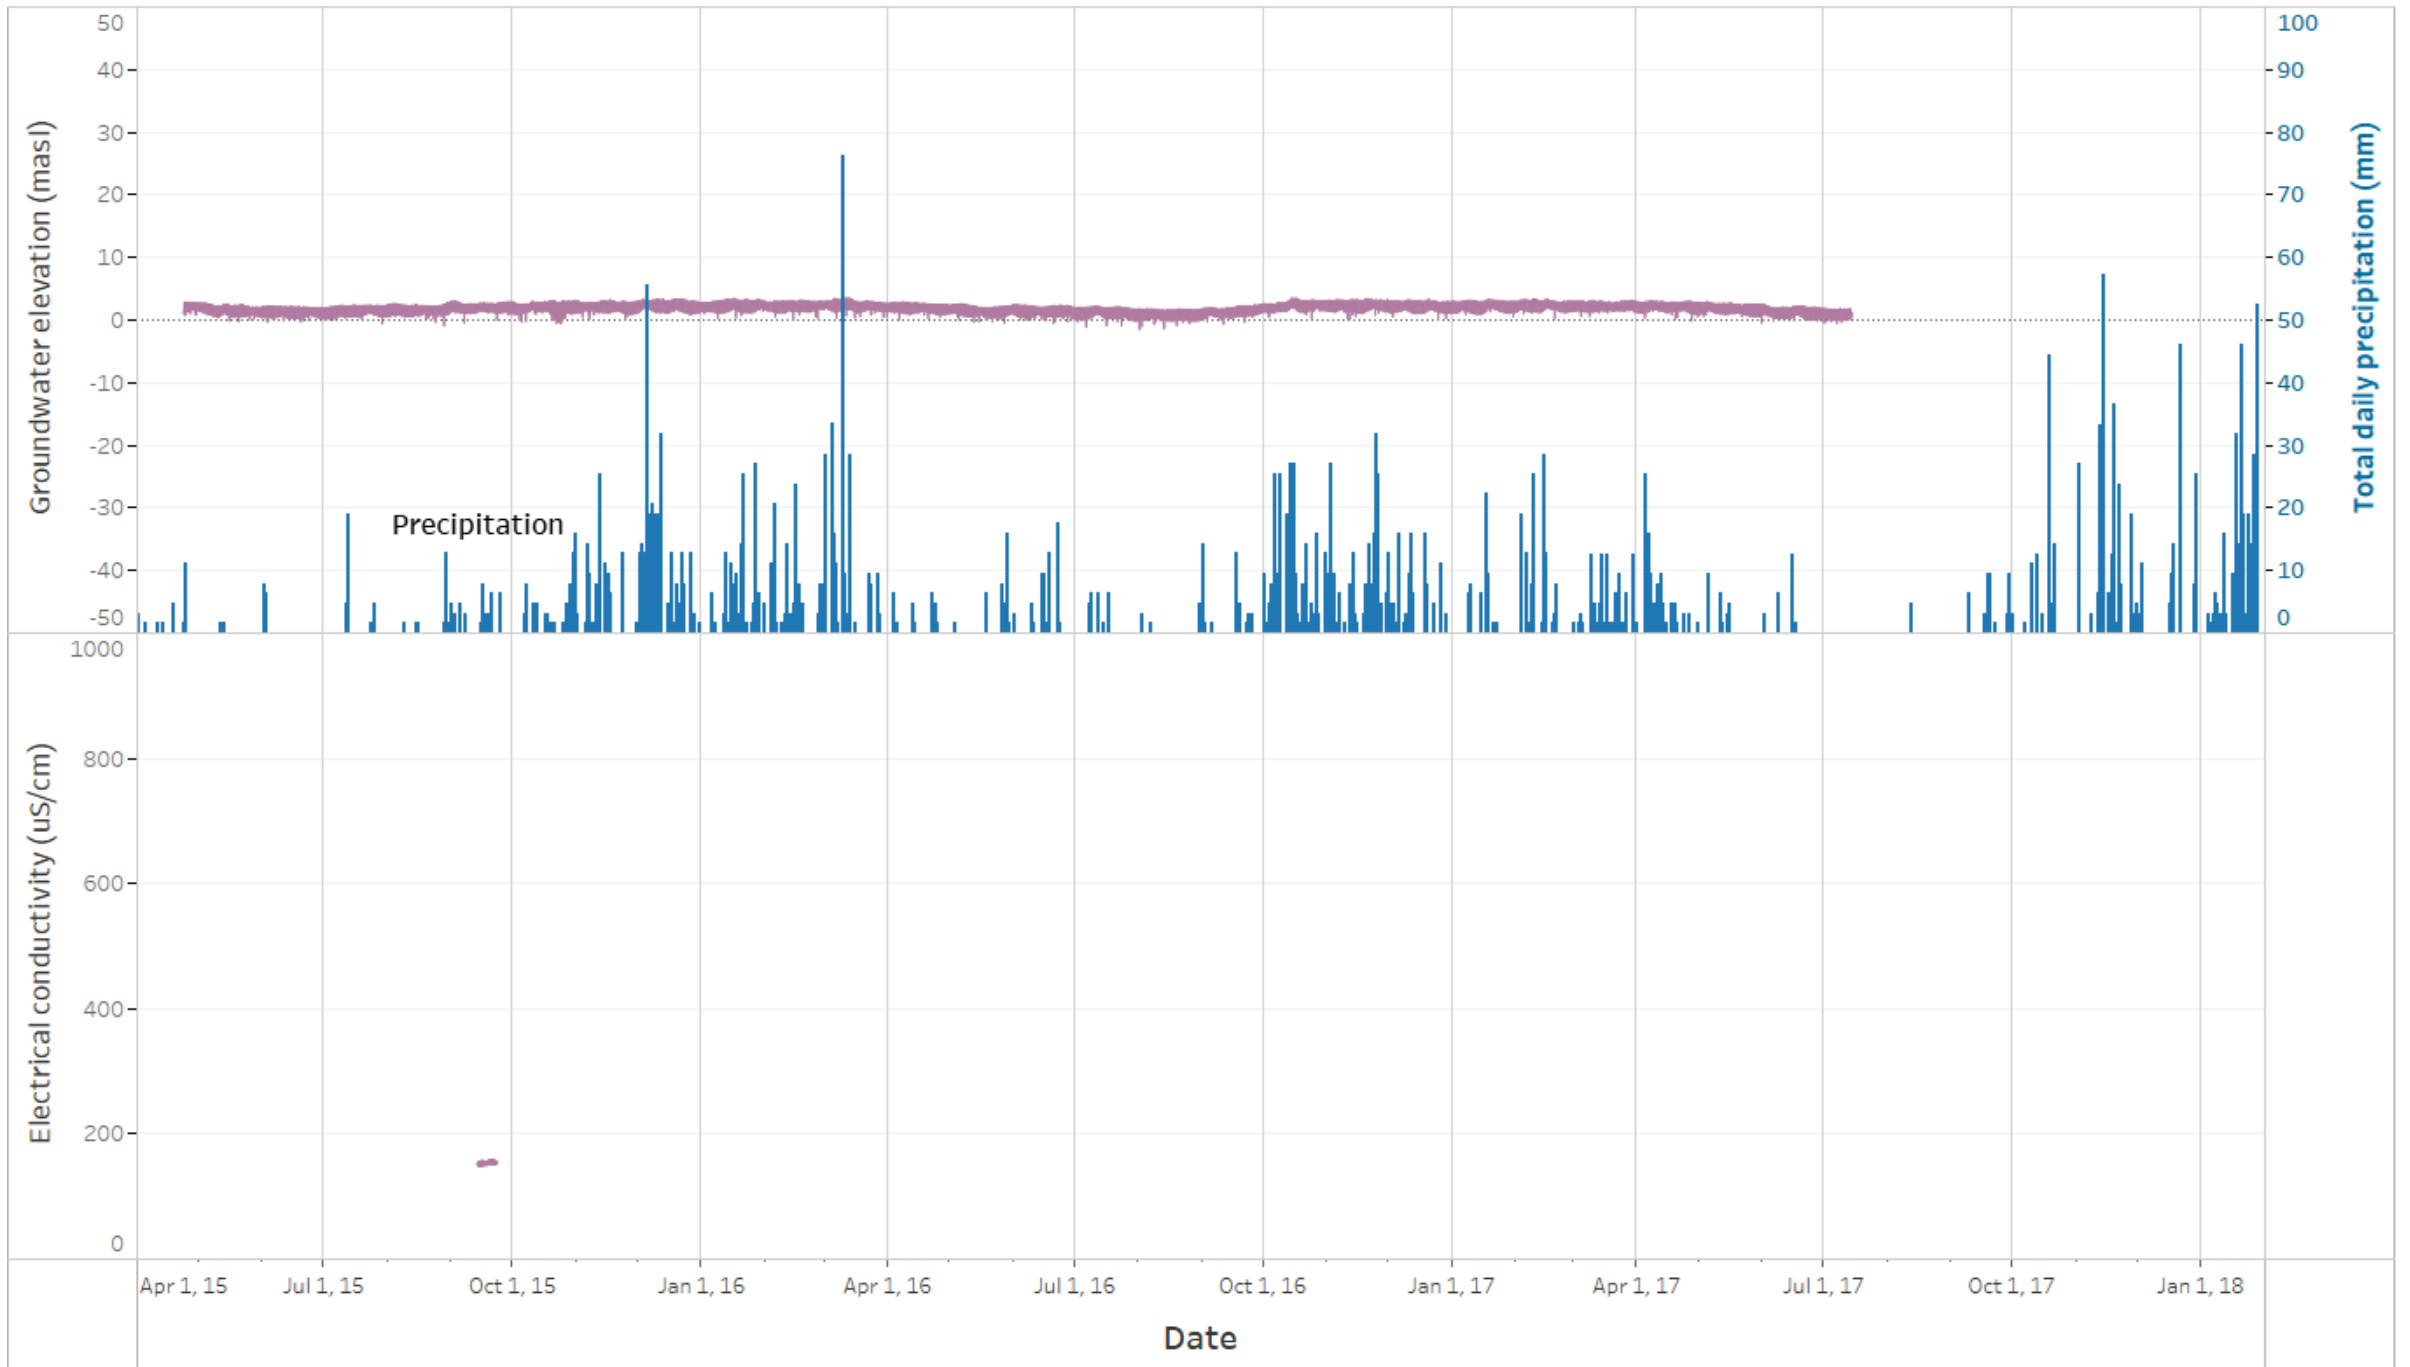
Groundwater elevation, precipitation and electrical conductivity in O2

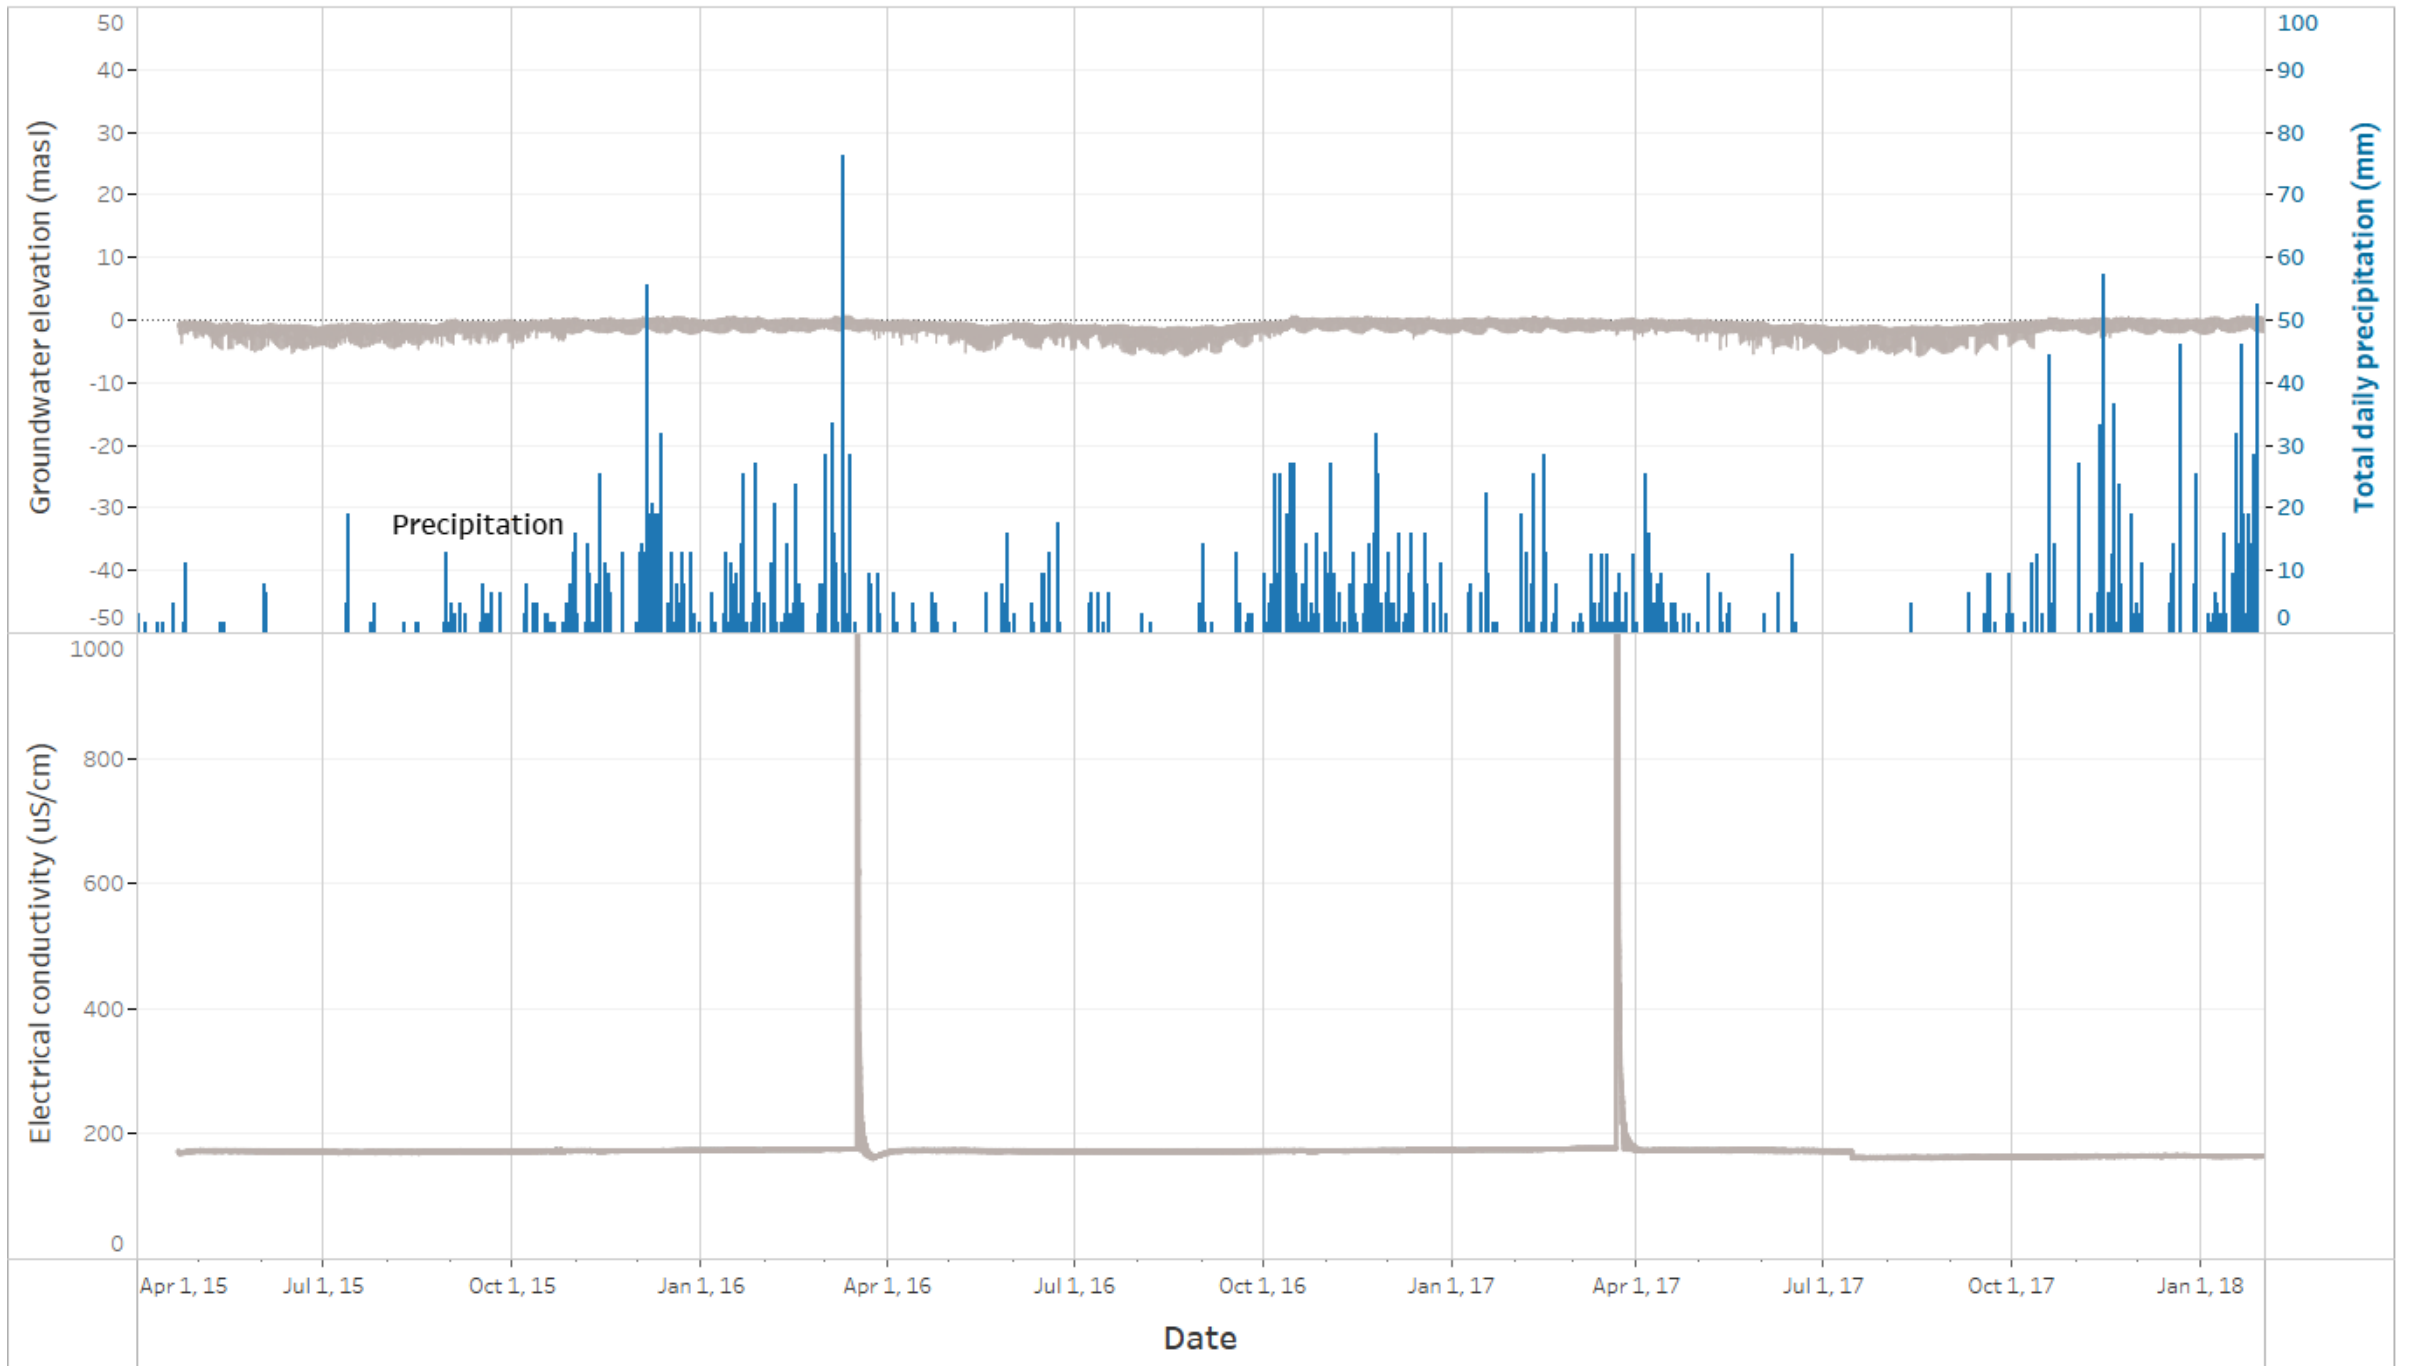
Groundwater elevation, precipitation and electrical conductivity in O3

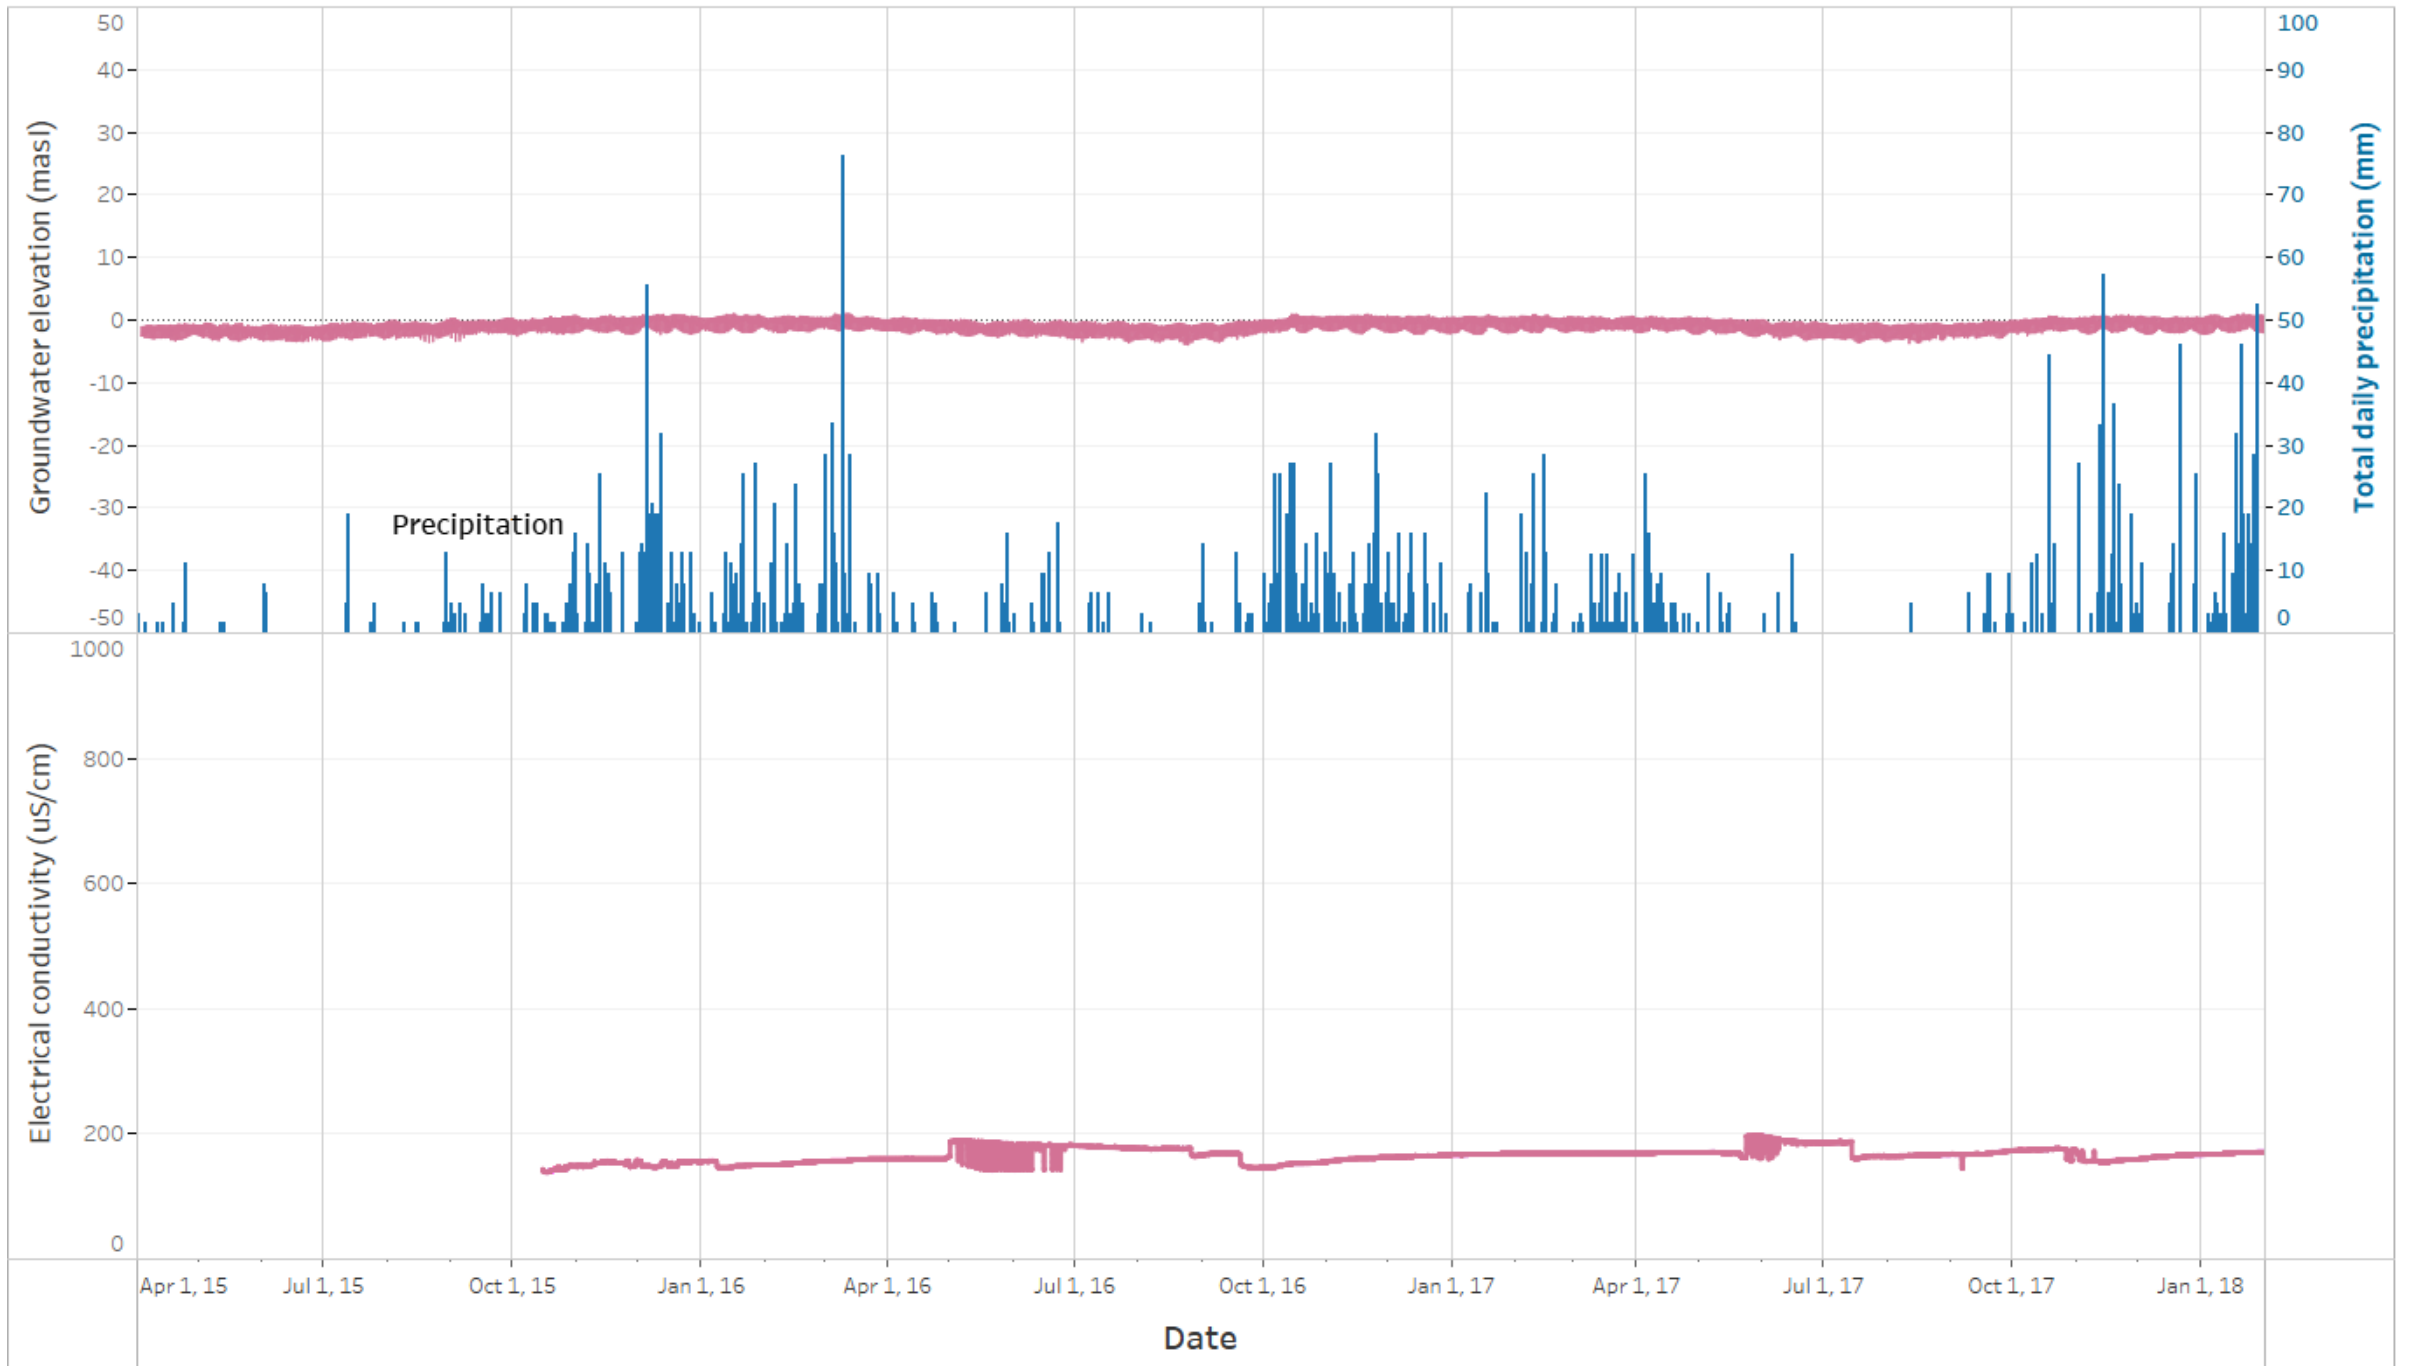
Groundwater elevation, precipitation and electrical conductivity in O4

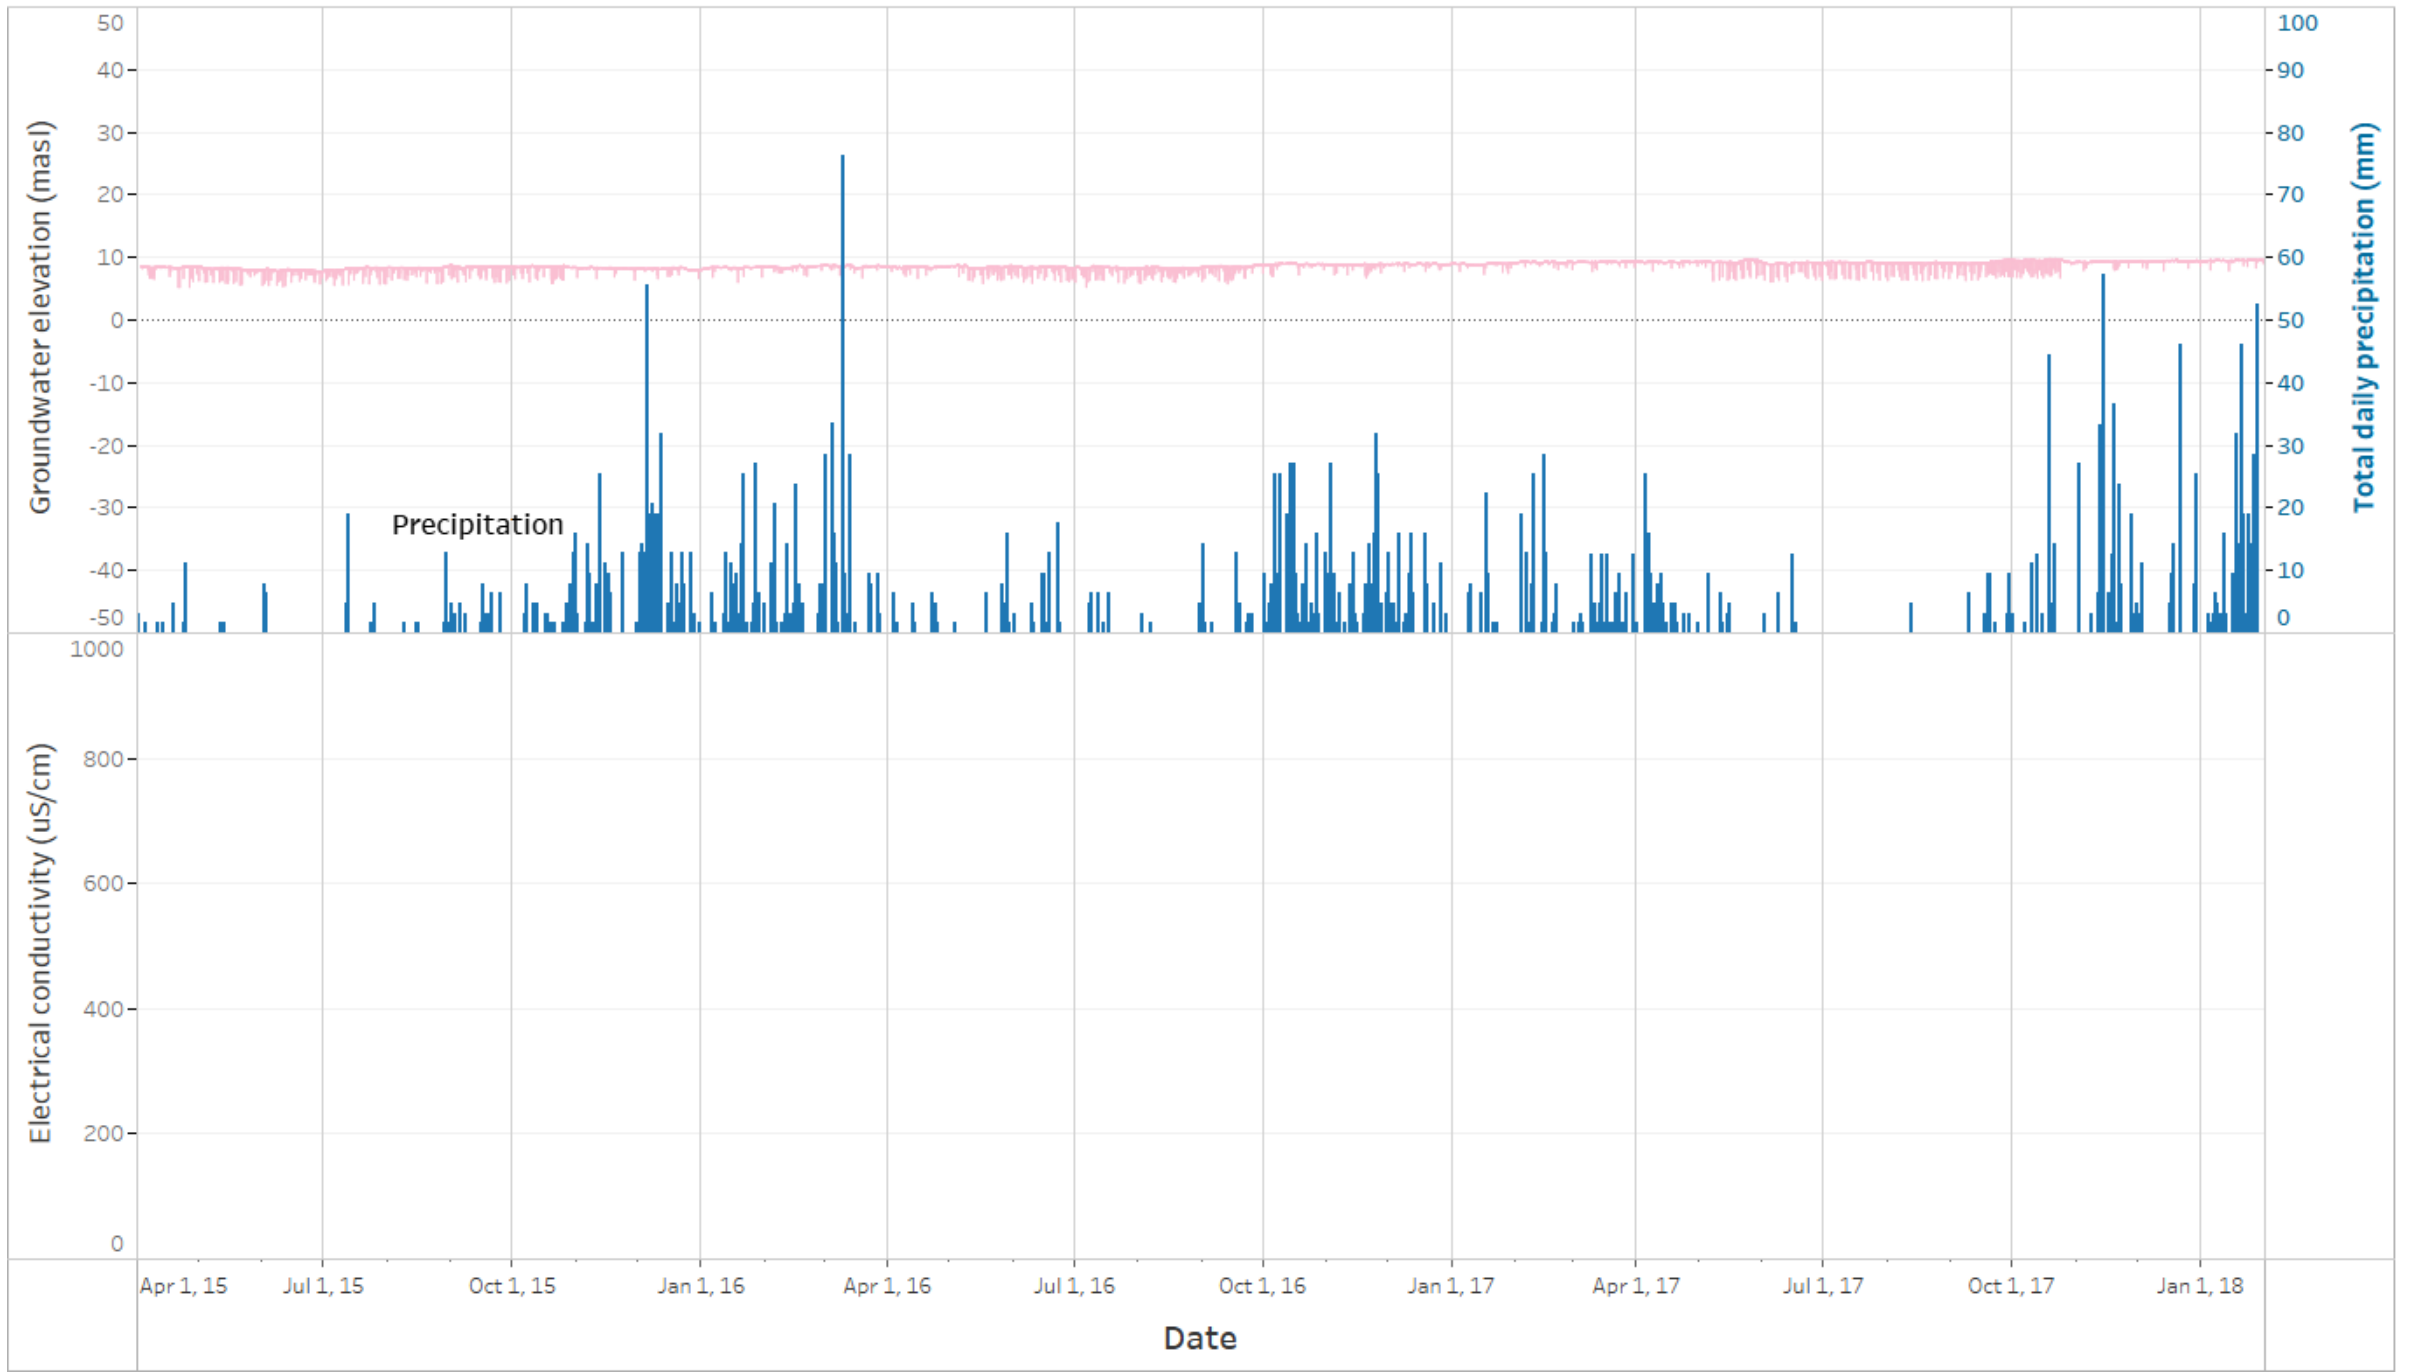
Groundwater elevation and precipitation in 05

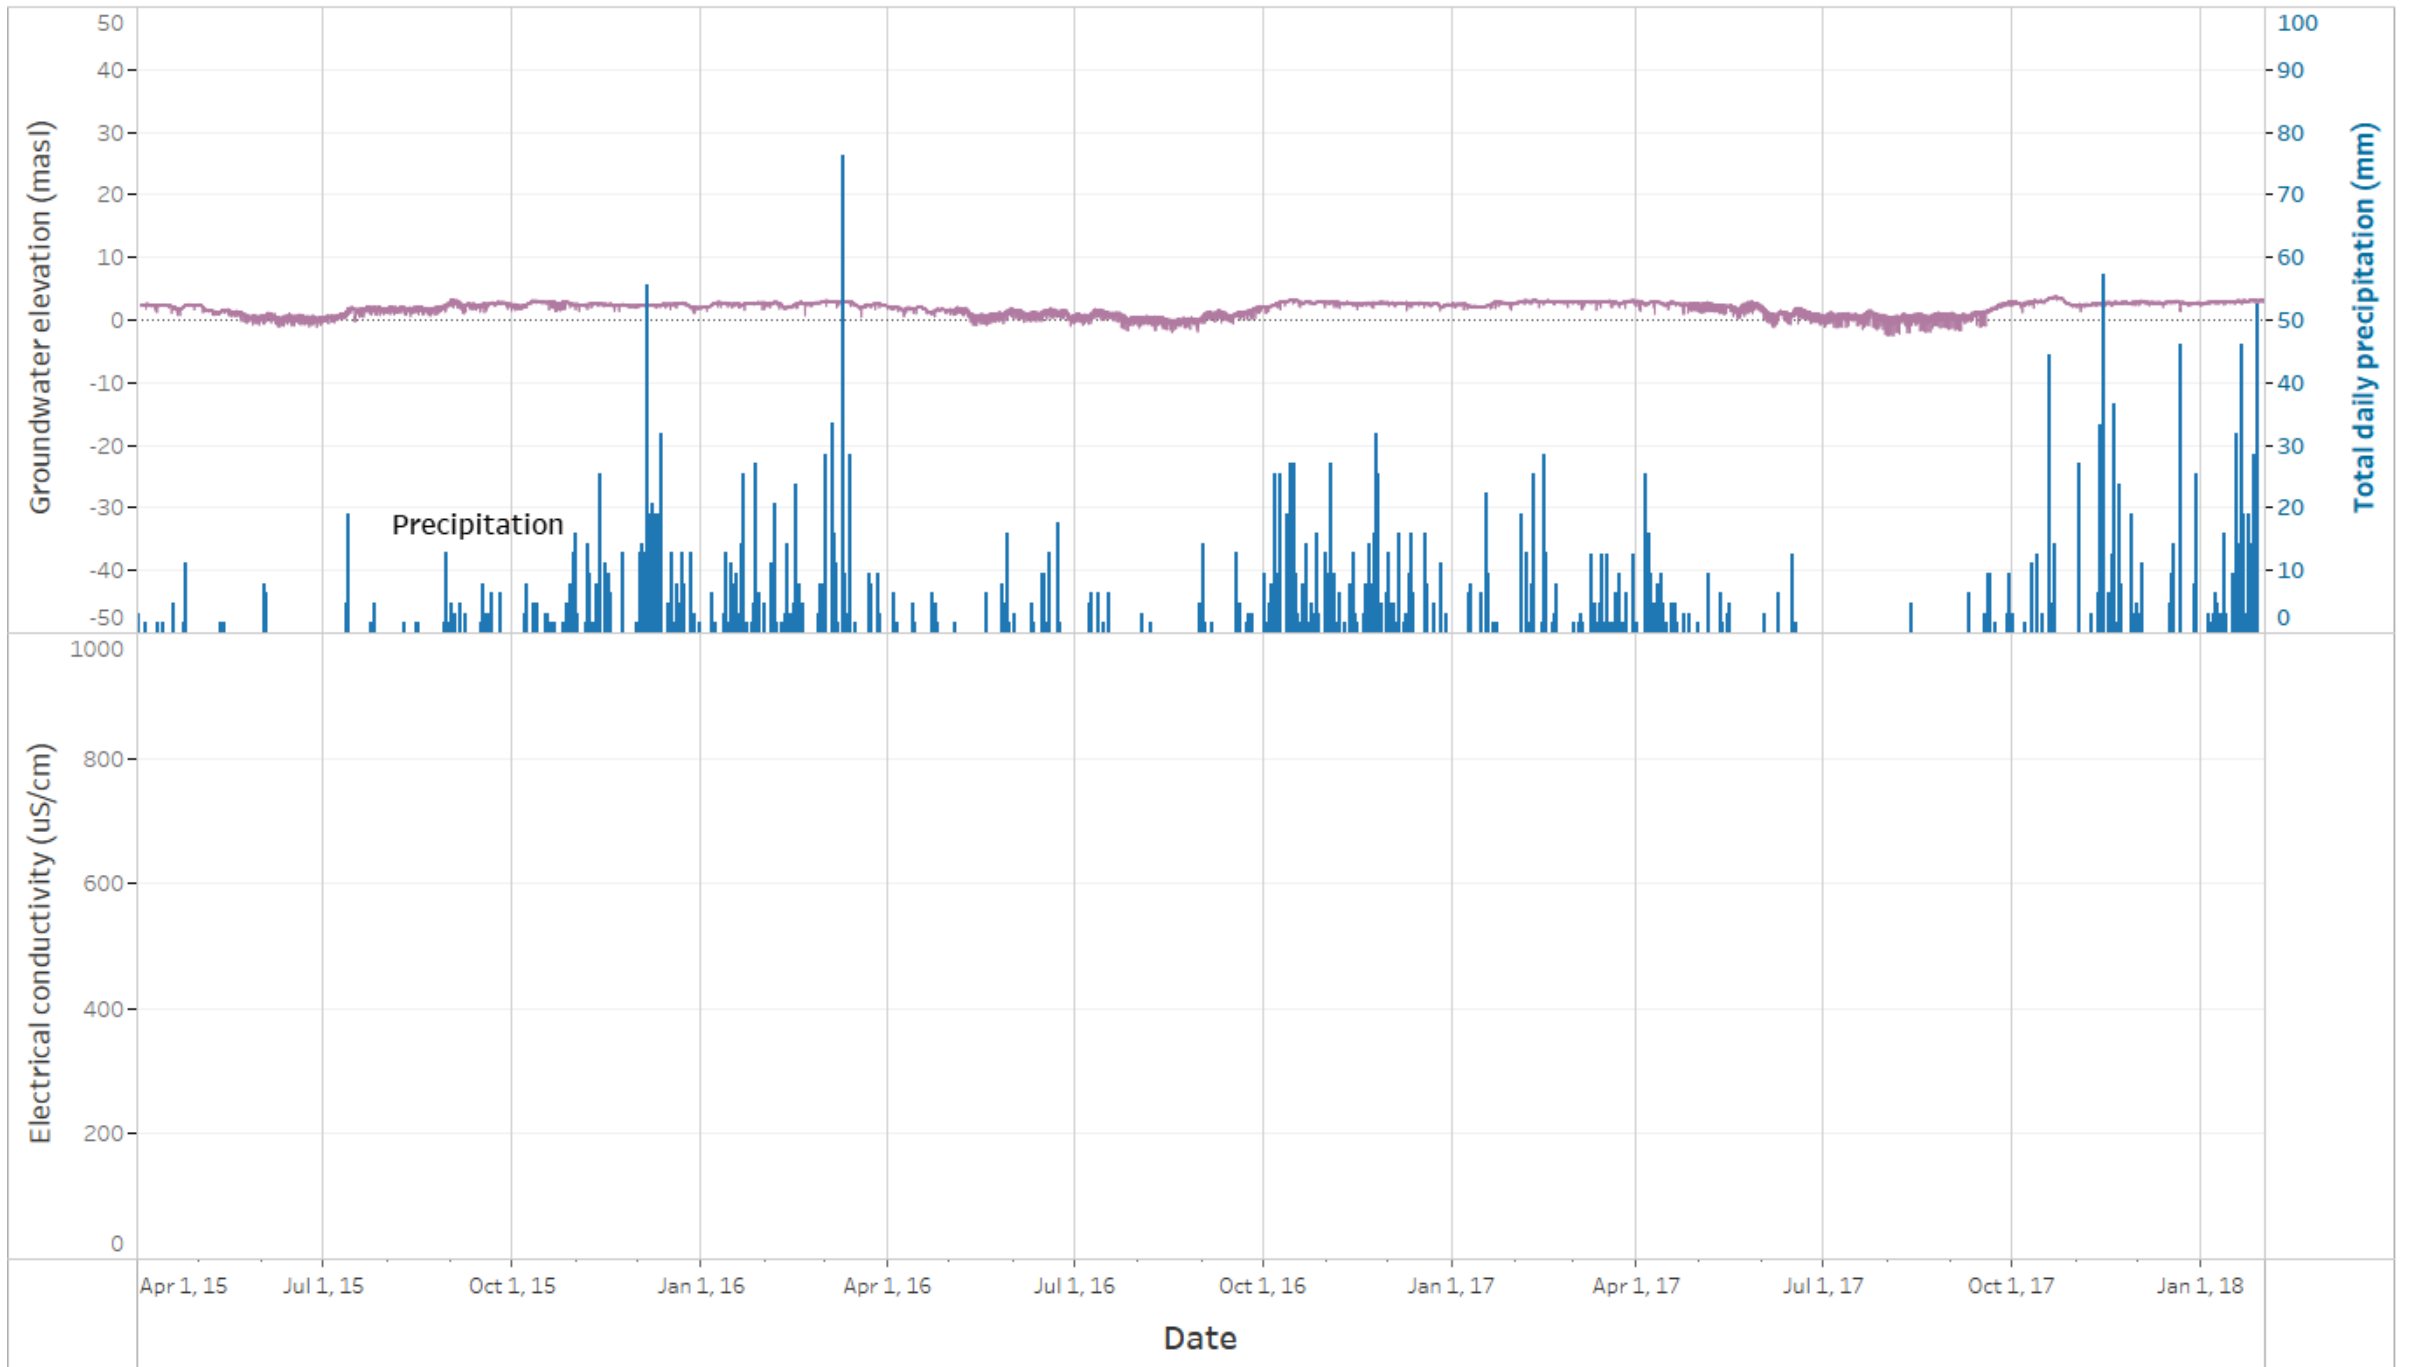
Groundwater elevation and precipitation in O6
