Parker Road Monitoring program

Water level graphs to February 1st, 2018

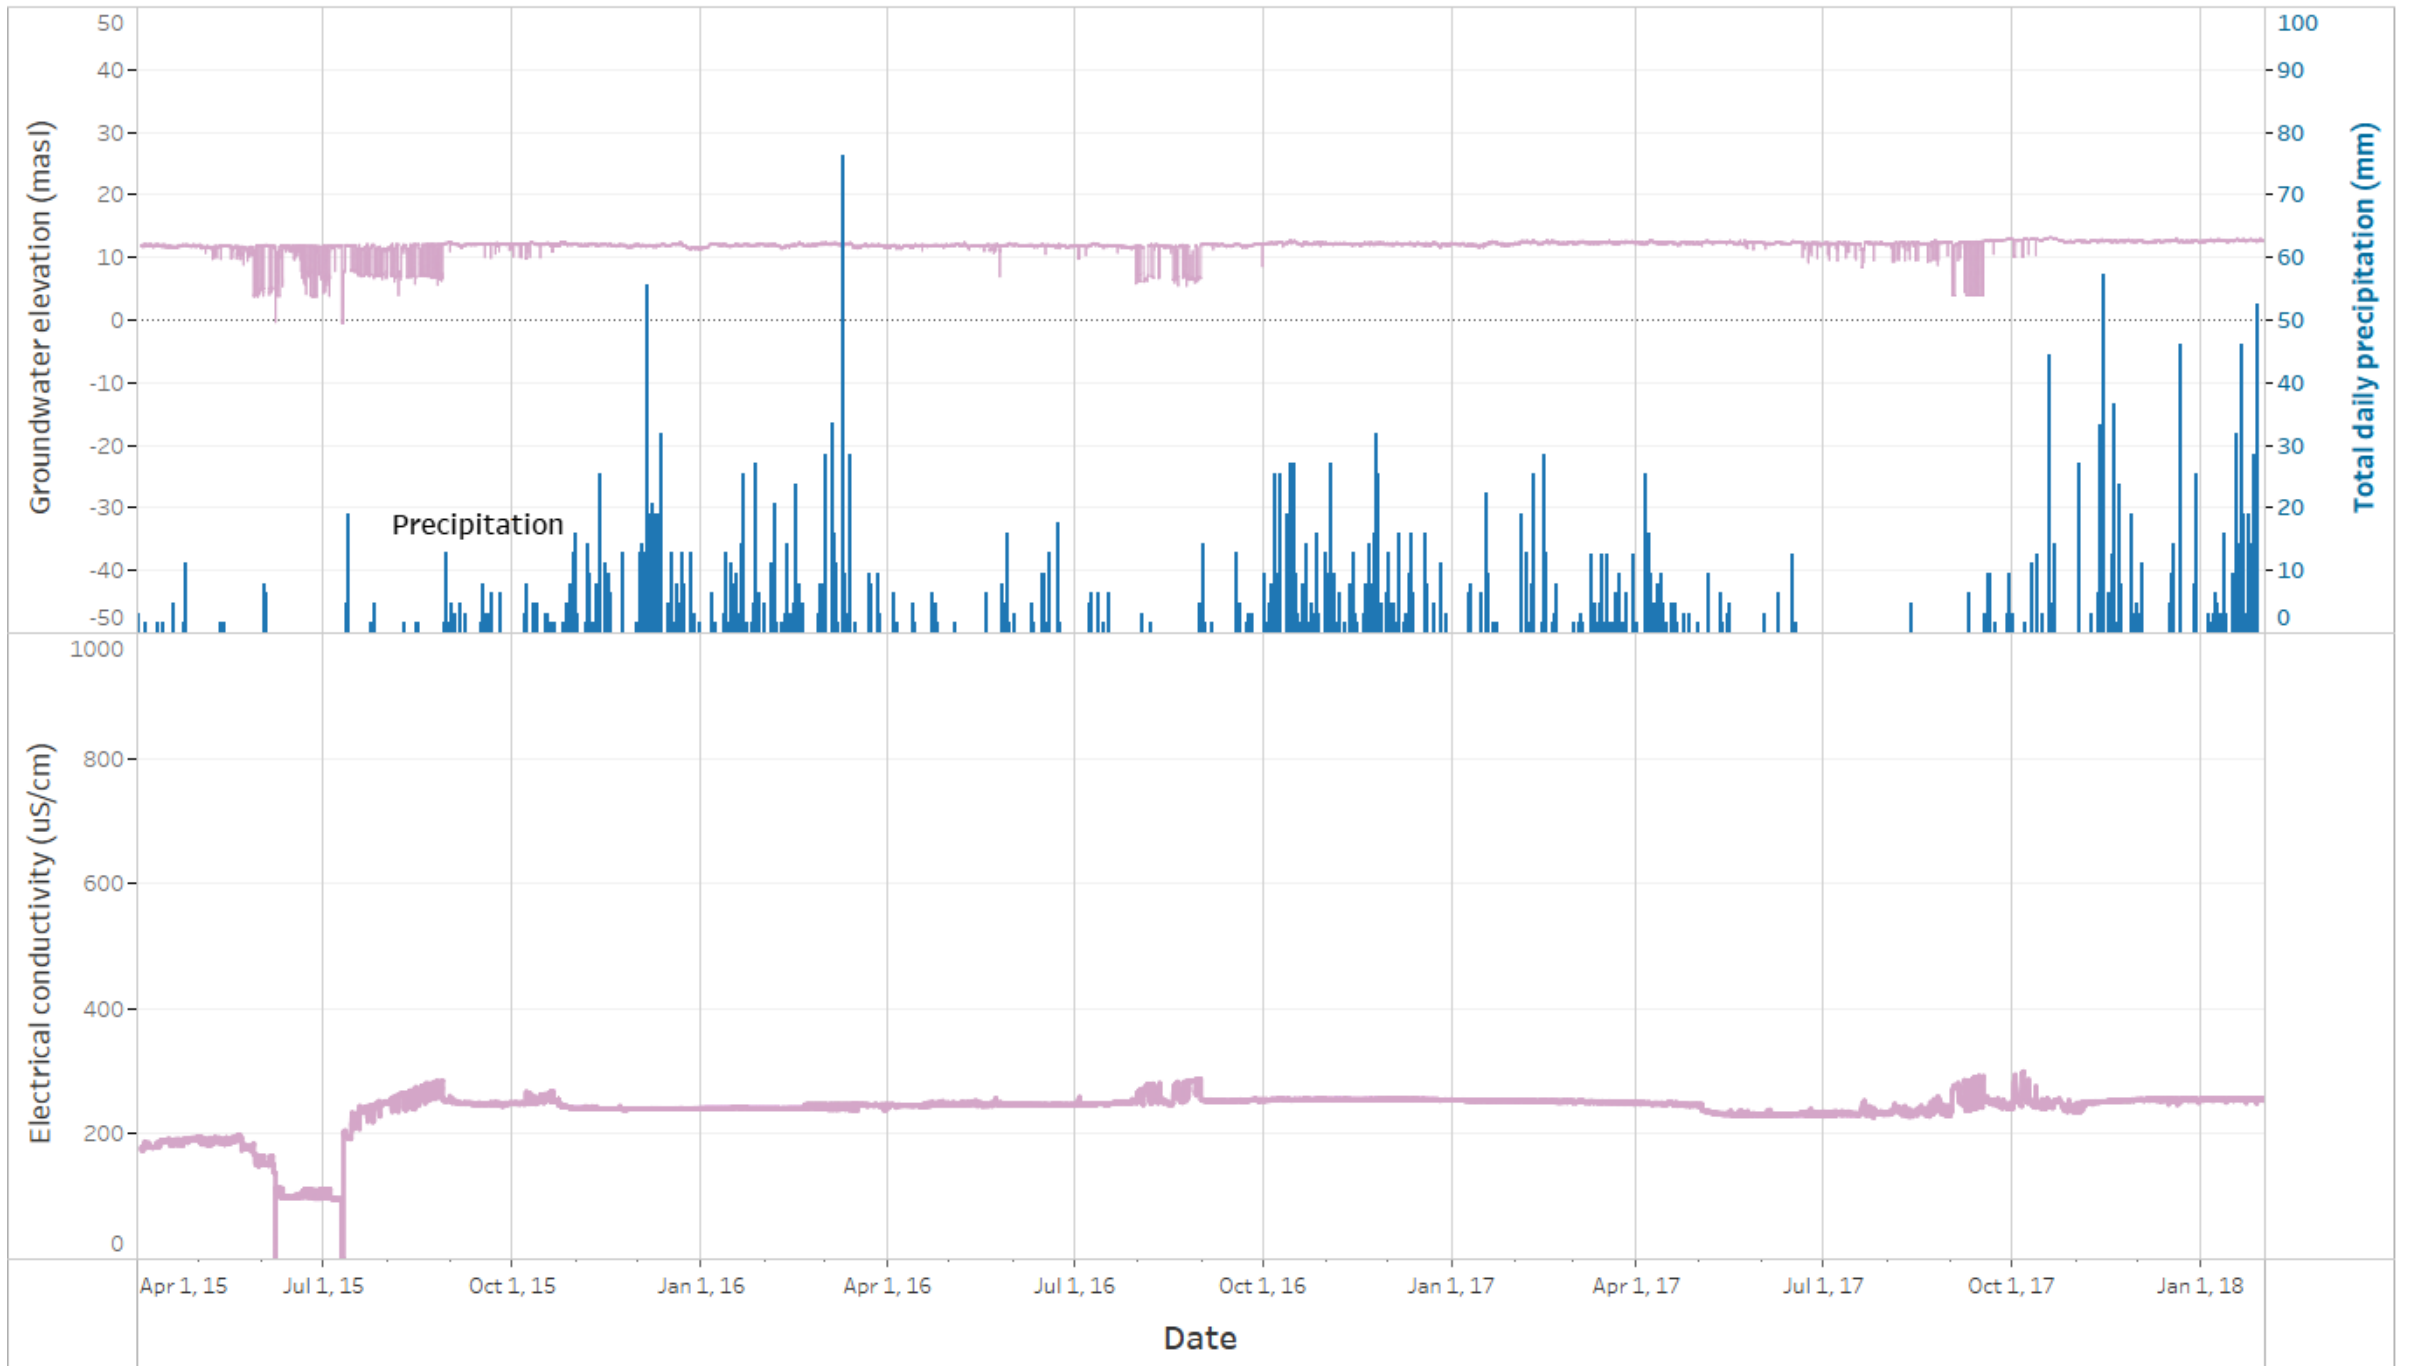
Groundwater elevation, precipitation and electrical conductivity in O7
