# REGIONAL DISTRICT OF NANAIMO

## Water Service Area Annual Report 2012

### Englishman River Community Water System

June 2013

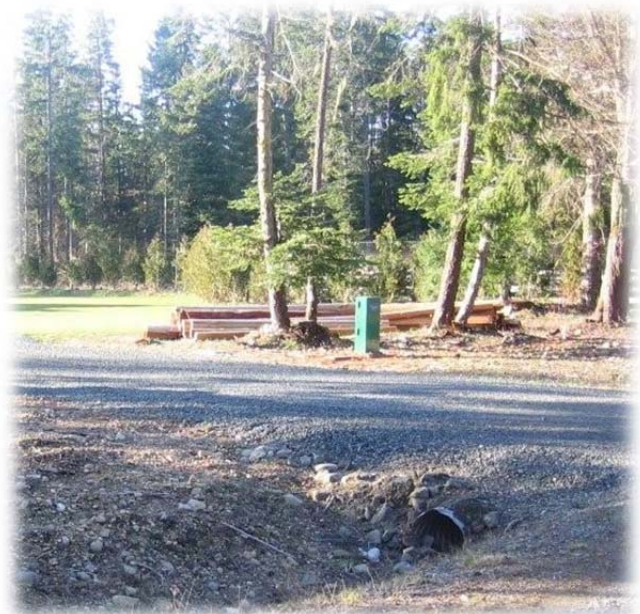
Watering Sampling Station on Rascal Lane

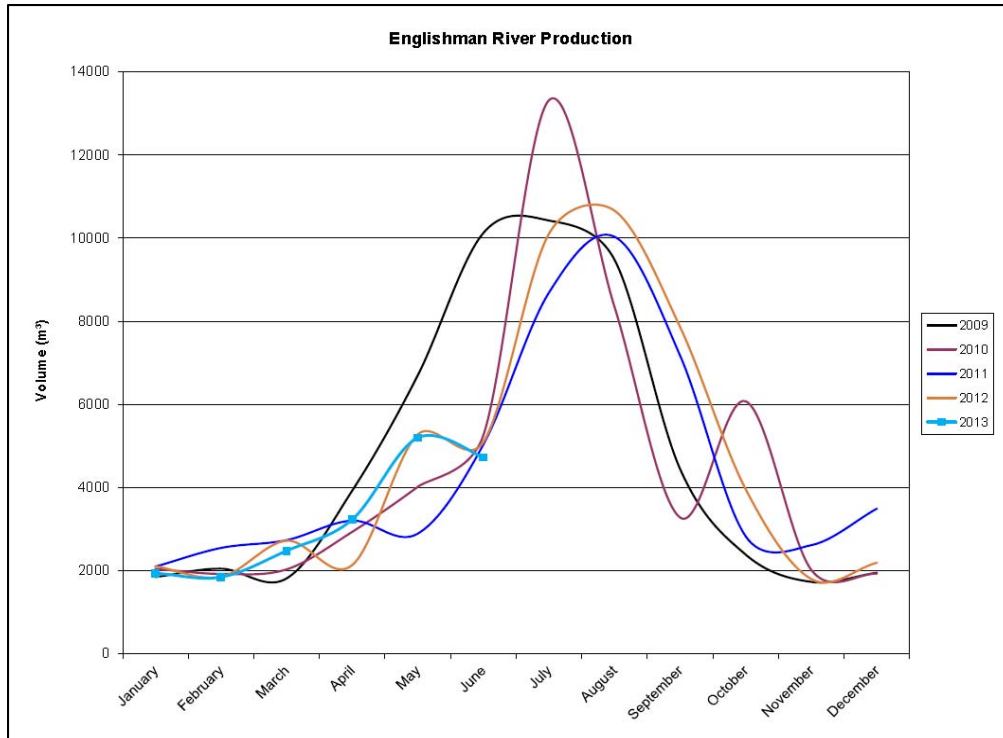
The monthly groundwater production in the Englishman River Water Service Area for the past 4 years is shown in the chart below. Groundwater production in 2012 was average in comparison to previous years, despite the new homes and landscaping being installed in this subdivision.
