REGIONAL DISTRICT OF NANAIMO

Water Service Area Annual Report 2016

San Pareil Water Service Area

June 2017

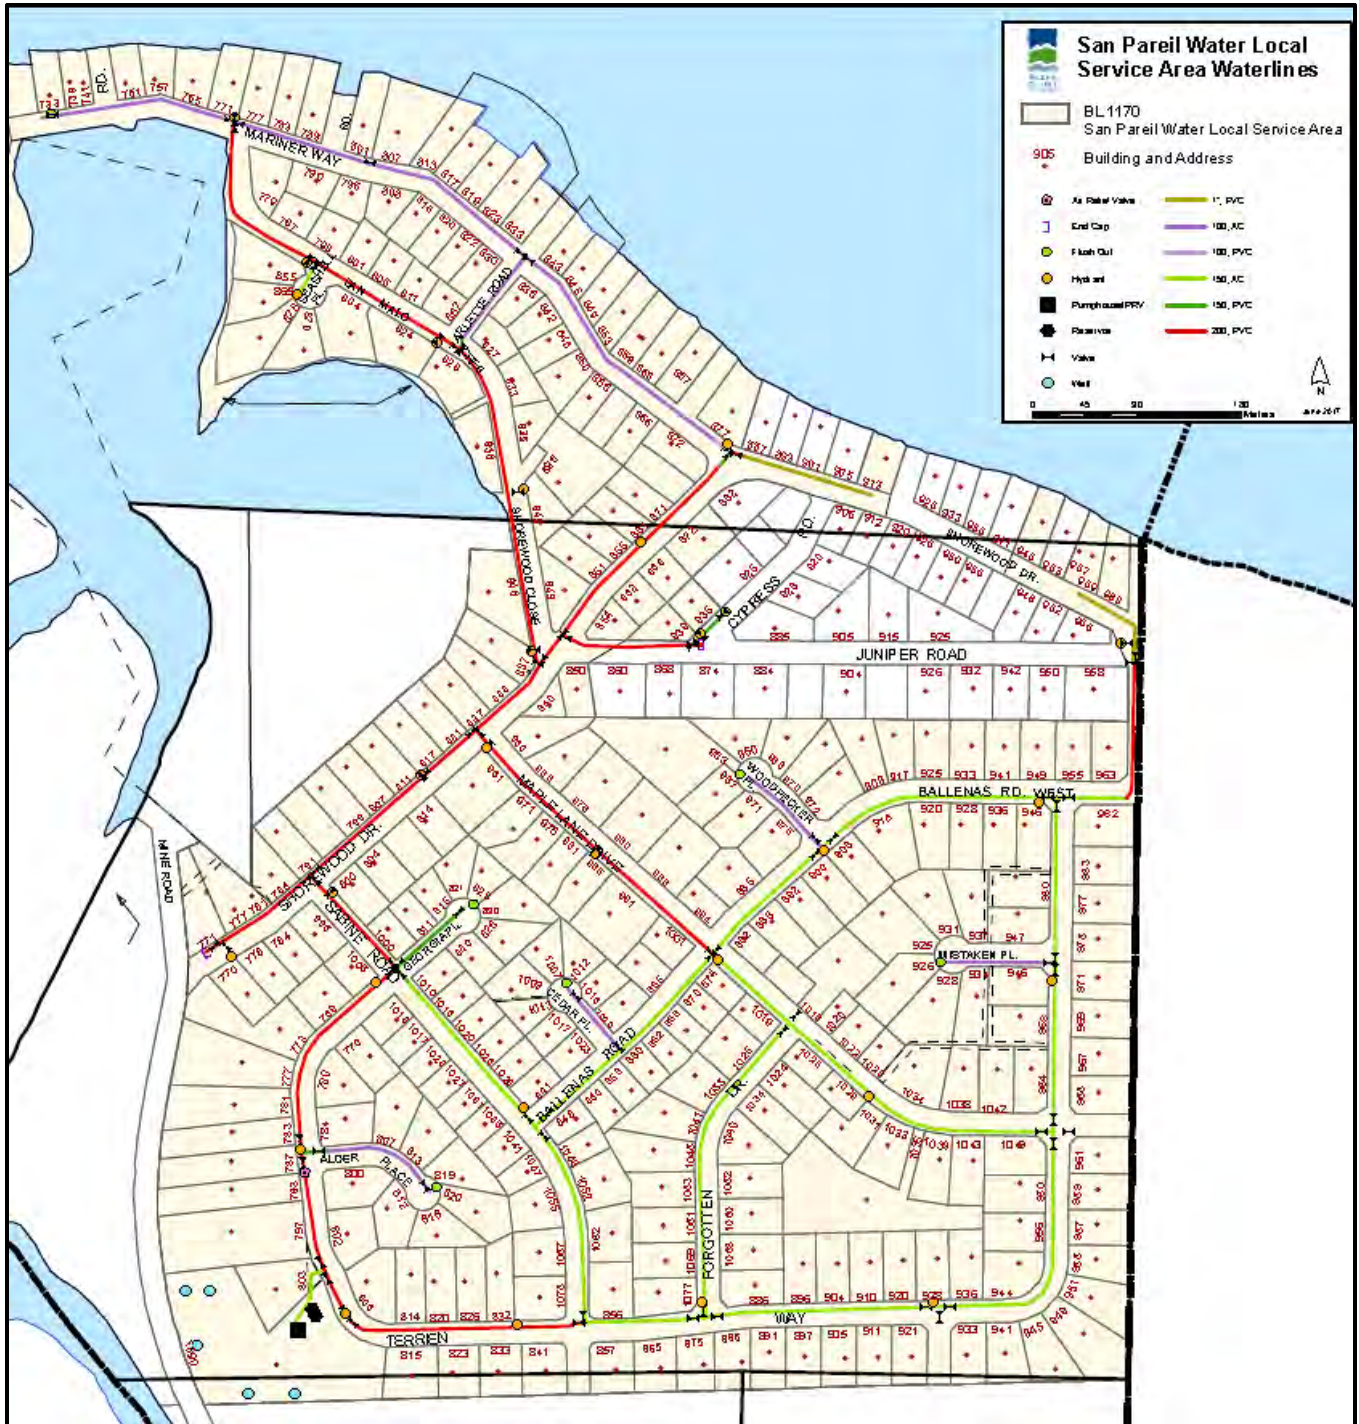
**MAP OF SAN PAREIL
WATER SERVICE AREA**

SAN PAREIL WATER SERVICE AREA

The San Pareil Water Service Area was established in 1999 when the RDN acquired the existing Bubbling Springs Water Utility. This system is located to the northeast of the Englishman River Bridge on the east side of the City of Parksville. There are 282 water service connections in San Pareil. The water source for the San Pareil Water Service Area comes from a series of groundwater wells located in the well field on Plummer Road. The well water is chlorinated and stored in two reservoirs. A back-up generator is present at the pumphouse, should it be required. A map of the San Pareil Water System is provided in Appendix A.
