SCHEDULE "DD": INTEGRATED STORMWATER MANAGEMENT PLAN

Final Report The Lakes District and Schooner Cove ISMP

November 21, 2013

KERR WOOD LEIDAL
consulting engineers

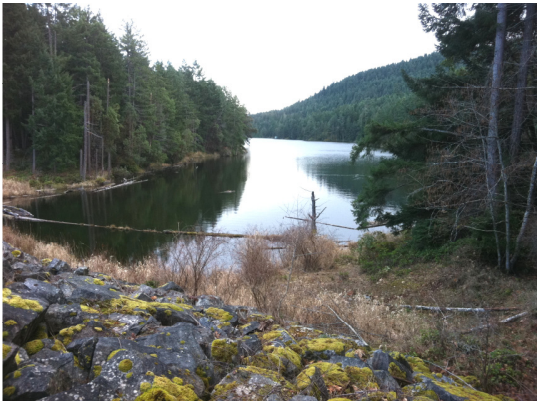
1. Enos Lake is about 12m deep at its deepest point and is fairly shallow at both ends (1-2m)

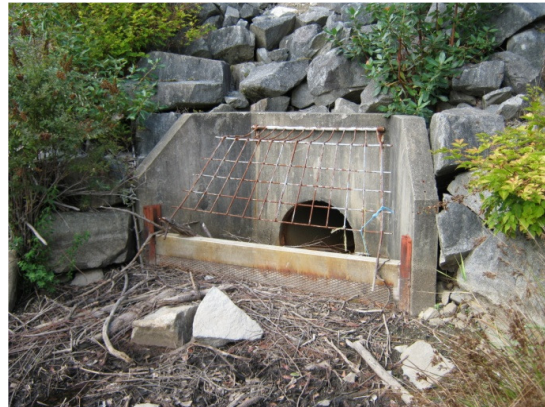
Enos Lake Outlet Structure

Enos Wetland W1. Some erosion of the cohesive clay/silt material downstream of the Enos Lake outlet culvert was observed. The Enos Wetland W1 is now more a meadow than a wetland since the beaver dam at the outlet was breached.

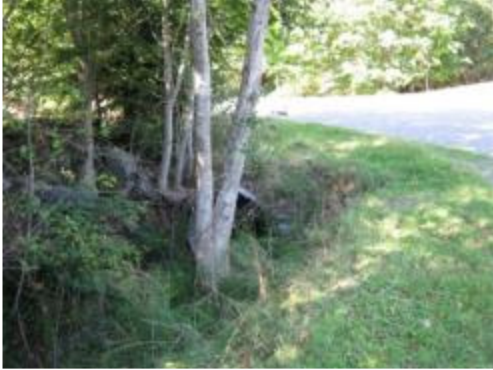
Enos Creek (S1) at Swallow Rd and Dolphin Drive looking upstream at 1,500 mm dia

Enos Creek (S1), flows out of Enos Lake and Enos Wetland W1. The creek is about 1.5 m to 2 m wide and flows through a well-defined bedrock gully. Significant wood debris is in the channel, which most likely remains from a beaver dam breach about 13 years ago. The stream downstream of the beaver dam shows signs of erosion.

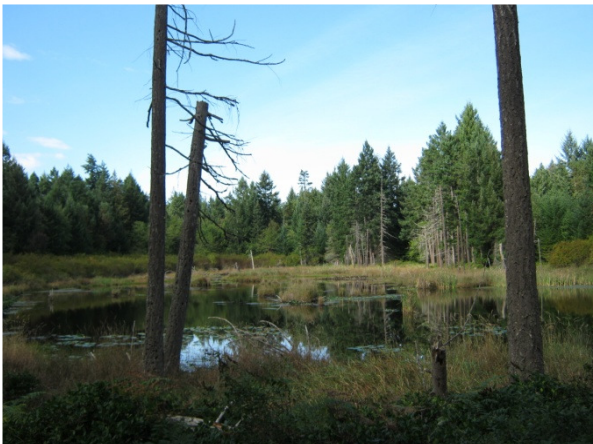
Wetland W2 on Stream S3

Stream S3 flows out of **Wetland W2** on the south-west side of Enos Lake. This wetland is located high on a bedrock ridge above the lake. The pond was formed when peat was excavated from the area and the water level has been raised about 0.5 m by a beaver dam at the outlet. There were no signs of recent beaver activity or active erosion or instability of the dam. The stream flowing out of the wetland flows over an exposed bedrock meadow and over a cliff into the lake.

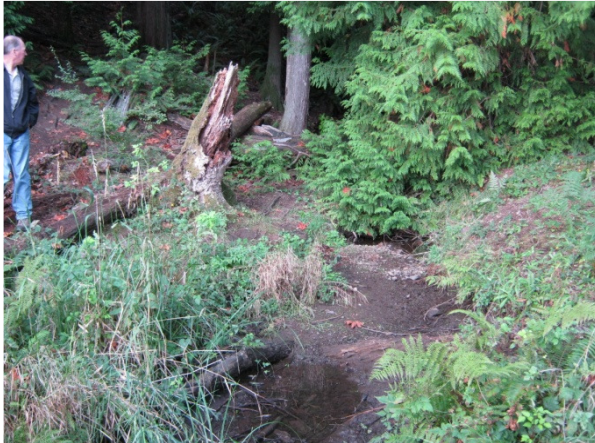
Stream S6 near Outlet to Lake

Stream S6 flows out of Wetland W4 and outlets over a 5 m high bedrock waterfall to Enos Lake. It is approximately 1 m wide and about 0.5 m deep and flows down a well-defined bedrock valley. The banks of the channel are cut into cohesive clay and glacial till soils and appear to be resistant to erosion. The banks are well vegetated, except where the stream flows through cedar groves.

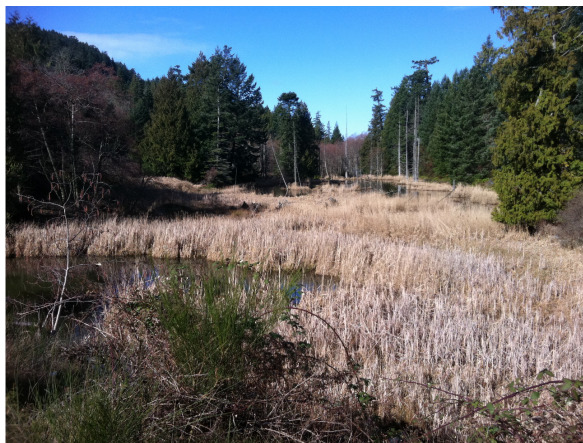
Wetland W7 located at upstream end of Enos Lake

Wetland W7 flows into Enos Lake. No erosion or stability concerns were observed. There are existing stormwater detention ponds located upstream (south) of Wetland W7.

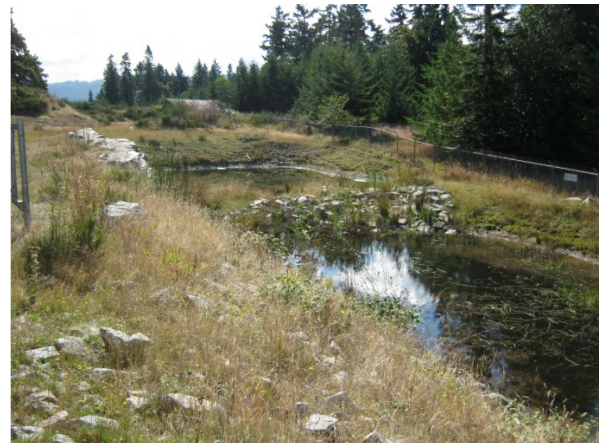
Existing stormwater detention ponds south of Fairwinds Drive

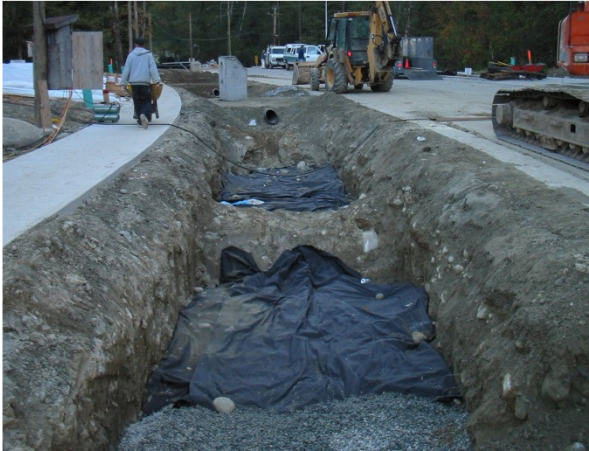
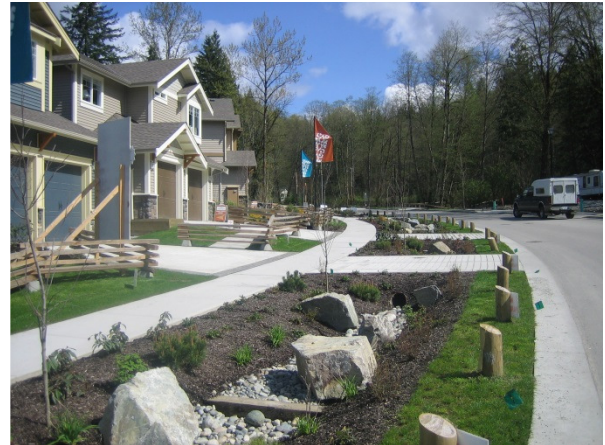
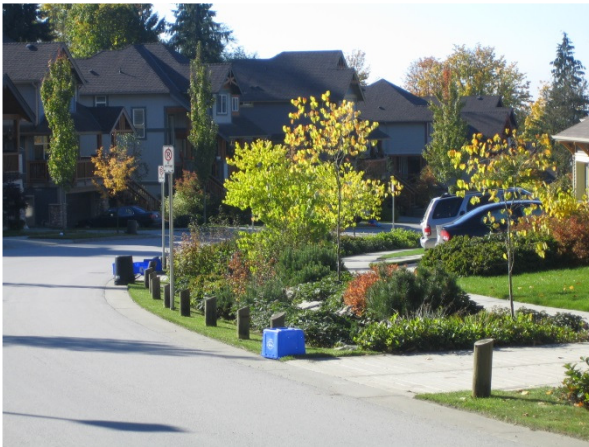
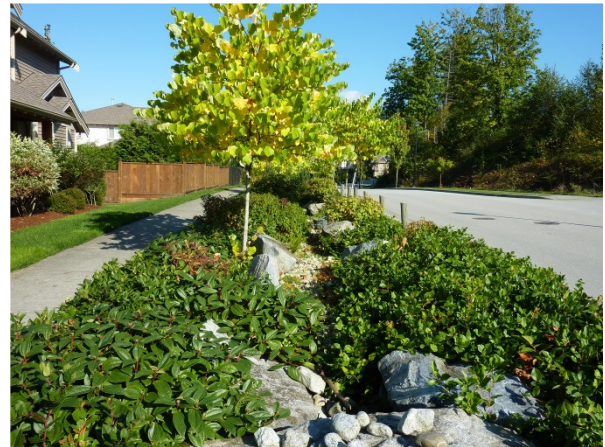
Rain Gardens in Silver Ridge Residential Subdivision Example

Roadside rain gardens were designed and constructed in January 2004 at Silver Ridge in Maple Ridge (annual rainfall 2300 mm compared with Nanoose Bay 910 mm).

2004

2005

2008

2012

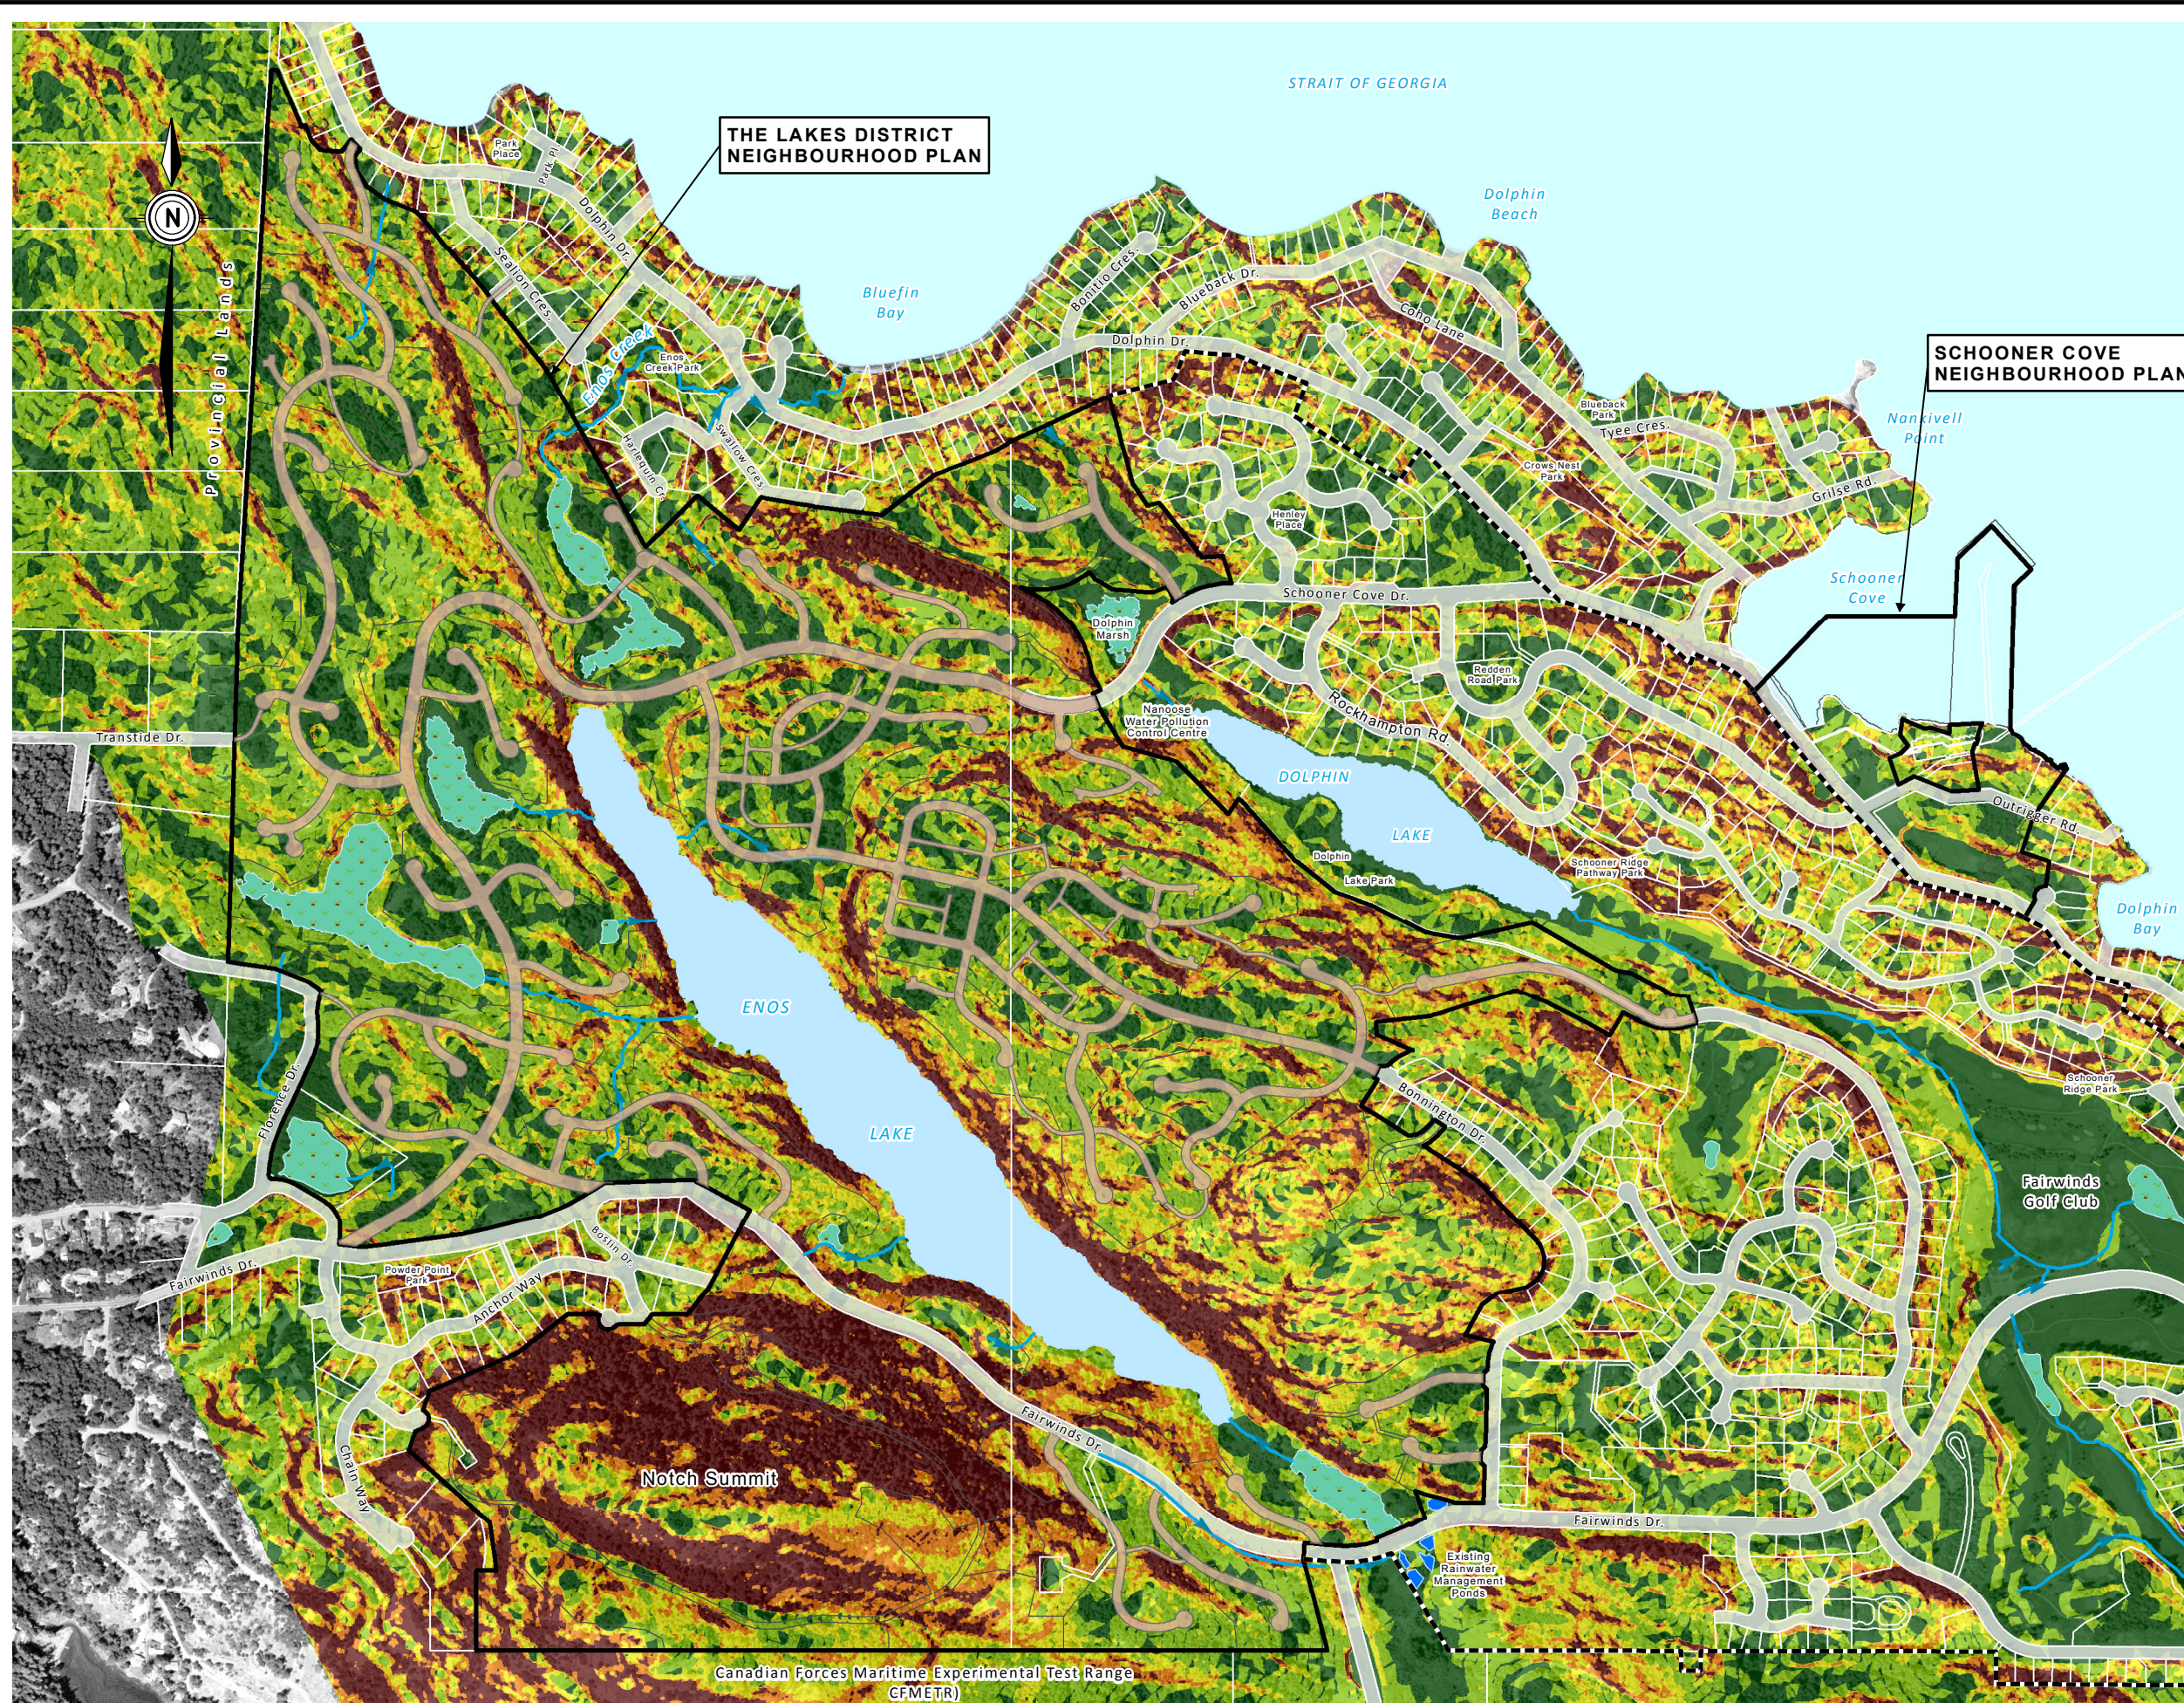
Topography

The topography is varied with hillsides, benches, terraces, lakes and lowlands. Figure 3 shows areas of gentle terrain (0 – 20% slopes, hillsides (20 – 40% slopes) and steep slopes (>40%).
